WILD TROUT TRUST

**River Moy Habitat Assessment
and
Management Plan**

East Mayo Angling Association, Co. Mayo, Ireland

July 2022

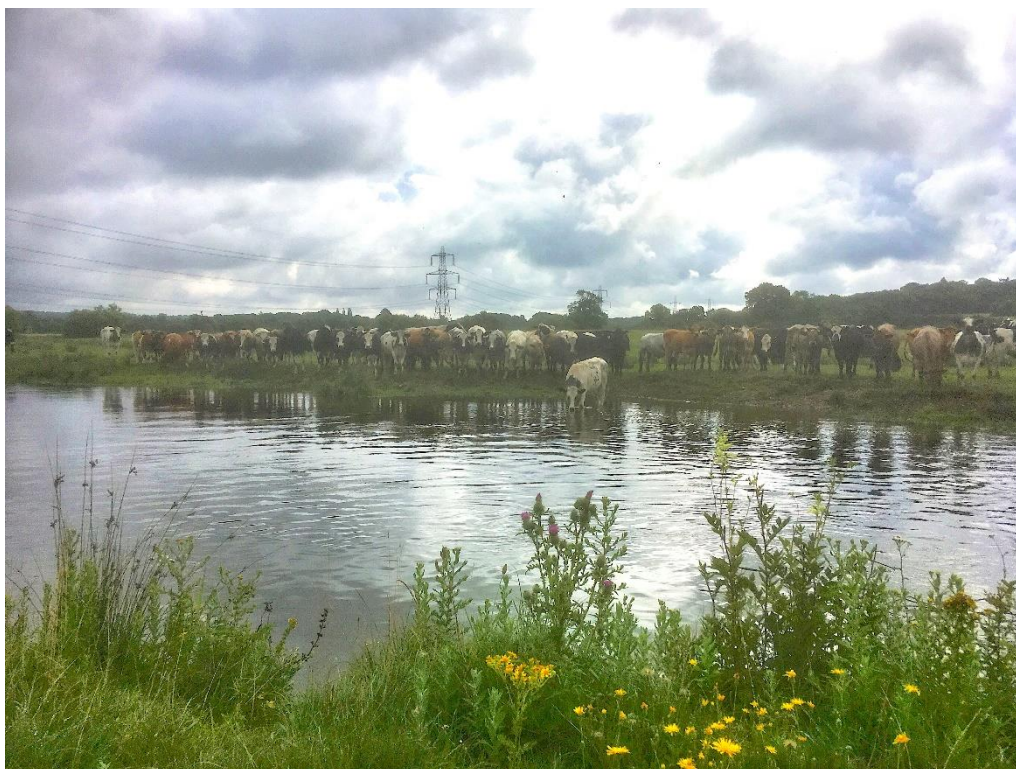
Figure 4. Cows congregating along a watercourse – a common occurrence on unfenced watercourses and around drinking bays, where the input of excreta and fine sediment can be considerable.

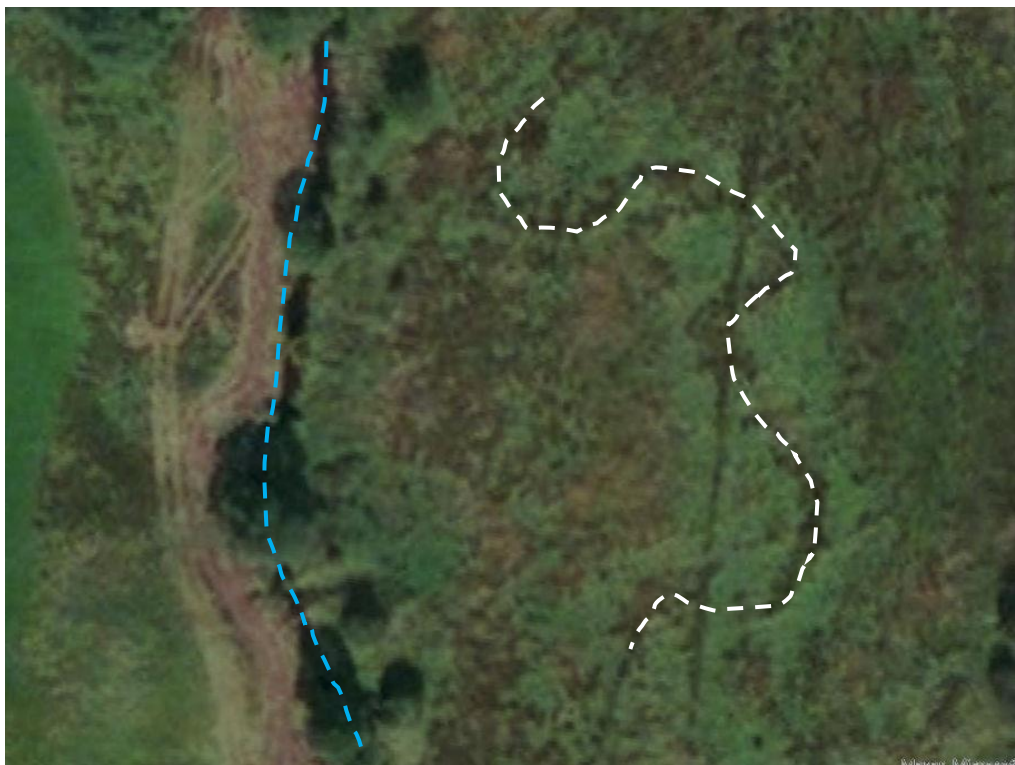
Figure 5. Clear signs of a naturally sinuous channel (white dashed line), evident by rushes and a wet area remaining in the field alongside the current straightened channel of the River Strade (blue dashed line). This area was not inspected in person but was identified from aerial photography maps. Similar can be found elsewhere all over the catchment.

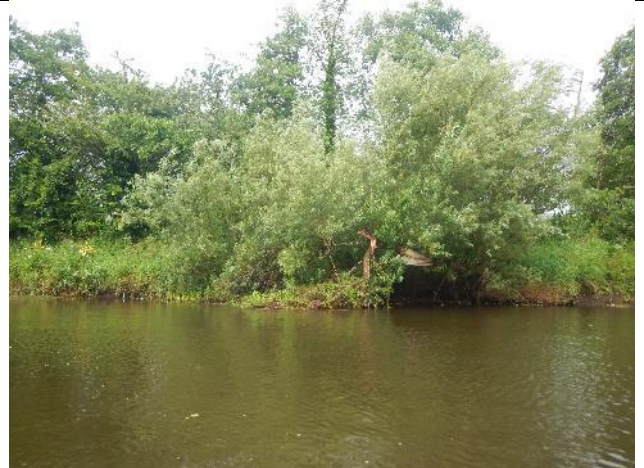
Figure 23: Mo 062 (53.955217, -9.022028). A collapsed crack willow bough trailing in the water, the kind of highly valuable habitat that is often removed on many fisheries to keep a reach 'tidy', but in doing so greatly reduces habitat quality. Any such features should be retained.

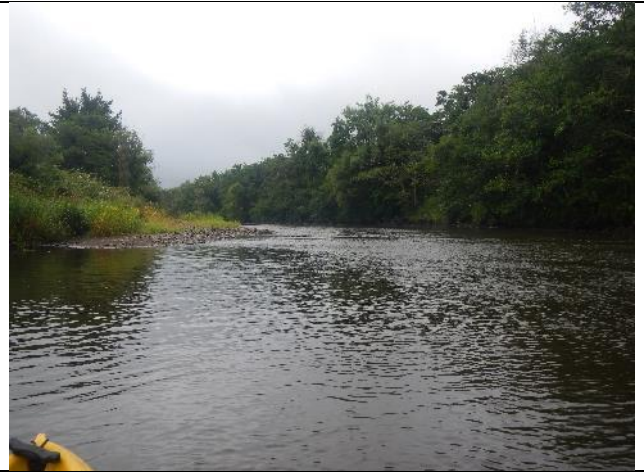
Figure 27: Mo 075. Further gravel retention at a bend, although it was largely lacking mid-channel. These areas create valuable storage of gravel, the sloping profile of which helps to concentrate lower flows to the deeper outside of the bend, maintaining depth in low water conditions.

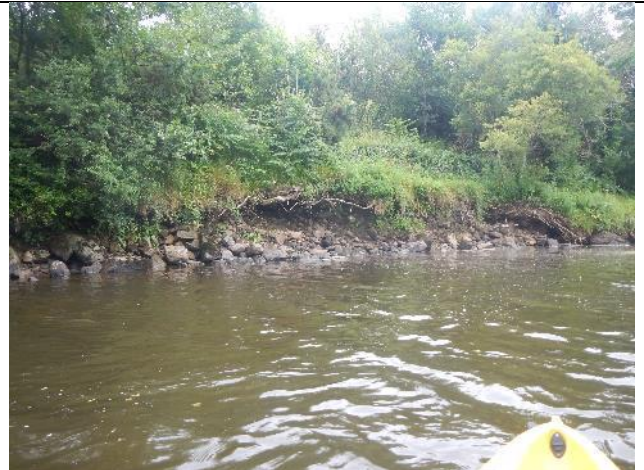
Figure 29: Mo 084. Bank erosion was not a major issue on the Moy, and areas where it was occurring (often likely to be a response to the past dredging/bed-lowering) were helping to re-supply some of the lacking coarse sediment to the river. N.B. This is very different to the detrimental elevated fine sediment and nutrient inputs from livestock access and drinking bays.

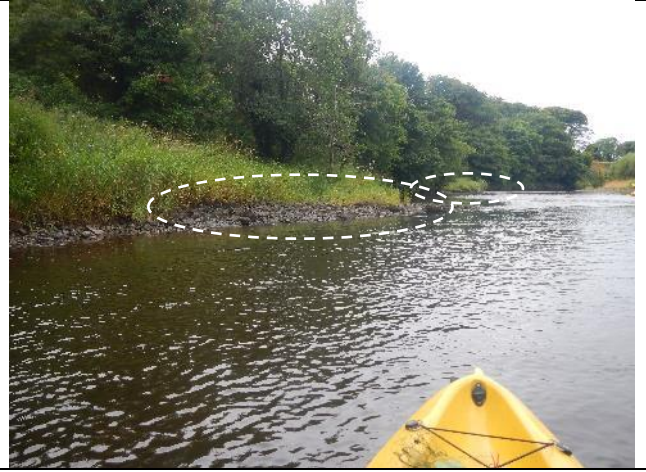
Figure 35: Mo 102 (53.94561, -9.03198). Deposition at a tributary (Mo(T1)) and then a short distance d/s at the Spaddagh River confluence created valuable sloping gravel bars and fish-holding features protruding into the channel (white ellipse). Groynes are an attempt to emulate these features, but usually fail as they are immobile structures that can't adapt to river flow.

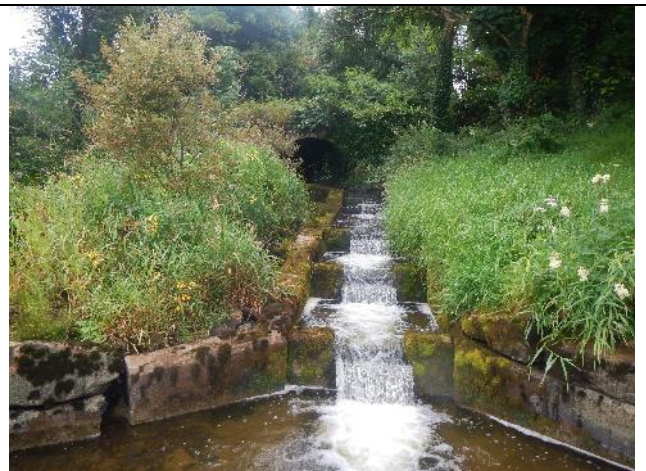
Figure 37: Mo 110 (53.944942, -9.033042). The second access to the Spaddagh is via an old-fashioned fish ladder. This will ease access, but the steps are larger than ideal for smaller fish and the pools are too small (~1.5m long is 50% of recommended) and shallow owing to sediment accumulation. The ideal solution would be to remove the disused bridge and footings u/s to reinstate free passage.

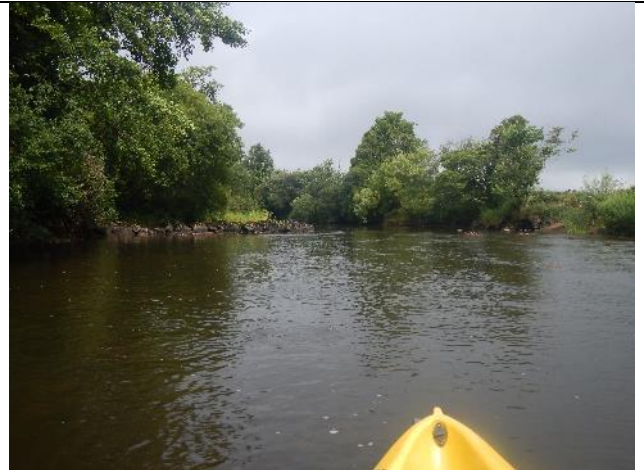
Figure 41: Mo 127 (53.946995, -9.0372). One of the 'better' placed groynes, on an inside bend. These were probably installed when the channel was significantly uniform and degraded post-dredging and benefits to channel morphology where probably achieved, but longer-term, it would be beneficial to remove them allowing more natural features to develop - which these groynes inhibit.

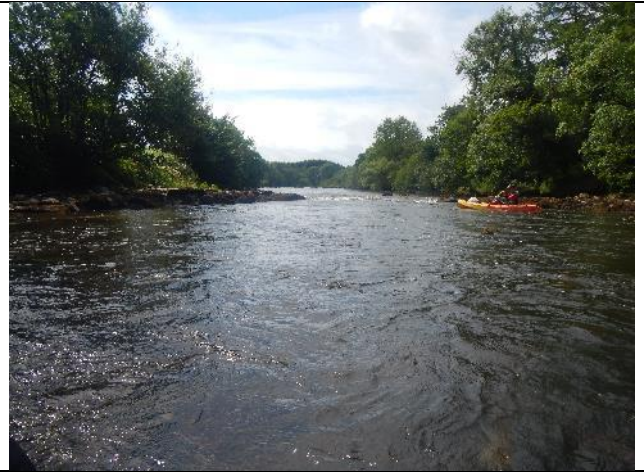
Figure 45: Mo 142 (53.94636, -9.044632). Paired groynes provide some flow deflection and acceleration but, ultimately, the habitat recovery of the river Moy would be better served by maintaining a channel free from man-made structures, that facilitates natural depositional features of coarse sediment, wherever the flow dictates (not artificial, static groynes).

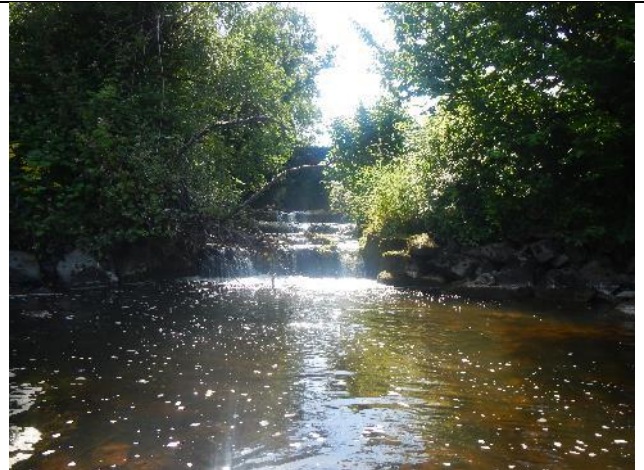
Figure 53: Mo 182 (53.934547, -9.050158). Access from the Moy to the Killeen River is inhibited by a series of boulder weirs. It was not evident whether these were scour protection for the bridge footings u/s or an attempt to ease fish passage over the footings, but access remains restricted.

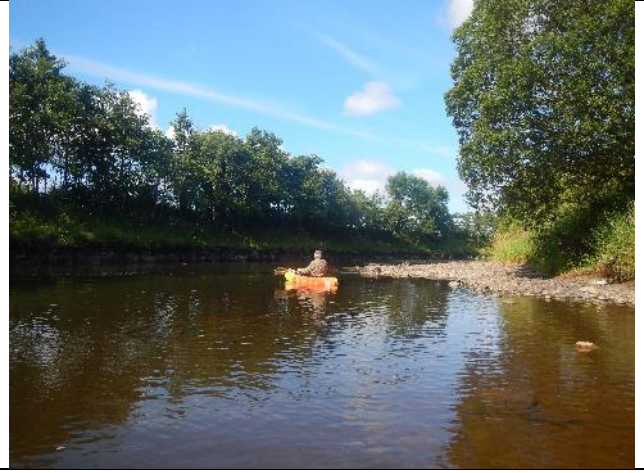
Figure 57: Mo 193 (53.932118, -9.052833). Significant boulder revetment along the LB, which is far from ideal. Bankside (rather than set-back) trees and vegetation should be promoted (including planting) so that when the revetment fails, natural stability will be provided. The revetment should not be reinstated. Planted trees could be trained over the river to increase cover.

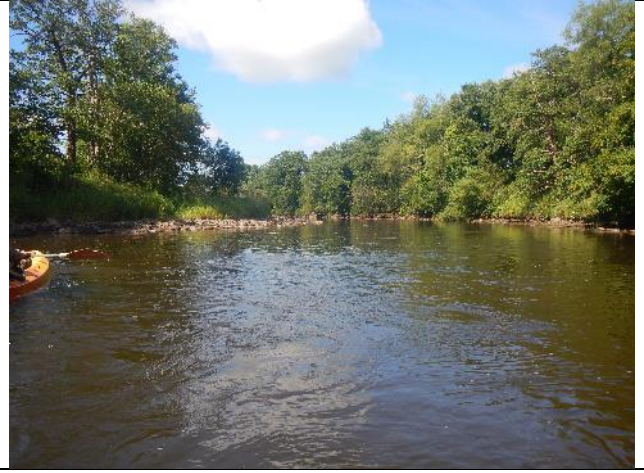
Figure 63: Mo 212 (53.935698, -9.065408). Coarse substrate on the apex of a bend appeared to be the remains of a low groyne. Such features should be encouraged to disintegrate further and adjust to high flows to facilitate the deposition of a naturally transient feature instead. Loosening the leading edge/key stones may be all that is required.

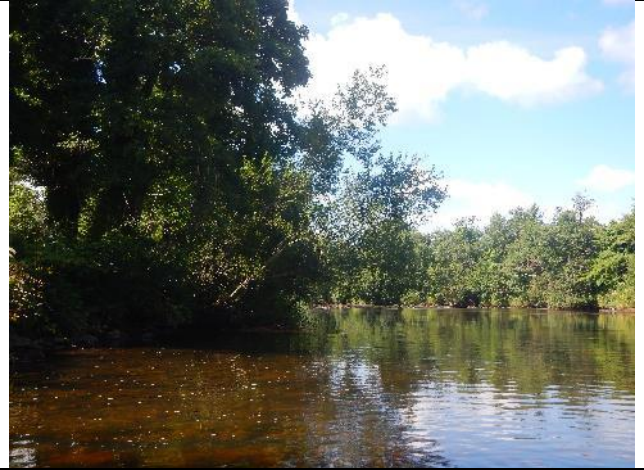
Figure 65: Mo 219. A leaning willow that will ultimately fall into the channel. This could be deliberately laid in to ensure a strong hinge is retained that will secure a valuable habitat feature. Such features provide habitat for fish and a range of invertebrates, along with invertebrate food and refuge from high flows and predators.

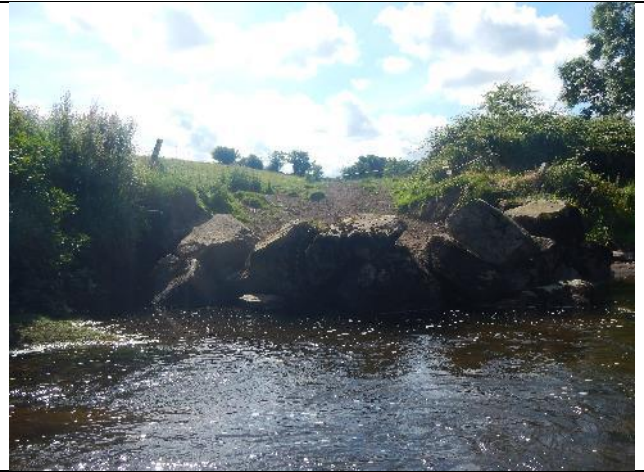
Figure 69: Mo 225 (53.931938, -9.070647). Although enclosed by boulders, this drinking bay was clearly supplying fine sediment and should be replaced with offline watering facilities.

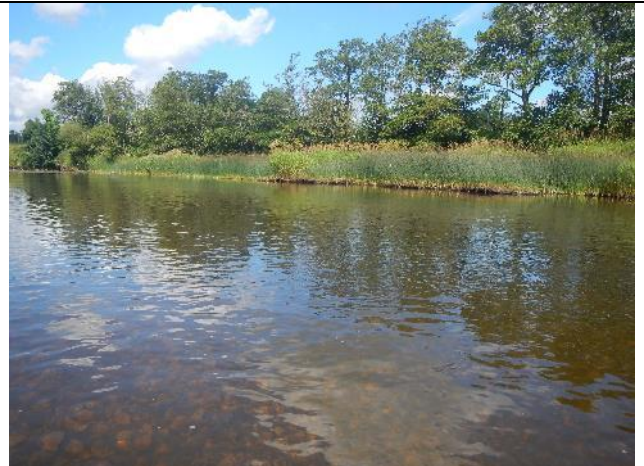
Figure 73: Mo 239. With the reduced gradient and a greater degree of meandering d/s of the Gweestion, emergent vegetation growth increased, beginning to pinch the channel in from the margins in over-capacity areas. However, there was also slight signs of erosion into the vegetation, demonstrating how natural features can adapt to the prevailing flow conditions.

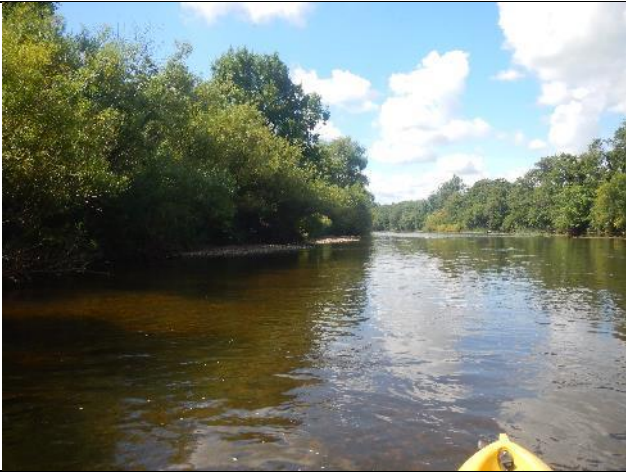
Figure 74: Mo 241 (53.933777, -9.080035). Where dense trees (willow) predominant on a fishing bank, it would be beneficial to accept the reduced access or only create occasional, discrete access points down to the water from an access track set well back from the river, rather than removing branches from over the channel to allow easy access along the river margin.

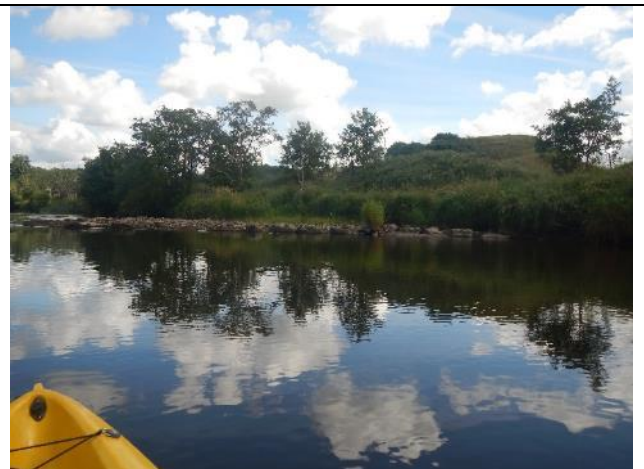
Figure 79: Mo 261 (53.931833, -9.088253). The largest groyne observed extended ~1/2 way across the channel and as with many others, will disrupt the natural transition of flow between two natural bends, but focussing flow hard along the LB after a large RH bend and before a LB bend.

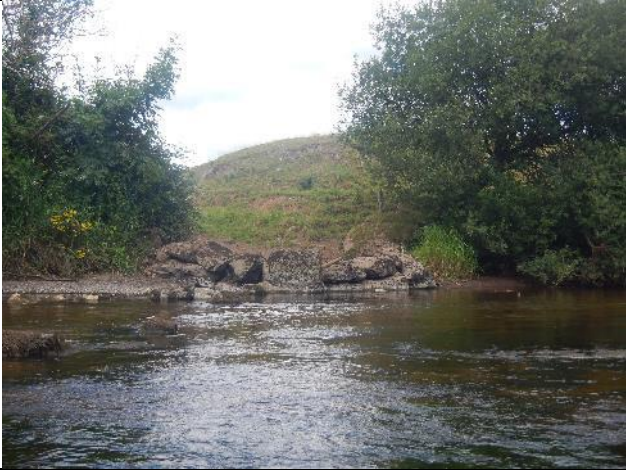
Figure 80: Mo 267 (53.934953, -9.087362). Although dry at the time of the visit, poaching at this drinking bay clearly supplied fine sediment (LB).

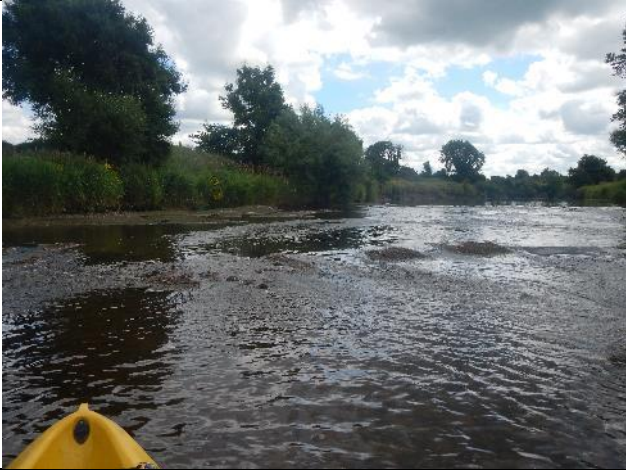
Figure 86: Mo 289. With the wider, lower gradient channel, areas of fine gravel formed a bar in the reach upstream of Ballylahan Bridge. Much of the material was too small for large salmon spawning, but may offer some substrate for smaller grilse, sea trout and resident trout, providing the fine sediment inputs from u/s do not infiltrate or smother the gravel.

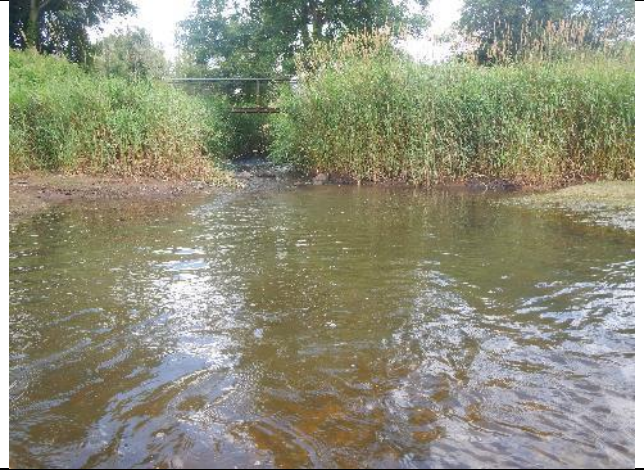
Figure 87: Mo 290 (53.940312, -9.093848). The larger of two small RB tributaries u/s of Ballylahan Bridge appeared accessible and of suitable size to act as a spawning tributary, making it worthy of further investigation (accessibility, fine sediment inputs etc.).

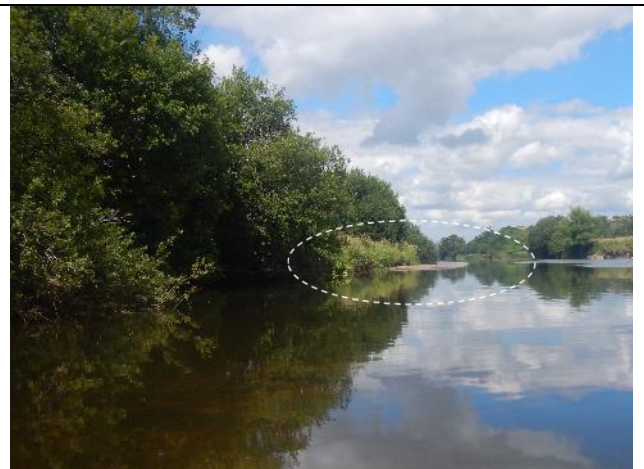
Figure 97: Mo 326. In one small area, gravel deposition along the inside bank (white ellipse), d/s of a bend and aided by roughness from bankside trees, demonstrated some of the slow recovery of morphological features that will happen over (a long) time within the degraded channel.

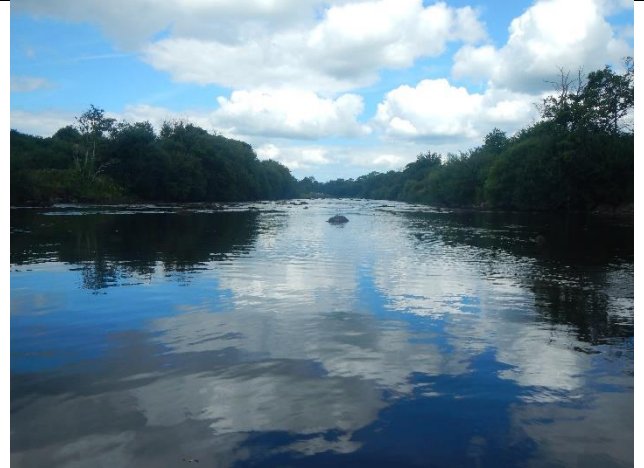
Figure 101: Mo 338 (53.945742, -9.123047). At the d/s end of the uniform section, a bedrock outcrop marked the start of return to more varied habitat. The outcrop may have been what reduced the impact moving d/s, although some of the rock did appear to have been broken out (as appeared to have been undertaken in areas u/s and on the Gweestion catchment).

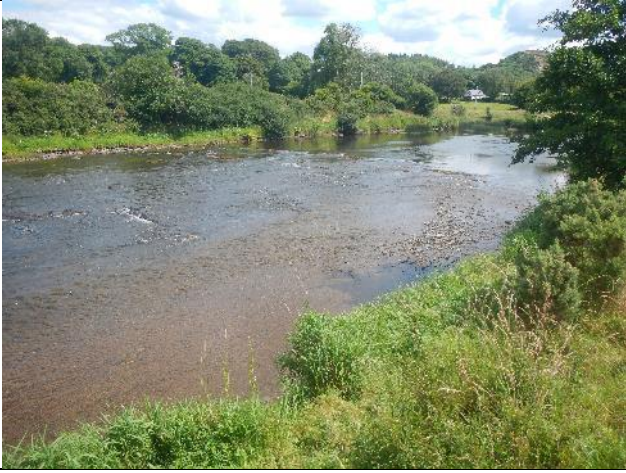
Figure 104: Mo 353. With the wider, less incised channel and lower gradient towards the d/s end of the fishery, varied habitat and high-quality gravel riffles offer a glimpse of what other areas of the river may have been like pre dredging/degradation.

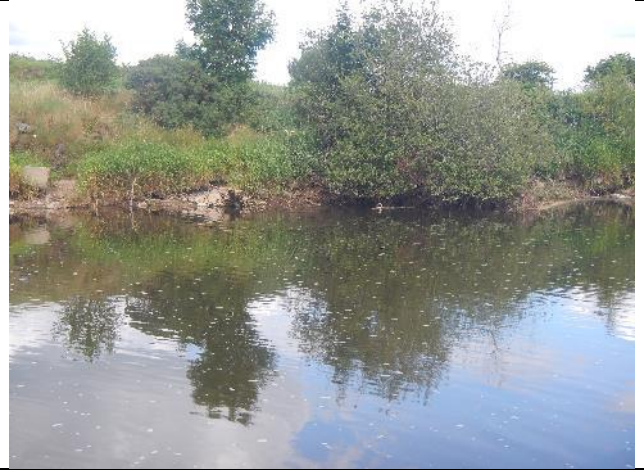
Figure 105: Mo 362. The very lower end of the fishery becomes over capacity again, but bankside trees create specific fish-holding features. A good-sized grilse crashed alongside the willow in this shot as it was passed, demonstrating the fish-holding potential.

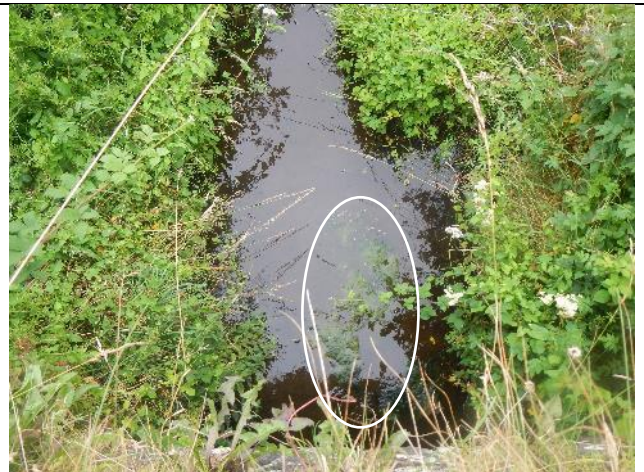
Figure 107: Mo(T1) 002. Looking down from the bridge revealed excess algal growth (white ellipse), indicative of enrichment and nutrient inputs u/s.

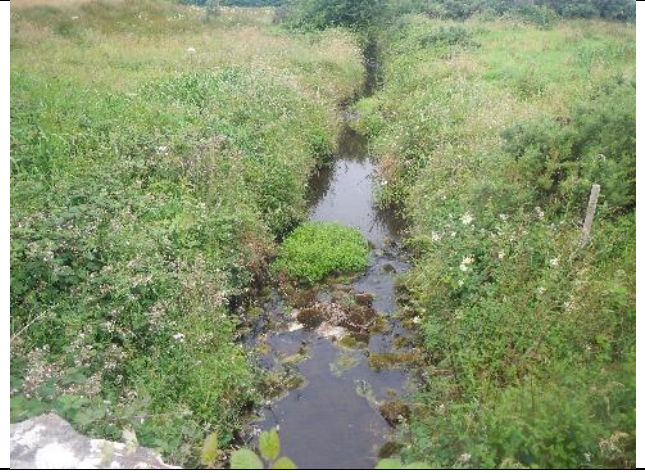
Figure 109: Mo(T1) 006. Habitat d/s of the bridge was similar to that u/s and certainly held juvenile salmonids, as observed.

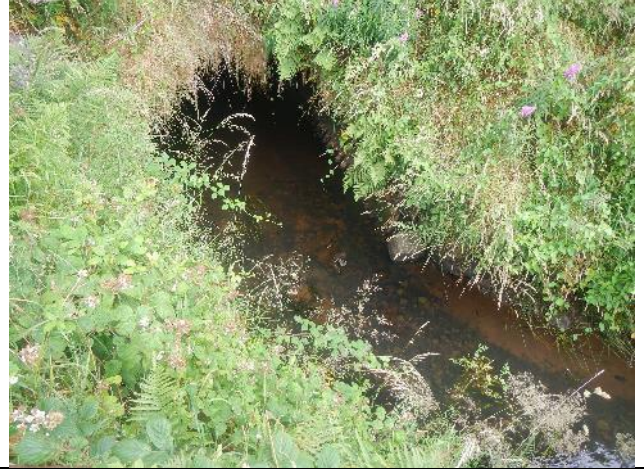
Figure 112: Sw 005 (53.944378, -8.929267). The N5 road culvert was appropriately sunken and provided free fish access. The substrate appeared to have an elevated fine sediment load, but juvenile salmonids were observed there. Further investigation of sediment sources u/s would be beneficial.

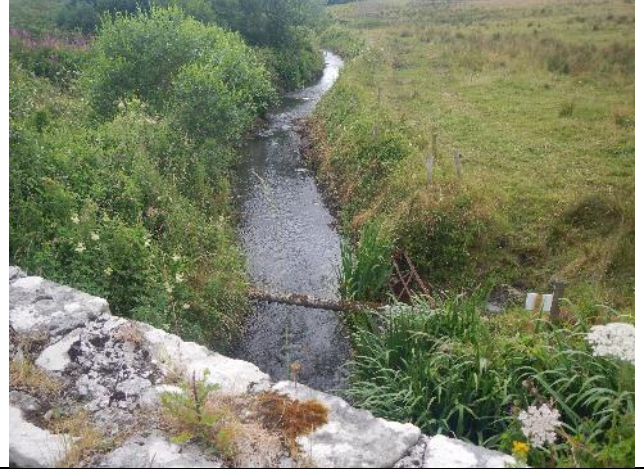
Figure 118: Sw 019 (53.949982, -8.973625). D/s of the Lagcurrach road bridge, a paired groyne and low-level weir were present just, with dredging having been undertaken recently, possibly because of sediment accumulation from the weir. The weir and at least LB groyne should be removed and drinking bay replaced with a pasture pump. Preventing further dredging would be highly beneficial.

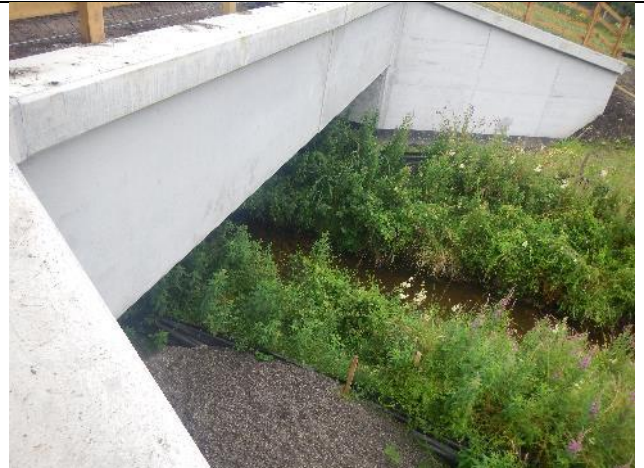
Figure 120: Sw 026. The N26 road bridge was clear-span, creating minimal impact upon the river and no issues for fish passage.

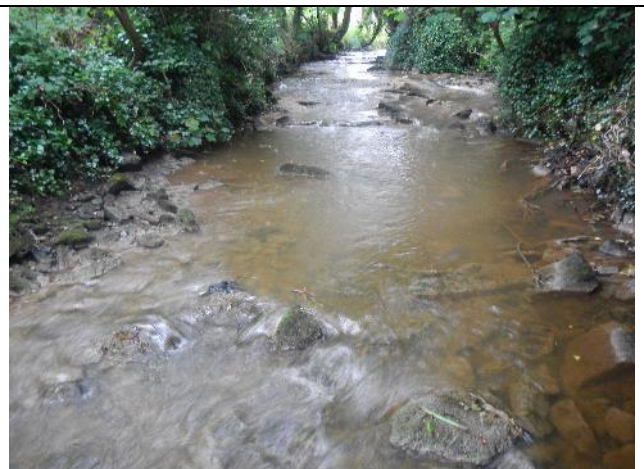
Figure 122: Sw 030. The lower section to the River Moy provided good juvenile salmonid habitat, but the slower areas were negatively impacted by fine sediment deposition.

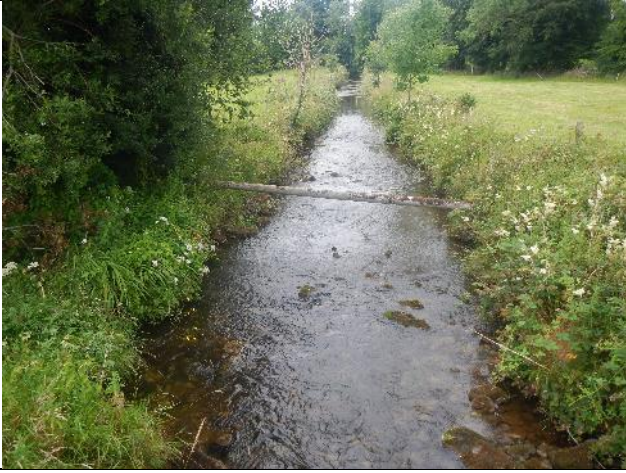
Figure 135: Sp 028 (53.93591, -9.023483). The straightened and uniform channel continued at the next location (u/s and d/s) but was protected from livestock and still provided juvenile salmonid habitat, if lacking shade and cover. Numerous juvenile fish were observed.

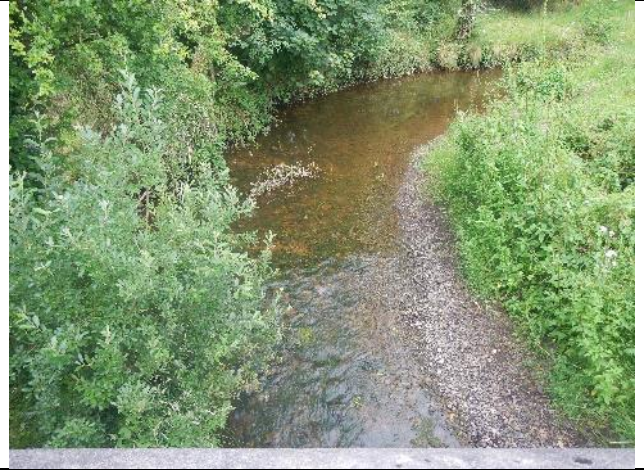
Figure 136: Sp 030 (53.936725, -9.024245). Gravel deposition at one of the few sharper bends observed demonstrates the high potential value as a spawning tributary.

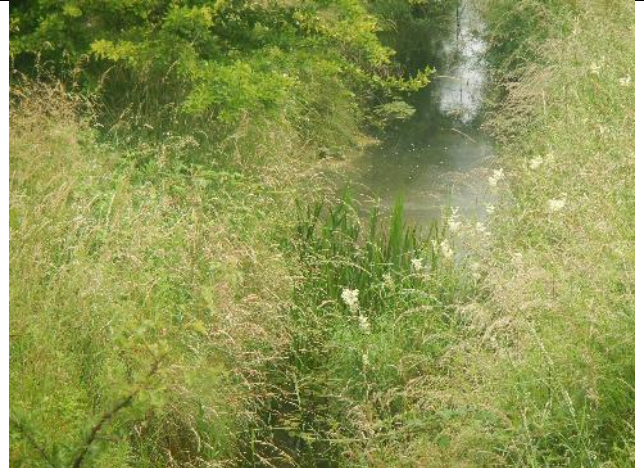
Figure 151: Ki(T1) 007 (53.918813, -8.962095). U/s of the R320, where impounded by vegetation, a scummy film observed on the surface of the watercourse was indicative of organic enrichment. This kind of encroachment and impoundment is usually the result of past dredging, creating an over-capacity channel that then infills with sediment and vegetation.

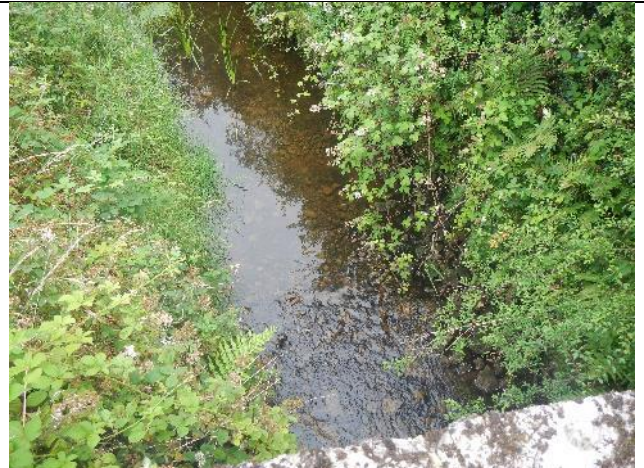
Figure 153: Ki(T1) 013 (53.923122, -8.976833). At the crossing u/s of the N5, although uniform, the channel provided substrate of a suitable size for salmonid spawning. Greater scouring and sorting would improve its quality and more in-channel structure would be beneficial.

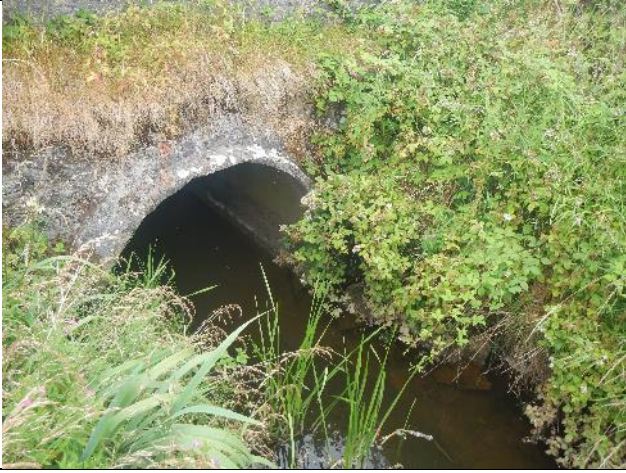
Figure 154: Ki(T1) 014. A culvert observed at the next spot-check was passable by fish.

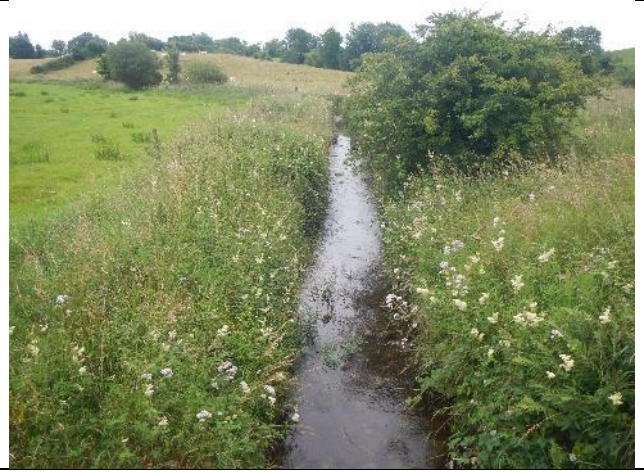
Figure 155: Ki(T1) 020 (53.927917, -9.004203). In the lower reaches, the Killeen tributary offered habitat for juvenile salmonids, despite being realigned and incised. Re-meandering would be highly beneficial. If this is not possible, the addition of woody material could provide improvement, along with the planting of more trees.

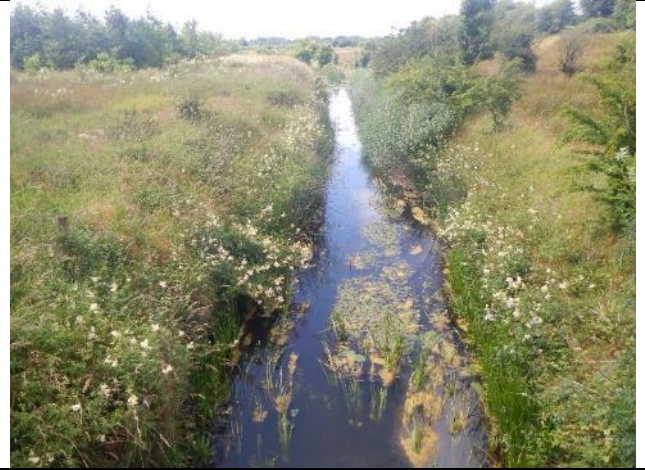
Figure 166: GI 038 (53.823533, -8.86525). D/s of the crossing, signs of significant enrichment were observed by the swaths of floating algae. This enrichment appears to have occurred between this location and the spot-check u/s, where no excess algae was observed (Figure 163).

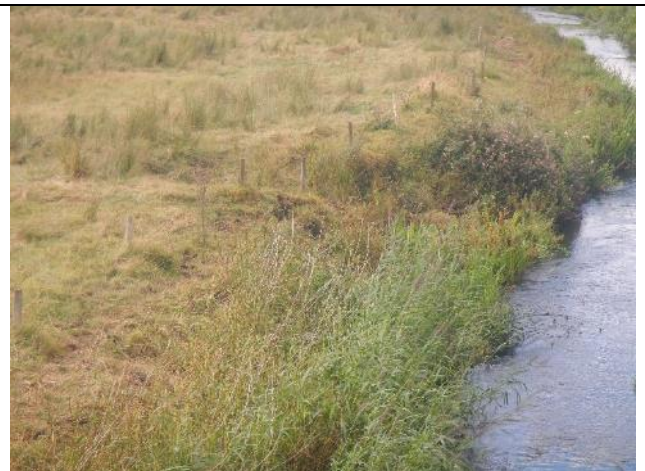
Figure 168: GI 044 (53.828303, -8.87376). D/s of the N17, livestock were gaining access to the LB buffer strip.

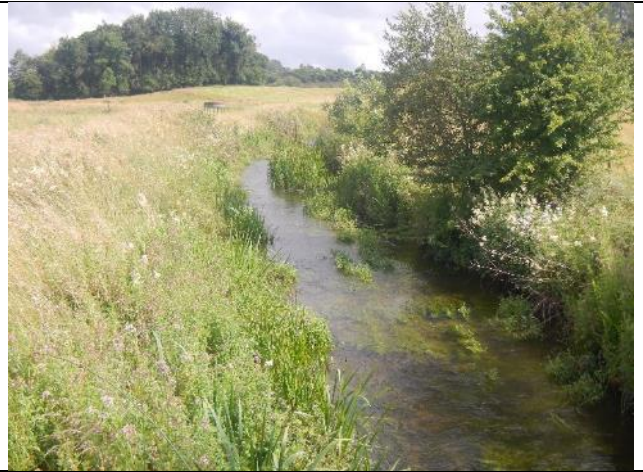
Figure 170: GI 048. Habitat u/s was of a reasonably good quality, although the channel remained realigned and over-capacity, with some natural vegetation narrowing/recovery. Although not observed, aerial photography suggests that there may be weirs around this area. If so, their removal would be beneficial.

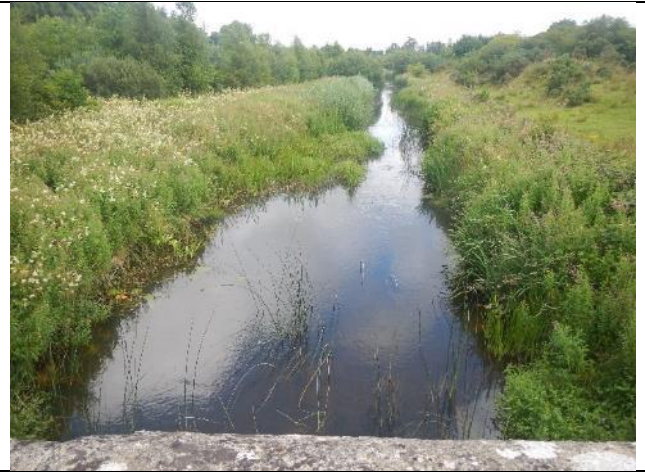
Figure 176: GI 061 (53.856677, -8.934283). Some good-sized adult fish were observed in the deeper sections, demonstrating opportunities for a well-managed trout fishery, but those areas often lacked shallower juvenile and spawning habitat for extended sections, which could improve salmon and trout prospects if improved.

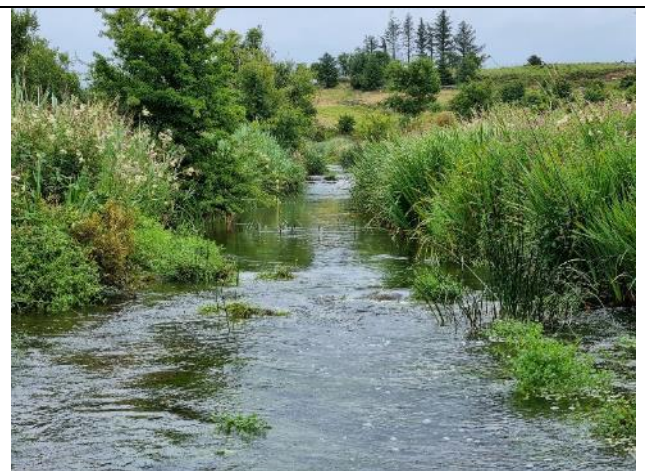
Figure 180: GI 072 (53.860299, -8.966197). Reasonably well recovering habitat, although still degraded by straightening/dredging and weirs. Gravel riffle reinstatement or, ideally, re-meandering could promote a high-value trout fishery here. Tufa (calcium carbonate precipitate) became increasingly prevalent from around this area, often forming barrages.

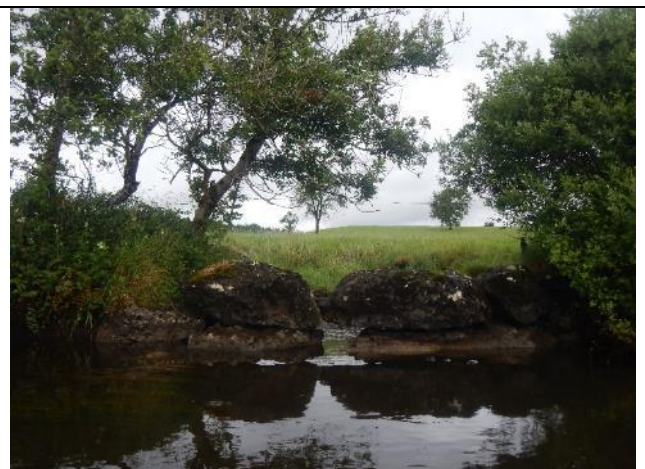
Figure 228: Gw 178 (53.914165, -9.031747). Drinking bay. Although not appearing to be in use at the time, it would be beneficial to replace this with alternative watering if the field is grazed.

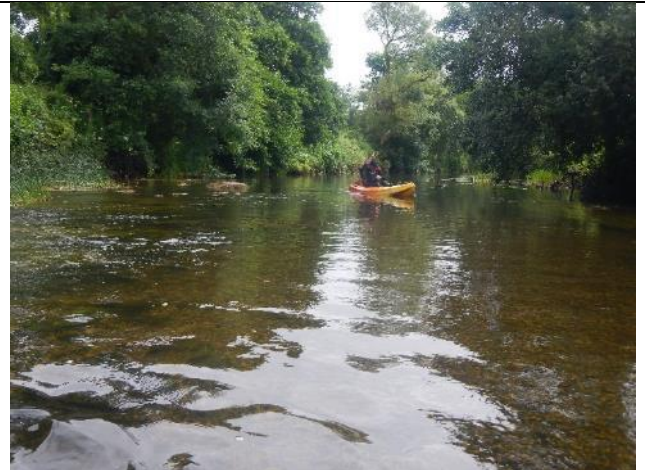
Figure 232: Gw 190. Wider sections in the lower river, where the gradient reduced, were also retaining more of the coarse substrate, providing improved invertebrate habitat, even in areas too deep for optimal salmonid spawning.

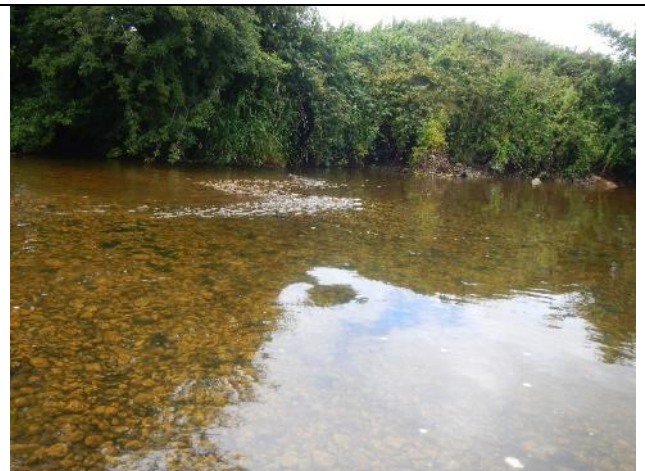
Figure 240: Gw 273. In the lower gradient areas of the lower Gweestion, high quality gravel bars were observed – along with the remains of redds.

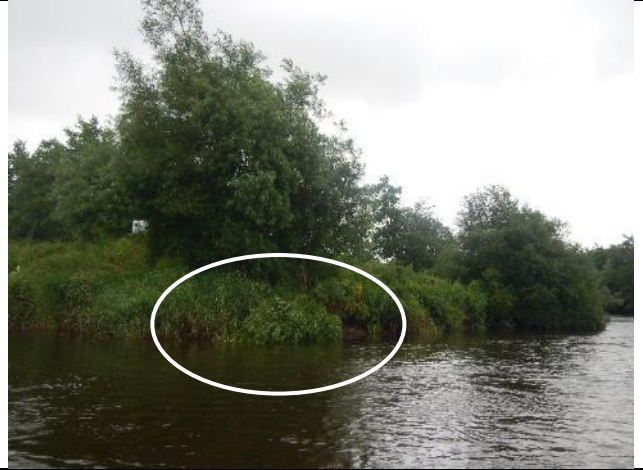
Figure 242: Gw 294. A recently fallen willow (white circle) on the RB at the confluence with Moy provides valuable trailing cover in the river margin and should be retained. Such features have traditionally often been removed from fisheries but in doing so, habitat is degraded along with the fish-holding potential of that area.

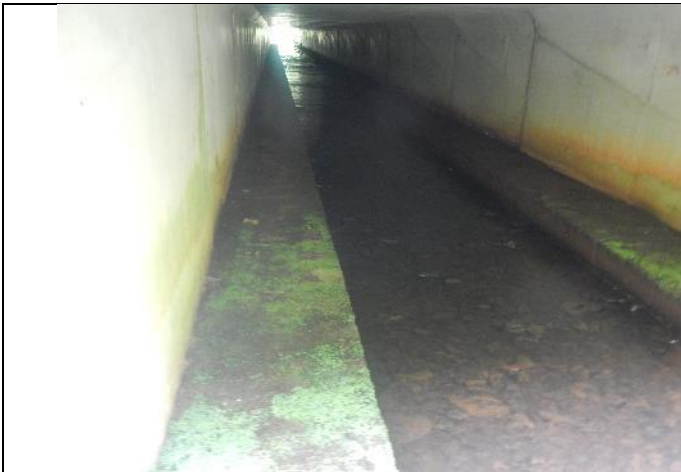
Figure 243: Gw(T1) 003. Although long, the natural substrate of R321 culvert provided reasonable fish passage

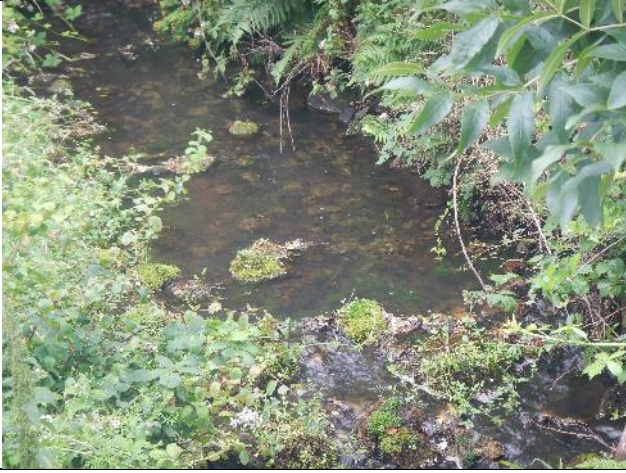
Figure 245: Gw(T1) 008 (53.898557, -9.022697). Substrate capable of supporting salmonid spawning was also observed in the lower reaches, although greater sorting would increase the likelihood of it being used.

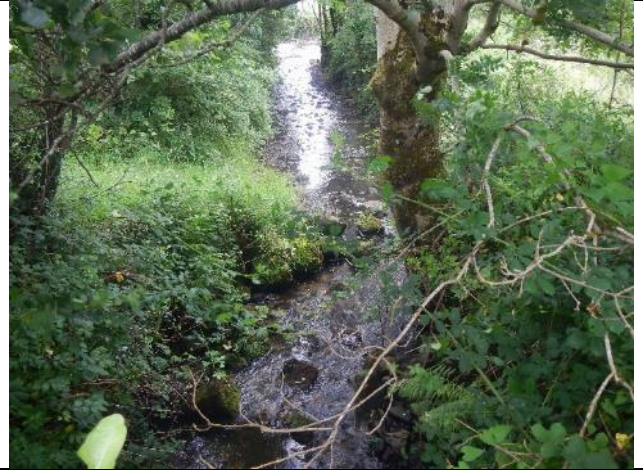
Figure 246: Gw(T1) 010. The lower reaches towards the Moy provided good juvenile habitat (for a straightened channel).

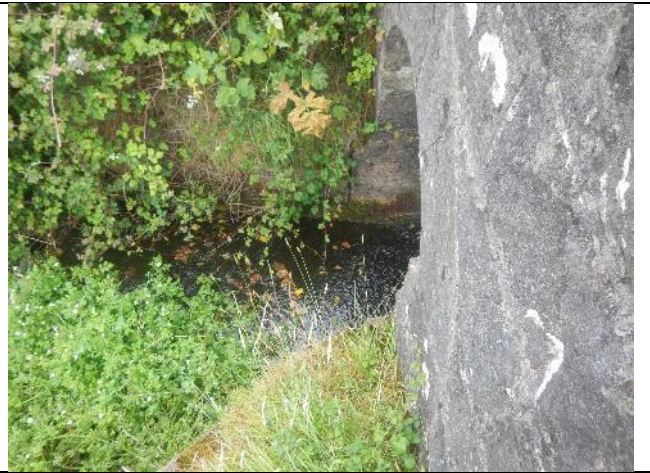
Figure 252: Gw(T3) 002 (53.916445, -9.054422). The tributary appeared to be accessible from the main river at the points observed, although shallow water over a smooth (presumed to be concrete) bed created a small obstruction at one of the road crossings.

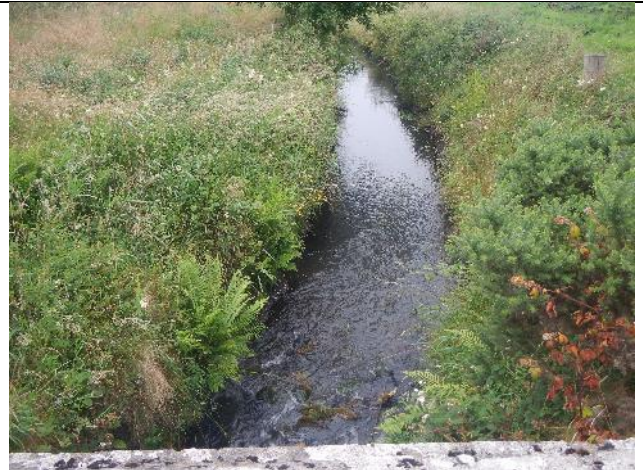
Figure 254: Tr 004. D/s of the road, raised bridge footings created a small obstruction but were rough and passable by fish. The turbulence they created gave hint of the flow diversity regular riffles and a more morphologically diverse channel should support. Lower grade land along the LB may offer the greatest potential for restoration/re-meandering but both banks have potential.
