WILD TROUT TRUST

**River Moy Habitat Assessment
and
Management Plan**

East Mayo Angling Association, Co. Mayo, Ireland

July 2022

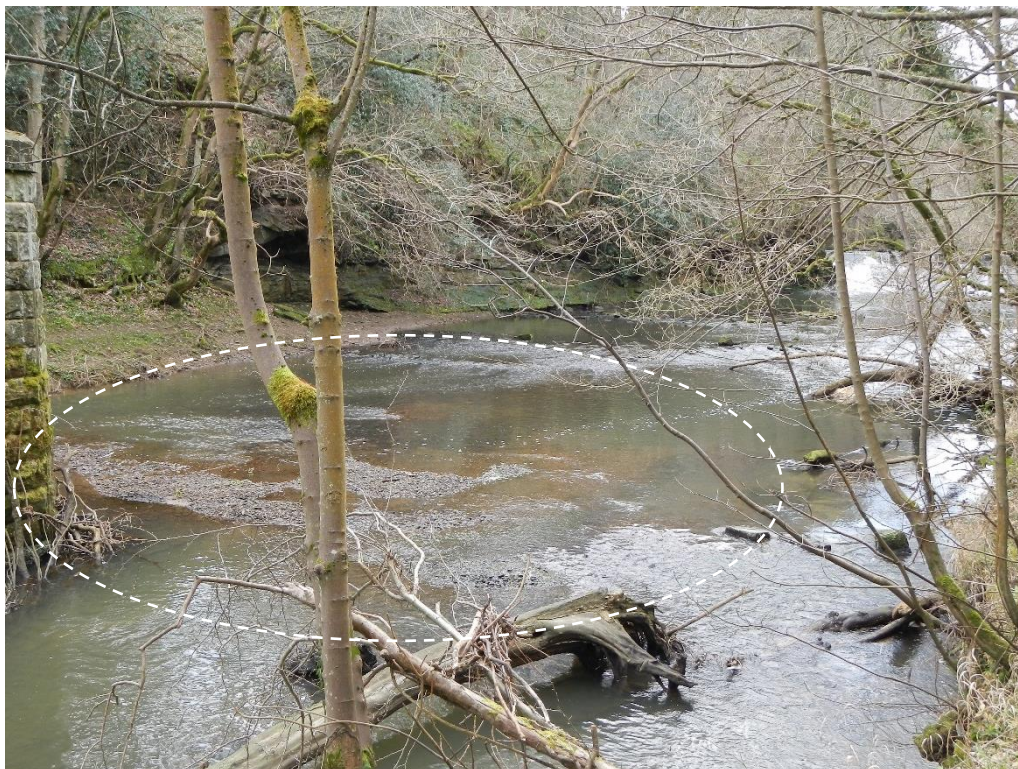
Figure 2. An area of redds (white ellipse) and significant over-cutting on the River Blyth in Northumberland, England. The weir upstream (right of shot) restricts access upstream, forcing numerous fish to spawn on the only suitable habitat downstream. This does not optimise recruitment within a river and can occur whenever there is a lack of habitat availability – whatever the cause.

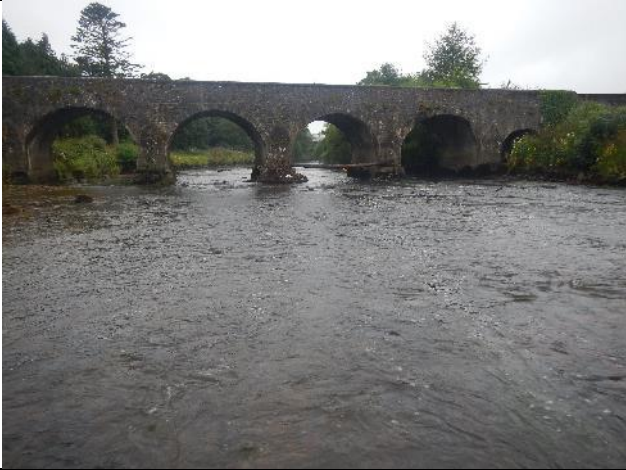
Figure 8: Mo 002 (53.958977, -8.993277). The furthest u/s point inspected on the Moy was just u/s of the old N26 road bridge. At that point, the river was shallow with a predominantly bedrock and boulder bed, supporting good juvenile salmonid habitat, although a scarcity of smaller cobble and gravel limited salmonid spawning opportunities.

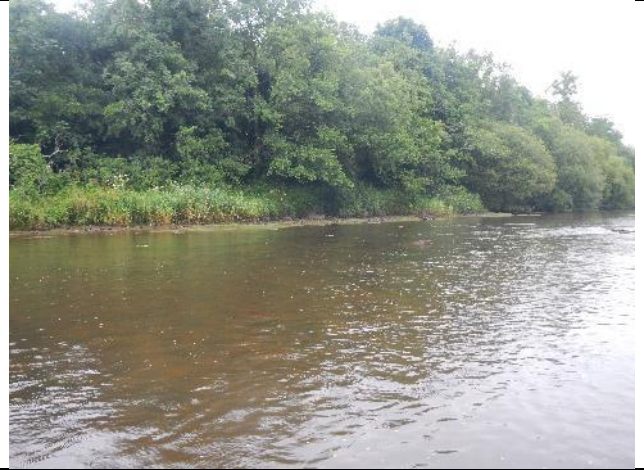
Figure 9: Mo 005. D/s of the bridge, deeper glide habitat was suitable for older parr. Coarse gravel and cobble substrate in the LB margin may have provided spawning habitat in the past but had become consolidated by aquatic vegetation as the channel adjusts its capacity to the natural variations in flow it receives.

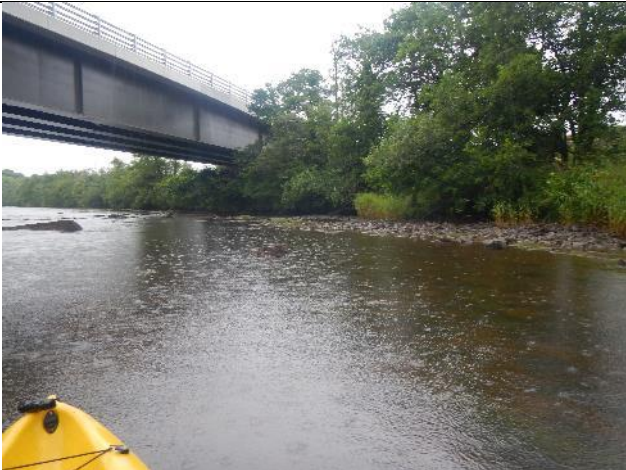
Figure 10: Mo 006. Cobble deposits (exposed during the low flow) in the RB margin u/s of the new N26 road bridge appeared to show signs of more recent signs of remobilisation, possibly spawning activity/redds.

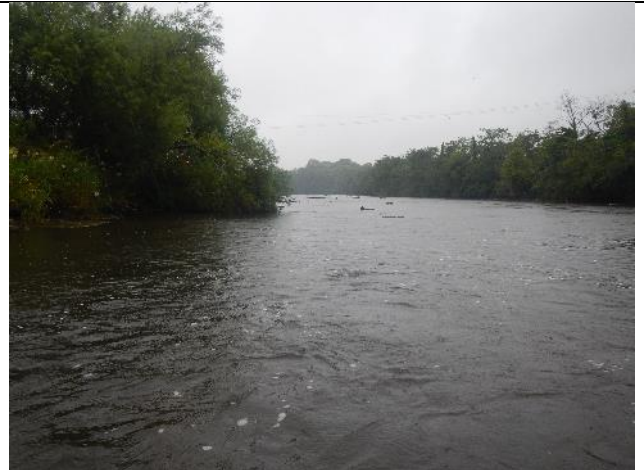
Figure 11: Mo 008. Moving d/s, bankside willows trailing into the river offering valuable refuge, shade, cover and flow diversity, the latter also encouraging valuable coarse sediment retention in the river margin.

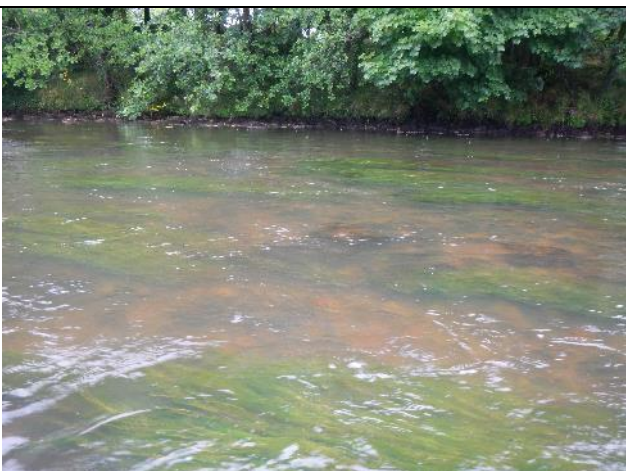
Figure 12: Mo 012. Aquatic vegetation within the channel enhanced habitat for juvenile fish and the invertebrates upon which they feed.

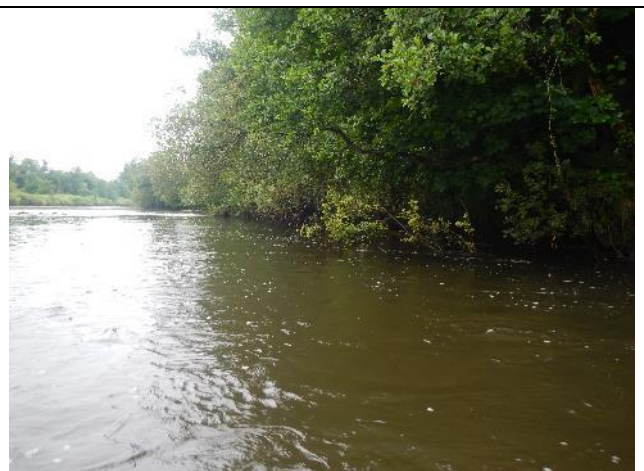
Figure 13: Mo 016. Valuable overhanging/trailing bankside trees providing cover, flow deflection and lies for adult fish in higher water. Some uneducated anglers may complain such features are snags and require pruning, but these features are the main reason fish will hold there – remove the features and you run the risk of removing the fish.

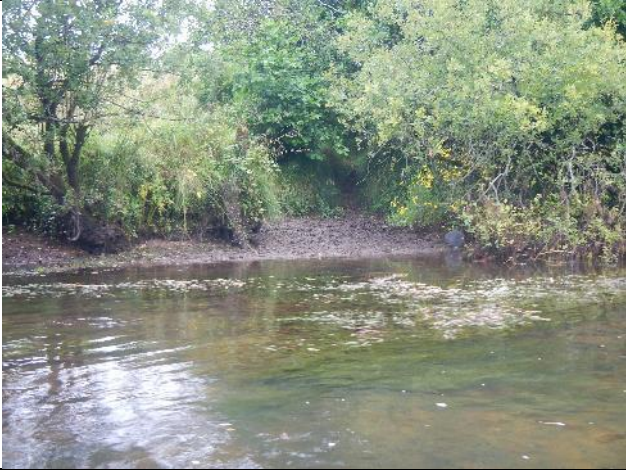
Figure 14: Mo 019 (53.955967, -9.003405). Fine sediment and nutrient input from drinking bay (RB).

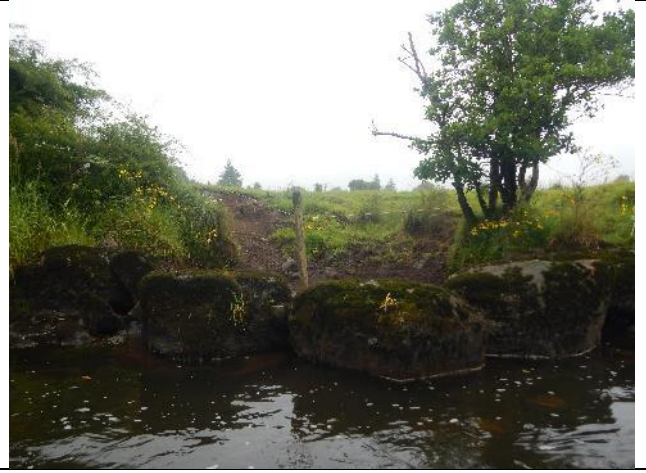
Figure 15: Mo 030 (53.953675, -9.008127). Fine sediment and nutrient input from drinking bay (RB).

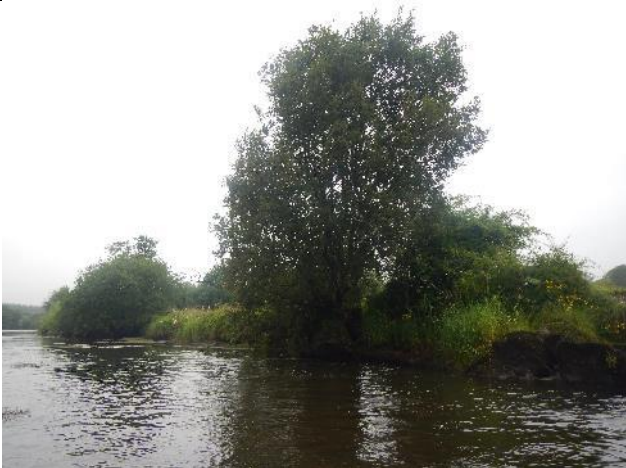
Figure 16: Mo 031 (53.953657, -9.00812). A mature willow tree could be beneficially hinged down into the channel to provide increased flow diversity and fish-holding, while also facilitating deposition and retention of gravels in the channel.

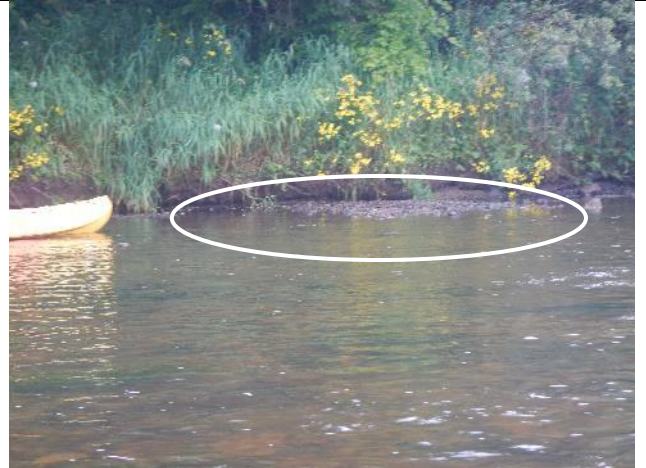
Figure 17: Mo 032 (53.953598, -9.008362). Raised gravel mounds that were likely to be old salmon redds along the LB margin.

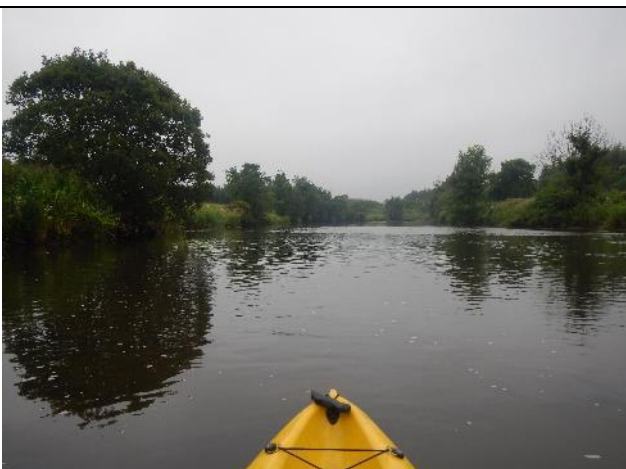
Figure 18: Mo 034. Larger pools provided resting areas for larger adult salmonids which will be further enhanced as the bankside willows grow out further into the channel, providing additional shade and cover.

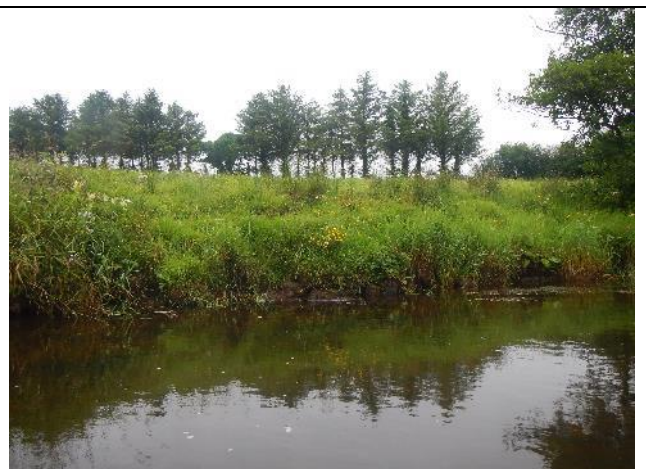
Figure 19: Mo 036 (53.953498, -9.01064). Livestock access LB. While the grazing appeared to be at a relatively low intensity, the pressure was sufficient to reduce the diversity of bankside vegetation and suppress natural tree regeneration. Buffer fencing would be beneficial.

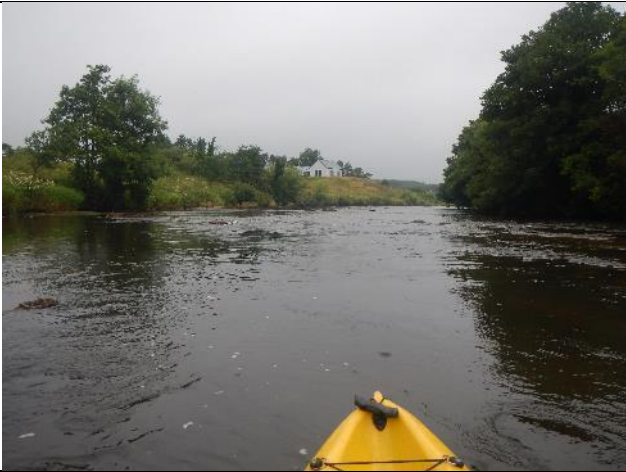
Figure 20: Mo 038. Regular faster-flowing areas d/s of the pools provided good juvenile habitat, but the gravel lifts that would usually be associated with them were often lacking owing to past substrate dredging. This had undoubtedly reduced habitat diversity/quality and main river stem salmonid spawning opportunities in many areas.

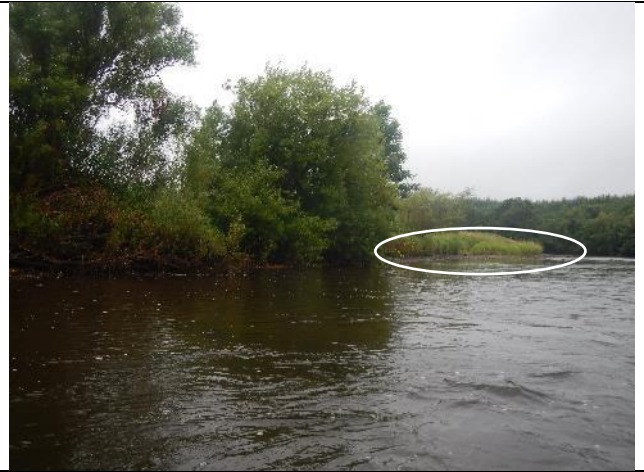
Figure 21: Mo 052. Where inside bends were sufficiently acute, gravel and cobble substrate were often retained (white ellipse). In this instance, further aided by bankside willows u/s that dissipate flow energy along the bank. As the river recovers from past dredging, these areas provide some surrogate habitat for gravel riffles lost mid-channel, until they fully recover.

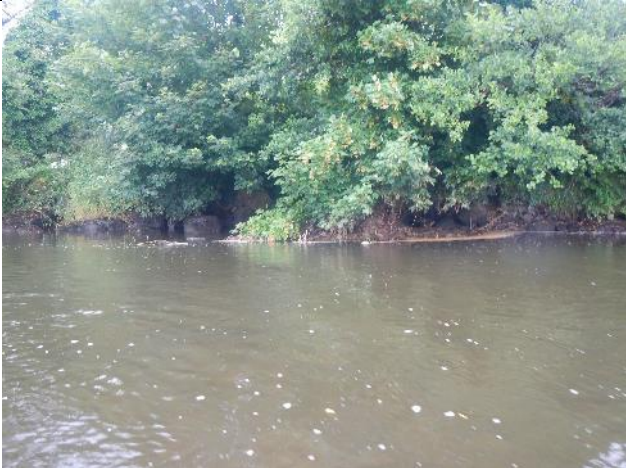
Figure 22: Mo 054. Branches and other organic debris accumulating on a trailing bough. Far from being an issue, features like this created valuable, natural fish-holding lies and food and habitat for a diversity of invertebrate species.

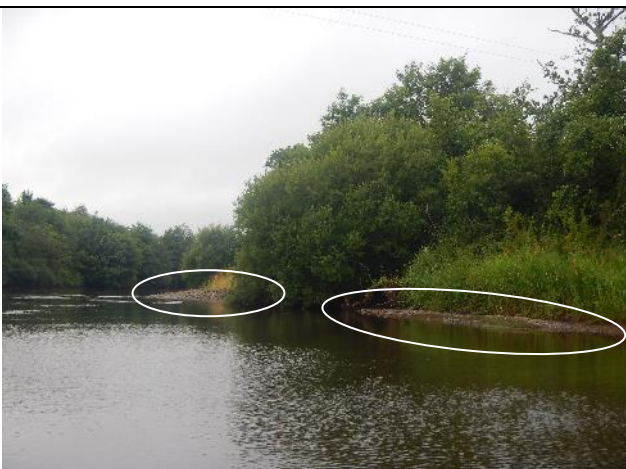
Figure 24: Mo 063. Further gravel accumulation (white ellipses) assisted by the bankside willows. This gravel retention and accumulation is a vital part of the channel's natural recovery process to reinstate more natural dimensions and morphological features following the past dredging.

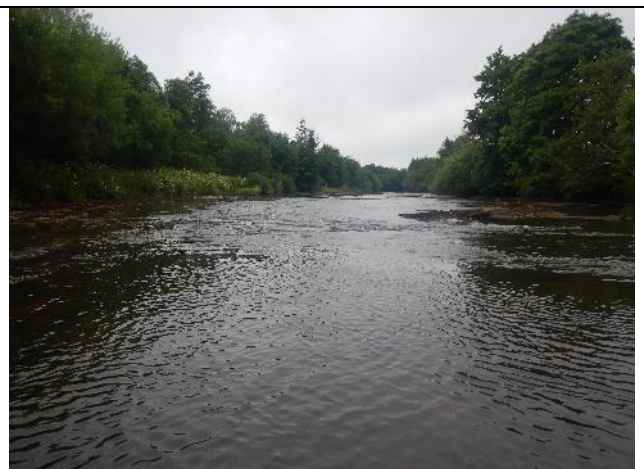
Figure 25: Mo 068. Exposed bedrock at many locations is likely to be a combination of natural outcrops and a result of past dredging to remove mobile substrate.

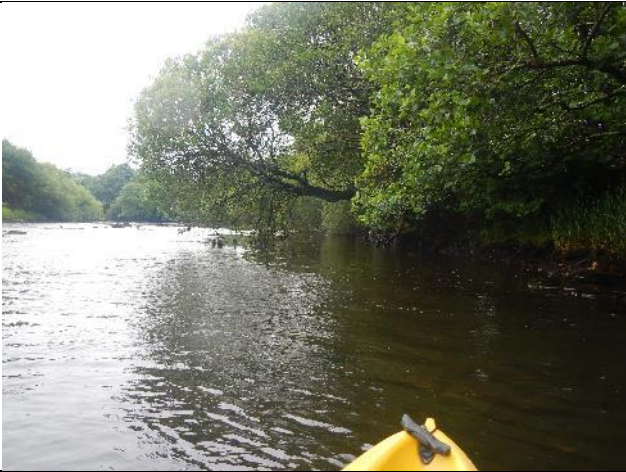
Figure 26: Mo 070 (53.953703, -9.029193). Low, trailing branches are often seen as a snag to lose tackle on, but they provide massive enhancement to a fishery through terrestrial insect input, increased fish-holding areas and refuge from predators. Remove the feature: remove the fish from that area of the pool (possibly the pool entirely).

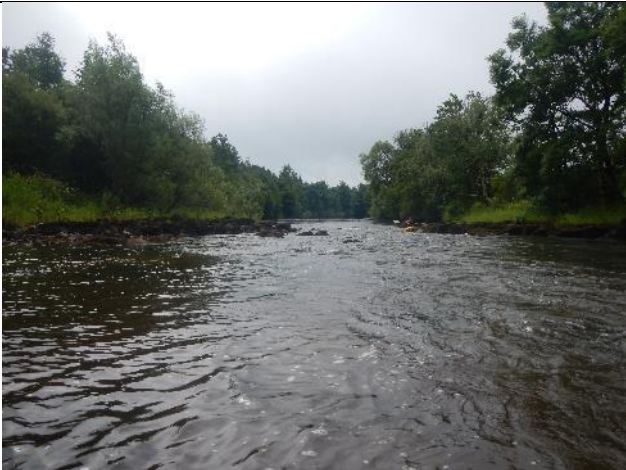
Figure 28: Mo 080 (53.951163, -9.029812). Numerous groynes were observed along the river, presumably installed as fishery enhancements following the degradation of in-channel habitat by dredging. However, unlike natural depositional features, they cannot adjust and often reduce flow sinuosity within the channel, inhibiting gravel retention in other areas.

The main recommendation for the Moy is to restore river processes and facilitate further natural channel recovery. Retaining the overhanging and trailing bankside trees will be vital, along with removing counterproductive groynes. It may be beneficial to prioritise the d/s groynes first as there is already more gravel in the river with progression downstream, so the positive impact is likely to be more rapid.

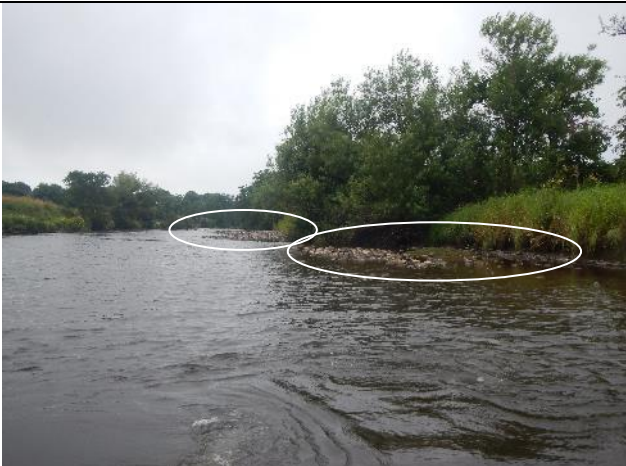
Figure 30: Mo 086 (53.948825, -9.028517). Note how valuable areas of gravel retention on this relatively gradual bend had been greatly enhanced by channel roughness created by bankside willow.

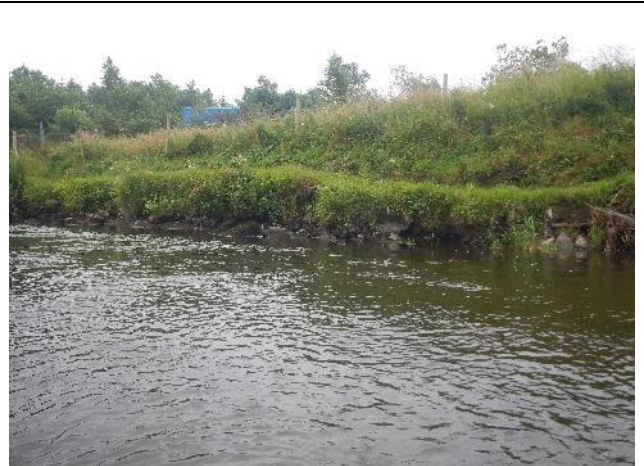
Figure 31: Mo 088 (53.948318, -9.028927). Maintaining a rougher, uncut vegetated fringe along the river side of a narrow access track would offer improved protection. Further protection could be provided with brush (live or dead) to dissipate the energy of flow hitting the bank face and/or the planting of willow whips.

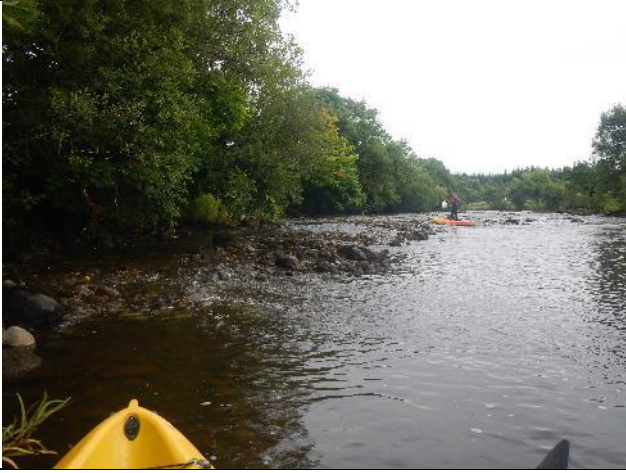
Figure 32: Mo 093 (53.946867, -9.031037). One of the few large, in-channel gravel and cobble bars in the upper section, d/s of a large bend and pool. This creates valuable channel diversity and hints at the long-term recovery occurring post-dredging.

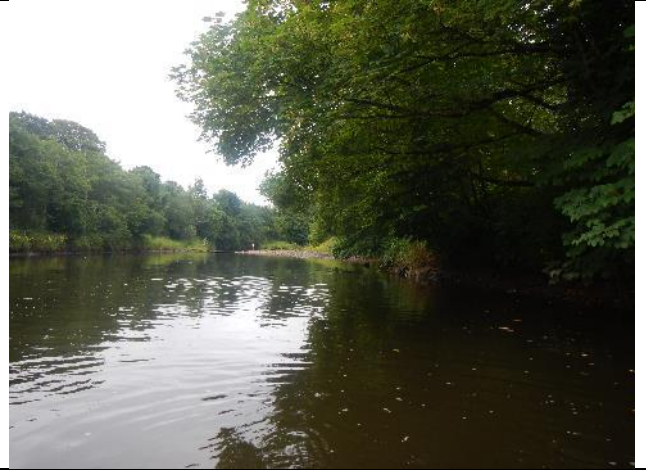
Figure 33: Mo 096 (53.946202, -9.031598). The low boughs of this tree were festooned with lures. Although many anglers don't appreciate low branches, they often inadvertently know their value as fishing features to fish too. Sadly, many then also want them removing to ease access, but without the branches there'd be fewer fish.

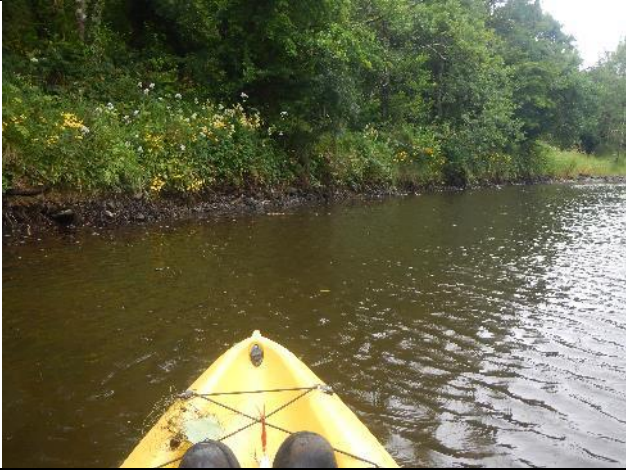
Figure 34: Mo 100. Further valuable gravel input from a gradually eroding bank. Note how the trees and vegetation were maintaining the erosion at an acceptable rate.

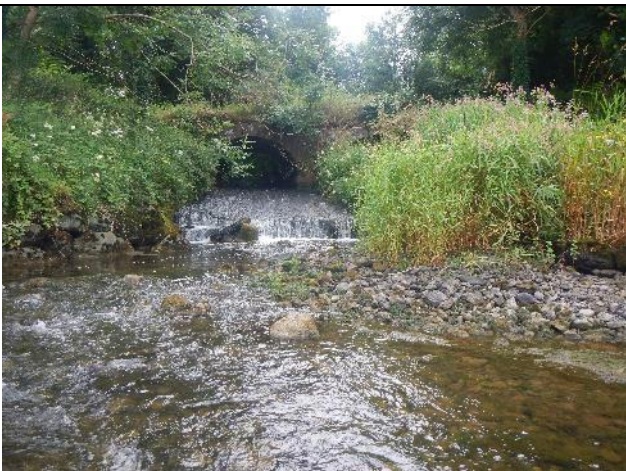
Figure 36: Mo 106 (53.945018, -9.03295). Two access routes exist to the Spaddagh, the first via perched bridge footings that are impassable in most flows but may attract and delay fish. Note the gravel deposition, which is likely to at least in part be material supplied by the Spaddagh.

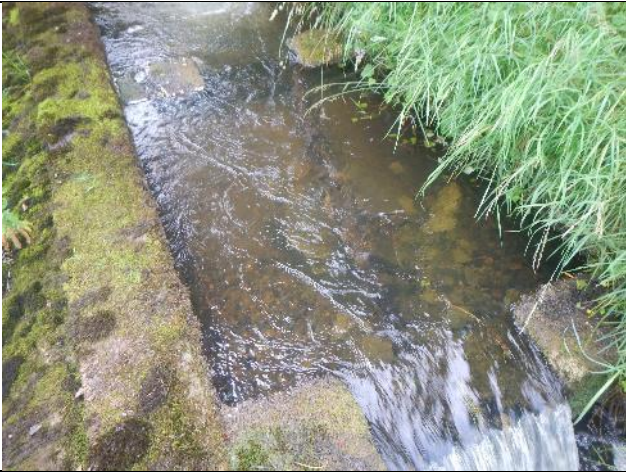
Figure 38: Mo 113. Gravel material partially infilling the pools of the fish ladder. This reduces depth and energy dissipation within the pools, thereby also reducing the ease with which fish can jump from pool to pool. The ideal solution would be to remove the old bridge and footings to allow free access to all fish in all flows.

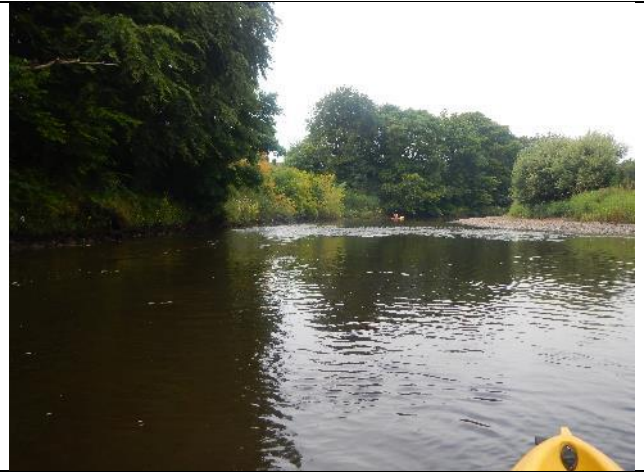
Figure 39: Mo 115. The pool d/s offers valuable holding water for any fish there waiting to ascend the tributaries. The increased channel width was facilitating valuable gravel deposition on the inside bend and mid-channel, providing significant habitat enhancement over the unnaturally bedrock sections.

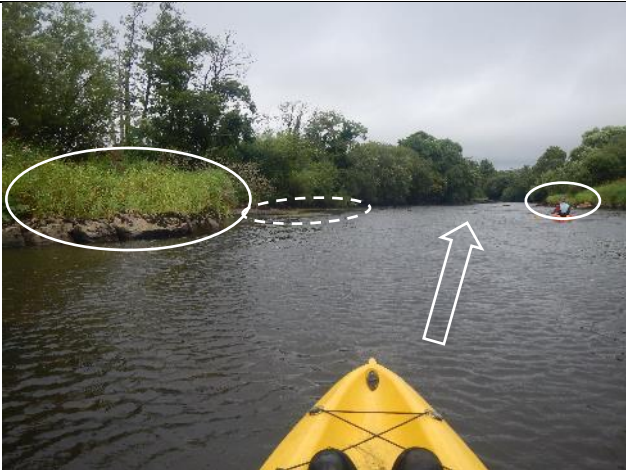
Figure 40: Mo 124 (53.94624, -9.03671). Poorly located groynes (white ellipses), focussing flow along a straighter course and detracting from the natural value of the bend. This was a common issue with many of the groynes, when the majority of flow should pass around the outside bend. The deflection had facilitated some gravel deposition d/s (dashed ellipse), but not in a useful or natural location.

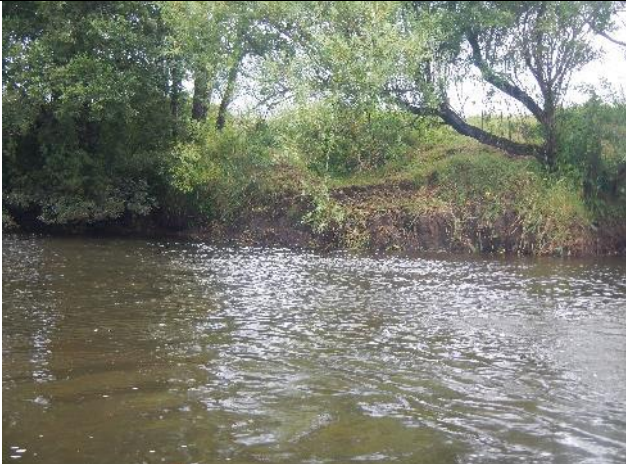
Figure 42: Mo 130 (53.947492, -9.037477). Fine sediment and nutrient input from drinking point (RB). These seemingly small issues mount up and could have a disproportional impact on a river where significant spawning activity occurs in the river margins owing to a lack of gravel mid-channel from dredging.

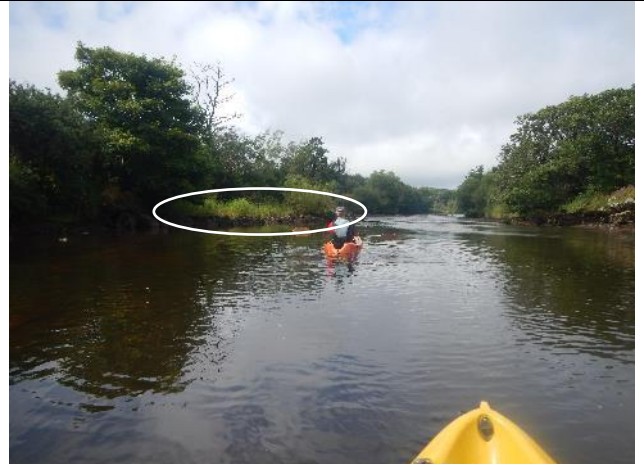
Figure 43: Mo 137 (53.947268, -9.039593). Another groyne preventing flow from passing round the outside of the bend (white ellipse), artificially and detrimentally straightening the flow pathway down the river.

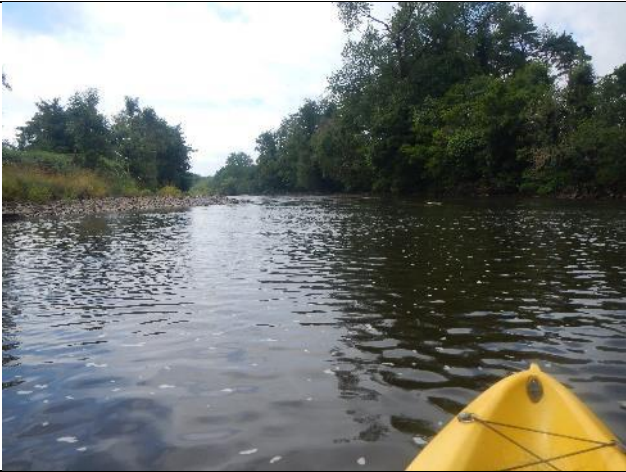
Figure 44: Mo 141. Gravel deposition on an inside bend, possibly aided by disintegration of an old groyne. These temporary storage areas for gravel provide valuable diversity to the channel morphology and a supply of gravel to areas d/s in higher flows, rather than the majority of gravels being flushed straight through the degraded river section.

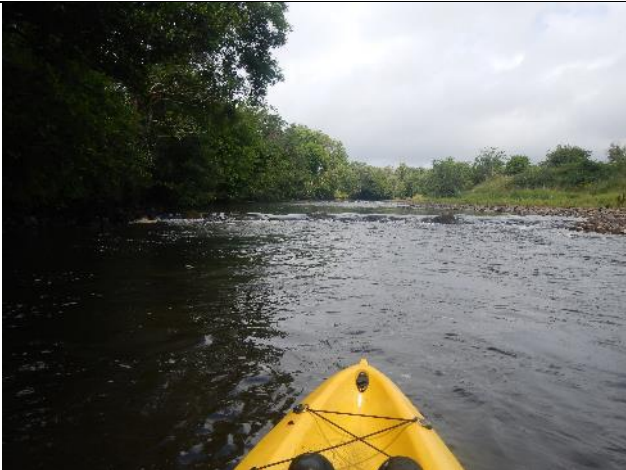
Figure 46: Mo 153 (53.94224, -9.04578). Boulder weirs may have created a feature in a channel lacking coarse sediment, but they now interrupt natural geomorphological processes, inhibiting sediment transport and ultimately creating a shallow, uniform channel upstream through the gravel trapped there. It would be worth at least notching (ideally removing) each weir.

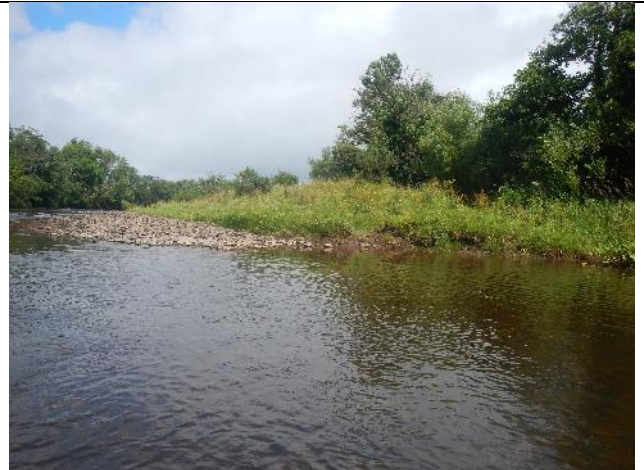
Figure 47: Mo 154 (53.942063, -9.045462). Livestock access and light poaching. The area would benefit from buffer fencing.

The wider more open channel and floodplain here benefits the retention of gravel. This is in contrast to the more incised areas elsewhere.

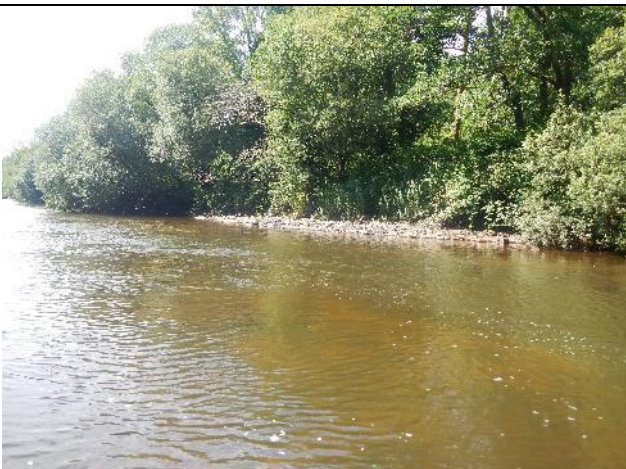
Figure 48: Mo 157 (53.941458, -9.045385). A treelined section of RB should naturally facilitate areas of gravel and cobble storage along the RB, which was inhibited by cobble and boulder groynes.

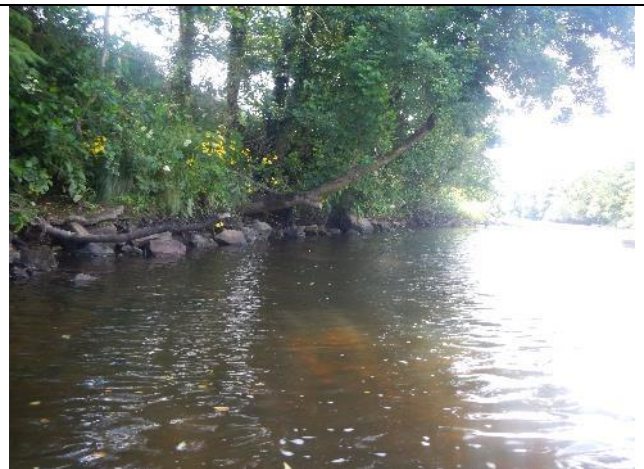
Figure 49: Mo 161 (53.93989, -9.046507). A section of past tree pruning had left a short section of channel (LB) lacking low and trailing cover. This work was almost certainly to improve angler access, but it would be far better to encourage anglers to fish the natural features that develop than removing habitat to improve access.

Photo	Observation	Recommendation	Lat/Long	Priority
Mo 161	Past tree maintenance/pruning	Resist calls by anglers to prune trees and retain low and trailing branches to improve habitat and fish-holding features	53.93989, -9.046507	1
Mo 169	Paired groynes	Remove groynes	53.9372, -9.04782	1
Mo 182	Poor access to the Killeen River	Investigate fish easement options. Likely solutions in priority: 1. Replacement rock ramp 2. Additional pre-barrages	53.934547, -9.050158	1
Mo 185	Offset groynes	Remove to facilitate more natural processes	53.934508, -9.050283	2
Mo 188	Mature bankside willows	1. Hinge branches/trunks into the river 2. Retain any naturally collapsed trunks/branches	53.933728, -9.051042	2
Mo 193	Boulder revetment (LB)	1. Plant bankside trees 2. Train trees over river margin 3. Do not reinstate boulders if/when they fail	53.932118, -9.052833	2
Mo 197	Drinking bay/fine sediment input	Fence off and provide alternative watering	53.93275, -9.05625	2

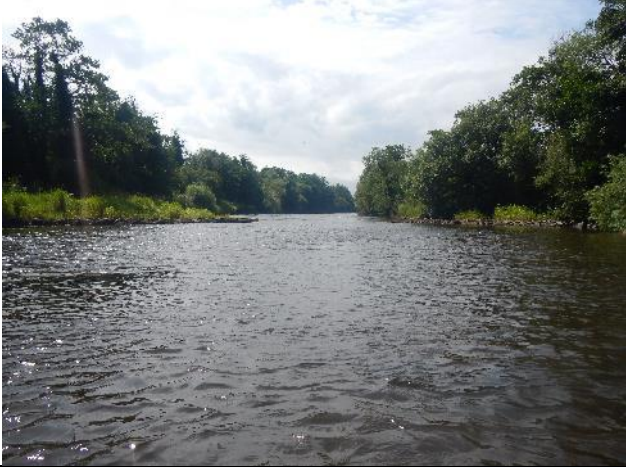
Figure 50: Mo 169 (53.9372, -9.04782). Two sets of paired groynes in a long straight channel section were inhibiting natural channel recovery by focussing flow down the centre of the channel.

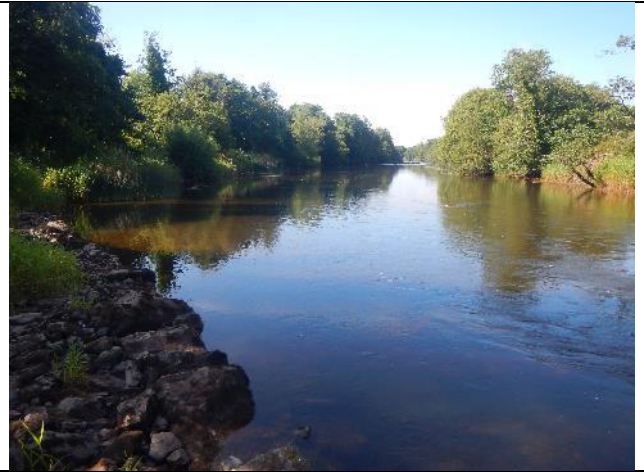
Figure 51: Mo 173 (53.937012, -9.047843). Flow was again encouraged to cut the corner d/s owing to the groynes.

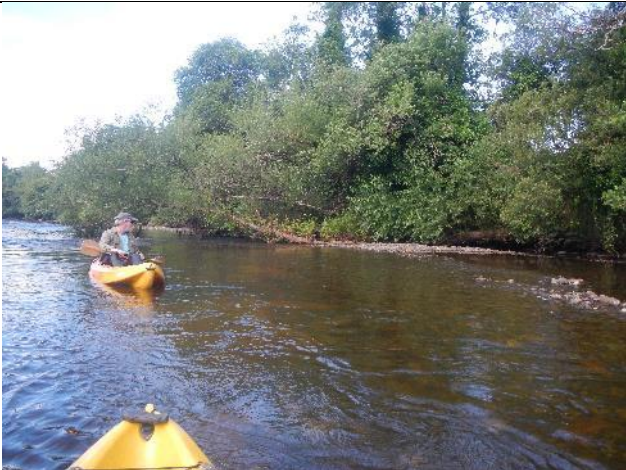
Figure 52: Mo 179. Gravel deposition facilitated by trailing willows. Features within the gravel were old salmonid redds. In the absence of gravel riffles, a significant portion of the main river's salmonid spawning appeared to be in the river margins, those being the main areas with suitable substrate. However, such areas are more susceptible to fine sediment degradation.

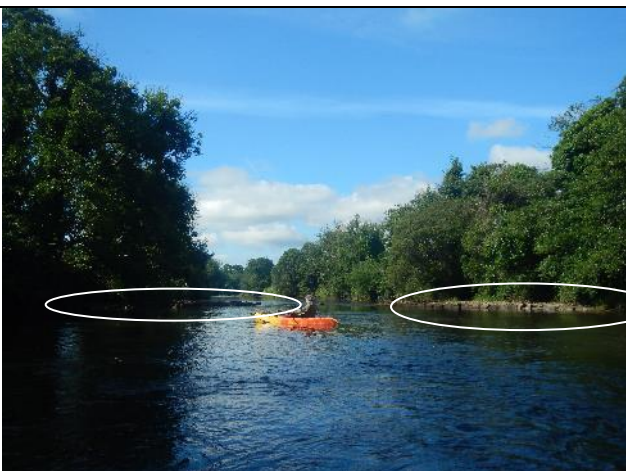
Figure 54: Mo 185 (53.934508, -9.050283). Where groynes are paired but slightly offset (white ellipses), they provide some more positive lateral flow deflection, but in most scenarios, it would still be preferable to simply allow natural depositional/gravel bed features to dictate the flow diversity.

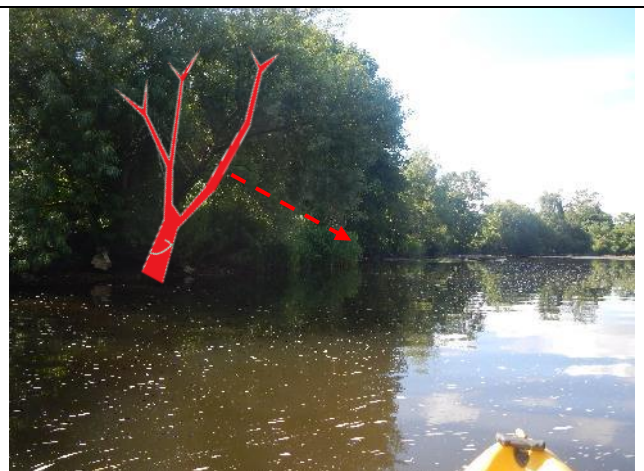
Figure 55: Mo 188 (53.933728, -9.051042). An overhanging willow that will undoubtedly fall into river at some point (white outline). When it does, it should be retained as a valuable habitat feature. High flow may push it round to lie along the bank ultimately. Alternatively, it could be hinged into the river to accelerate the process.

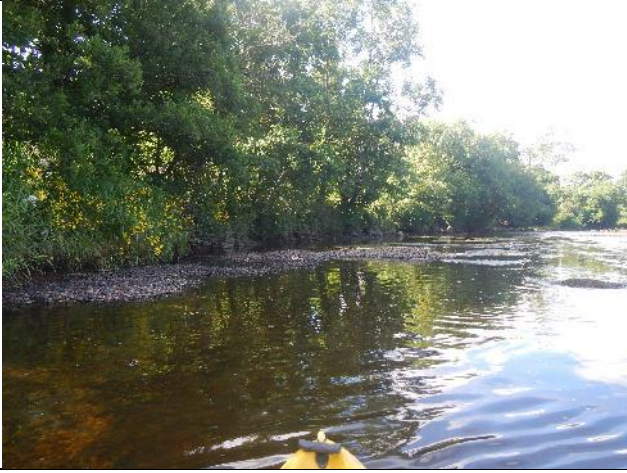
Figure 56: Mo 190 (53.933152, -9.051283). Large gravel bar with signs of extensive spawning activity (probably late 2021).

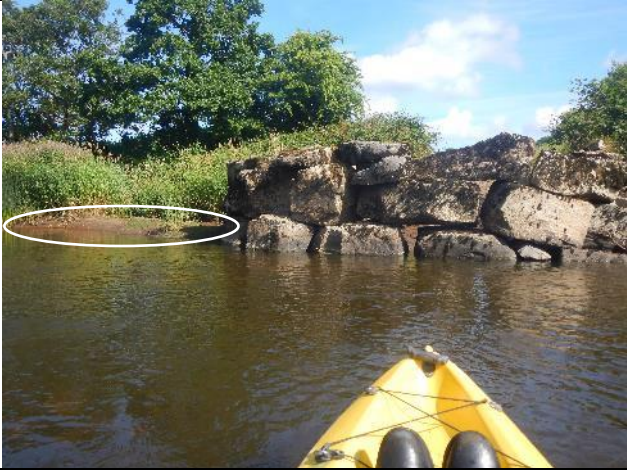
Figure 58: Mo 197 (53.93275, -9.05625). Although enclosed by boulders, this drinking bay was clearly supplying fine sediment, with deposits evident in the margin d/s (white ellipse).

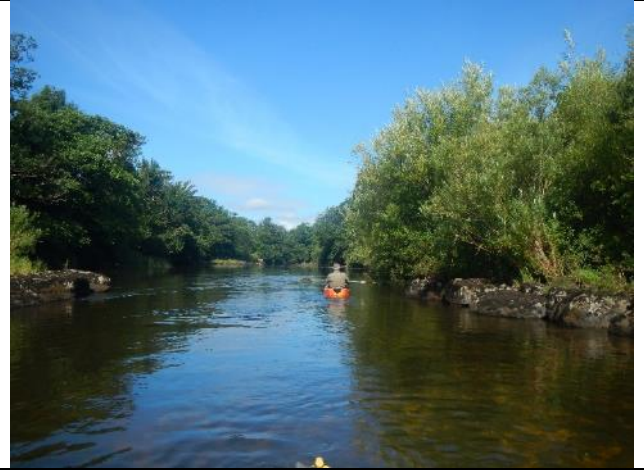
Figure 59: Mo 198 (53.93283, -9.056618). Two sets of paired boulder groynes constricting flow to the channel centre. The u/s groyne on the RB had been colonised by willows, offering some potential cover (which could be hinged over/into the channel in the short-term), but the groynes should be removed in the long-term.

Mo 198	Two pairs of boulder groynes	<ul style="list-style-type: none"> • Short-term - hinge willow into the channel • Long-term – remove groynes 	53.93283, -9.056618	2
Mo 201	Mature willow naturally collapsing into the channel	Retain any collapsed limbs	53.933418, -9.059275	1
Mo 212	Disintegrating groyne	Encourage disintegration through further loosening of key stones	53.935698, -9.065408	2
Mo 217	Boulder groynes	Encourage disintegration through further loosening of key stones	53.935038, -9.067275	1
Mo 219	Heavily leaning willow	<ul style="list-style-type: none"> • Ensure tree is not pruned or removed from the channel • Could be hinged to control the process 	53.934313, -9.068462	1
Mo 225	Drinking bay/fine sediment input	Exclude livestock and provide alternative water source	53.931938, -9.070647	2

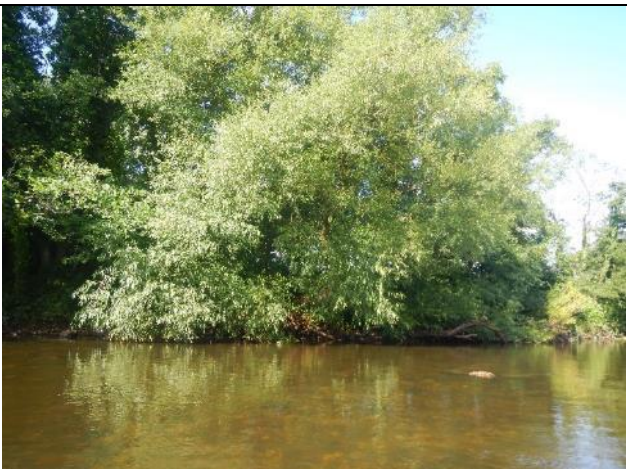
Figure 60: Mo 201 (53.933418, -9.059275). A large, mature willow showing signs of previous limb collapsing, which provides a natural habitat enhancement through increased in-channel structure and should be retained when it occurs.

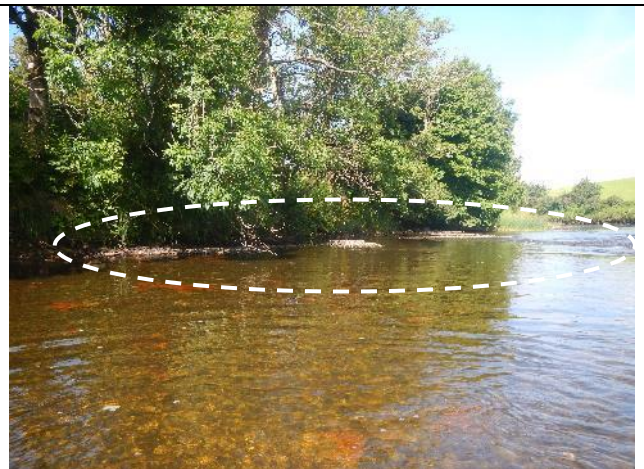
Figure 61: Mo 205. Around the mid-point of the EMAA waters, the gradient reduced and the gravel component of the bed began to increase, with a corresponding increase in the diversity and quality of invertebrate habitat and more salmonid redds in the margins (probably also mid-channel but more easily smoothed over in high flow).

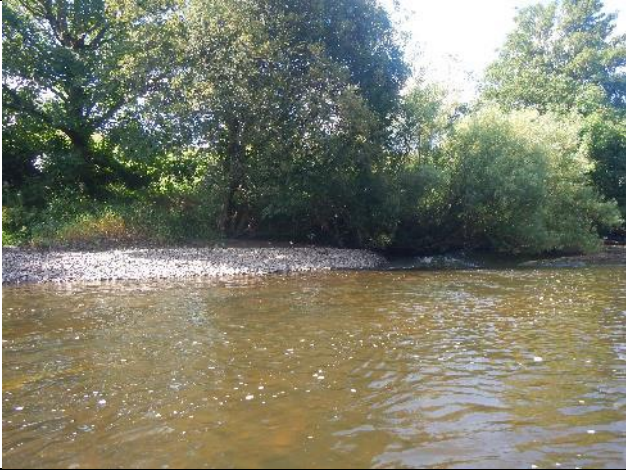
Figure 62: Mo 209. Significant gravel deposition mid-channel and as a sidebar, creating a fast run beneath a bankside willow. Further signs of natural channel recovery.

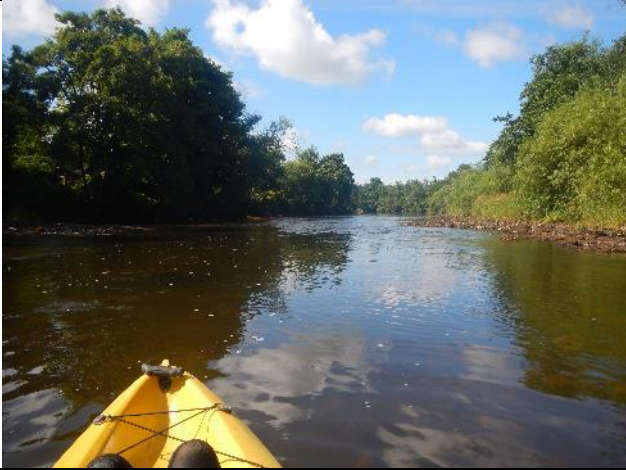
Figure 64: Mo 217 (53.935038, -9.067275). Lower level/disintegrating groyne structures created some flow diversity but are still a poor second to natural depositional features within the channel. This is again a case that they may have delivered greater benefit in a more recently degraded/dredged channel but will be an increasing inhibition to natural processes as the channel recovers.

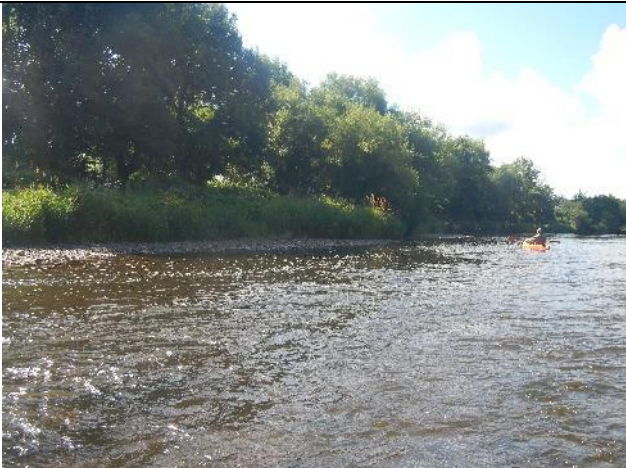
Figure 66: Mo 222. Not all depositional gravel areas appeared to be used for spawning and this is primarily owing to the flow the area receives and the fine sediment component, which increases in lower-flow/lower-gradient areas. Fine sediment can block the spaces between gravel particles that are required to supply oxygenated water to incubating ova.

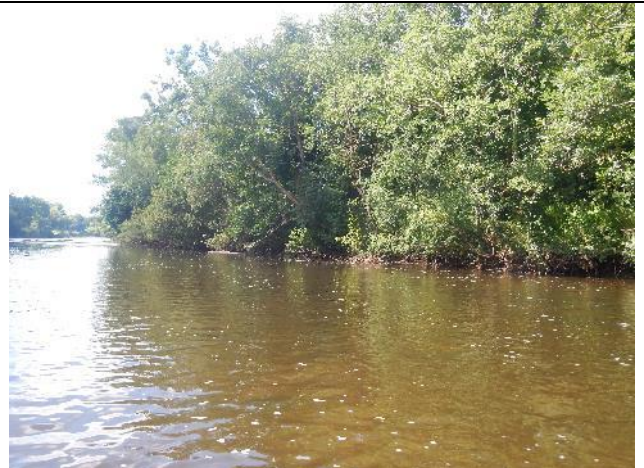
Figure 67: Mo 223. While completely treelined banks can prevent access, on non-fishing banks they create highly valuable shade, structure and cover for fish and a range of other wildlife. The trailing underwater branches are particularly important as refuge in which fish can evade predators like piscivorous birds and seek respite from high flow.

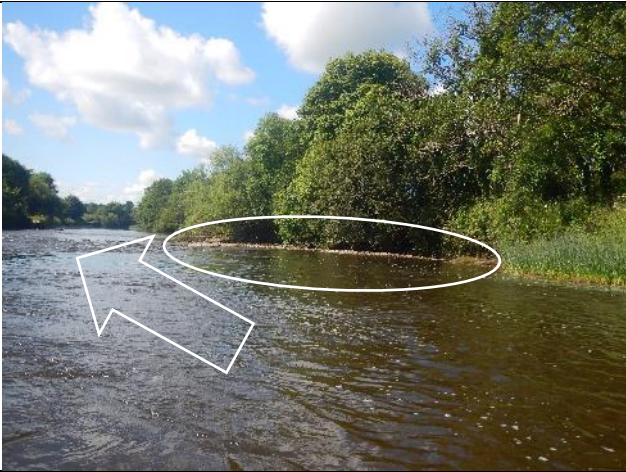
Figure 68: Mo 224. Bankside willows facilitating gravel deposition (white ellipse) that in turn diversifies the channel, pushing flow from the RB to the LB. This is the sort of natural habitat improvement that can be encouraged by retaining protruding bankside willows, providing all of the benefits of artificial groynes, plus a many, many more.

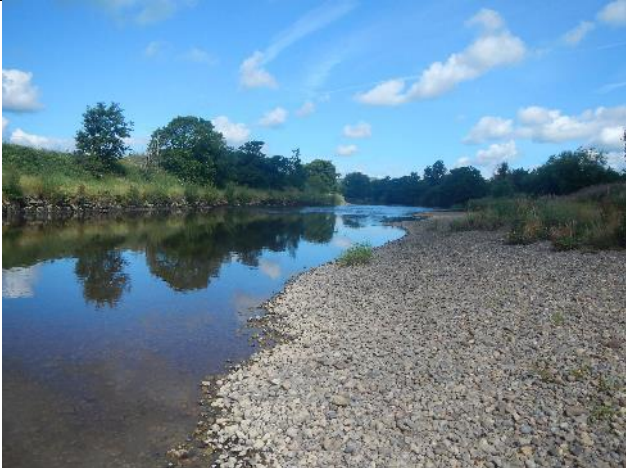
Figure 70: Mo 231 (53.93049, -9.073755). Extensive gravel bars and bed at the junction pool with the Gweestion River. The larger capacity of the channel, more significant meandering and larger pools in the middle reaches of EMAA waters further increases coarse sediment retention. The tributaries also play an important role in resupplying gravel and cobble to the main river channel.

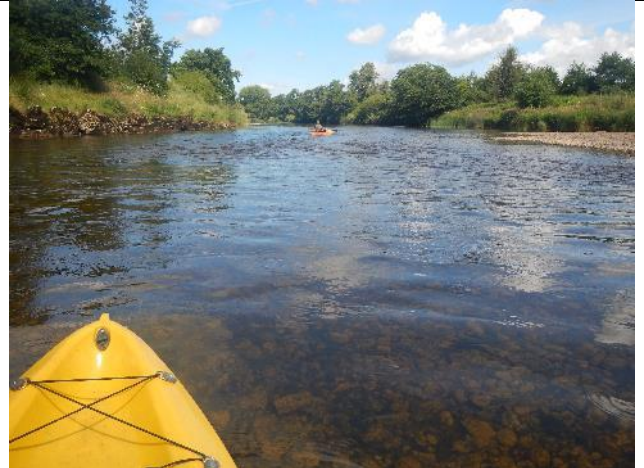
Figure 71: Mo 233. The gravel riffle at the d/s end of the junction pool offered an example of what more areas might have looked like pre-dredging, with a far greater potential for main river spawning and a greater abundance and diversity of invertebrate habitat.

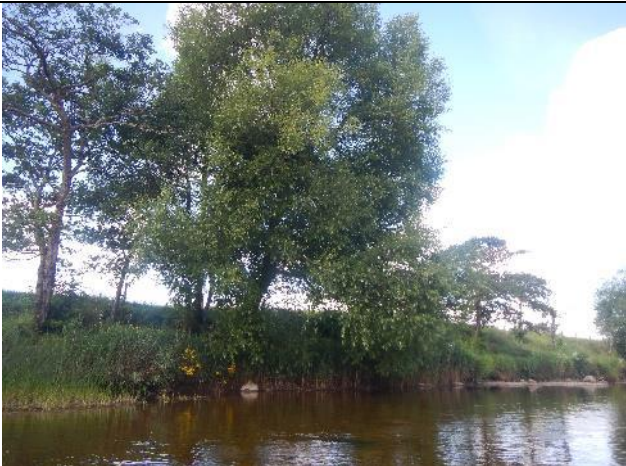
Figure 72: Mo 236 (53.932092, -9.075058). A large willow that could be hinged into the river. Failing that, it should be allowed to remain when it ultimately collapses in, as crack willows invariably do.

Photo	Observation	Recommendation	Lat/Long	Priority
Mo 236	Large mature willow	Hinge into channel or retain when it naturally collapses	53.932092, -9.075058	1
Mo 241	Willows lining the primary fishing bank	Accept reduced access for better habitat Create discrete access points, only if required	53.933777, -9.080035	2
Mo 061	Boulder groyne	Remove groyne. Removing key stones may allow the structure to disintegrate.	53.931833, -9.088253	2
Mo 267	Drinking bay/fine sediment input	Exclude livestock and provide alternative water	53.934953, -9.087362	2
Mo 276	Drinking bay/fine sediment input	Exclude livestock and provide alternative water	53.936883, -9.090152	2
Mo 281	Drinking bay/fine sediment input	Exclude livestock and provide alternative water	53.938118, -9.091017	2
Mo 285	Acceptable erosion	Establishing a backstop of trees would be beneficial	53.939553, -9.091975	3
Mo 290	RB tributary u/s of Ballylahan Bridge	Further investigation of potential as a spawning tributary	53.940312, -9.093848	2

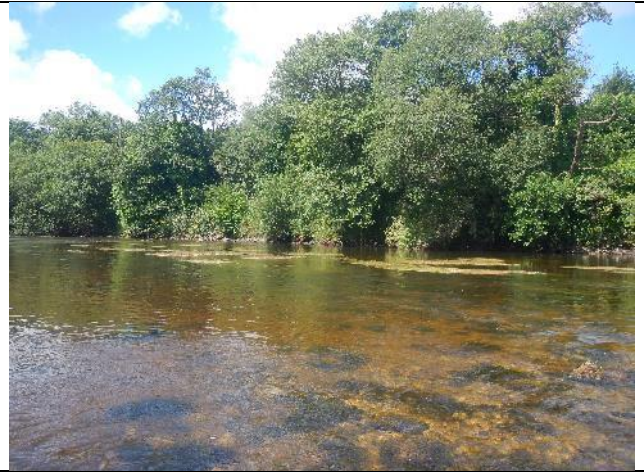
Figure 75: Mo 243. In many areas, aquatic vegetation was growing in undulating areas of the bed. These areas were likely to be old reeds that had subsequently been colonised. While they are therefore of lower quality for spawning, the consolidation of the bed created will assist with the establishment of beneficial bed features; in turn, these may well facilitate deposition and develop spawning areas.

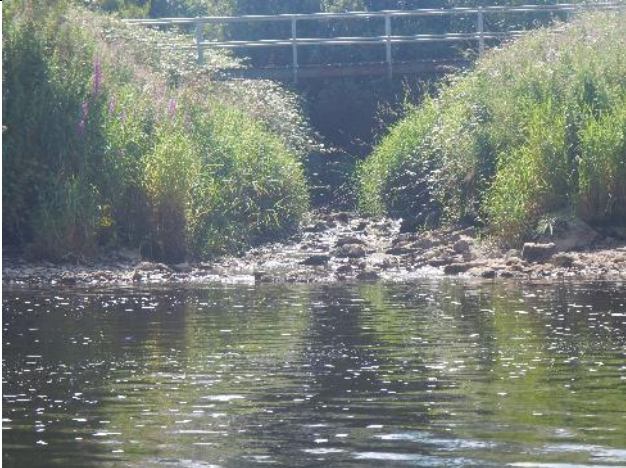
Figure 76: Mo 245 (53.93091, -9.084545). Although steep and shallow, access to the Carroward River appeared relatively free (no major barriers). Accessibility was probably reduced though by the dredging and lowering of the main river channel.

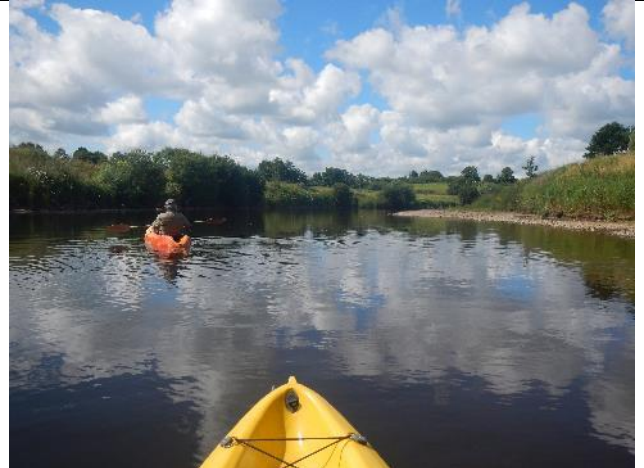
Figure 77: Mo 247. Large pool on a significant meander providing good adult fish-holding water. Willow trees on the LB should continue to grow out over the water to creating valuable cover, if left alone.
