WILD TROUT TRUST

**River Moy Habitat Assessment
and
Management Plan**

East Mayo Angling Association, Co. Mayo, Ireland

July 2022

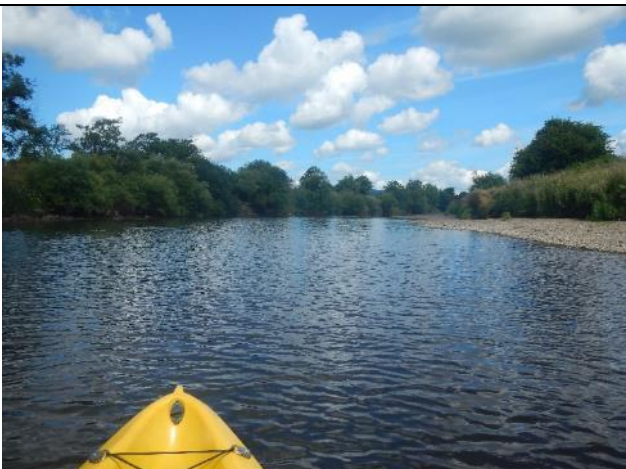
Figure 78: Mo 251. Large volumes of gravel were being naturally retained around the inside of the larger bends, demonstrating a reasonable supply of that material, which appeared to be passing through much of the upper reach inspected and/or is supplied from lower tributaries.

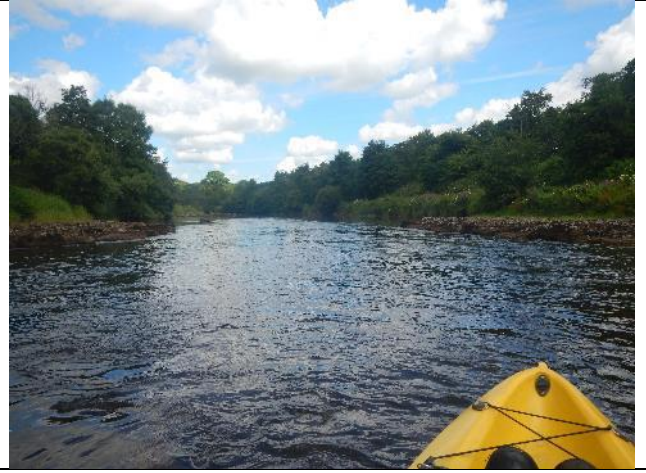
Figure 81: Mo 268 (53.935097, -9.087385). Paired groynes u/s of a single groyne on the inside bend (LB). The single groyne does push flow towards the outside bend, but the paired groynes u/s focus flow to the centre of the channel, inhibiting a more sinuous flow pathway down the channel.

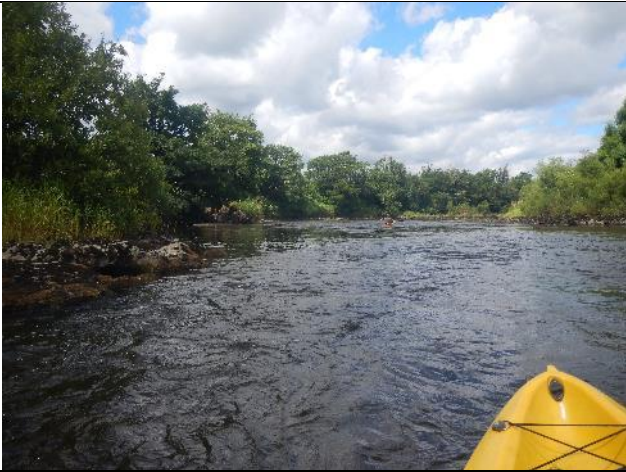
Figure 82: Mo 275 (53.936768, -9.089532). Further poorly located groynes forcing flow to unnaturally zig-zag in the run up to a natural bend.

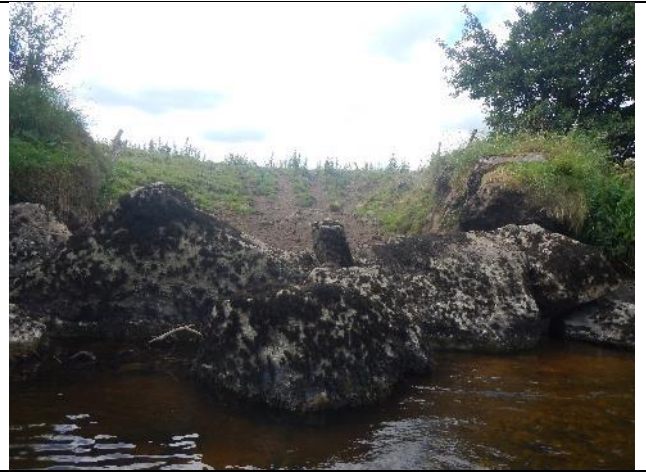
Figure 83: Mo 276 (53.936883, -9.090152). Fine sediment and nutrient input from drinking bay (LB).

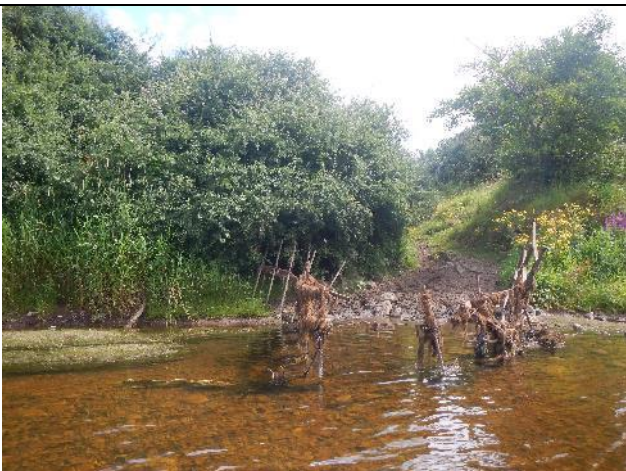
Figure 84: Mo 281 (53.938118, -9.091017). Fine sediment and nutrient input from drinking bay (RB).

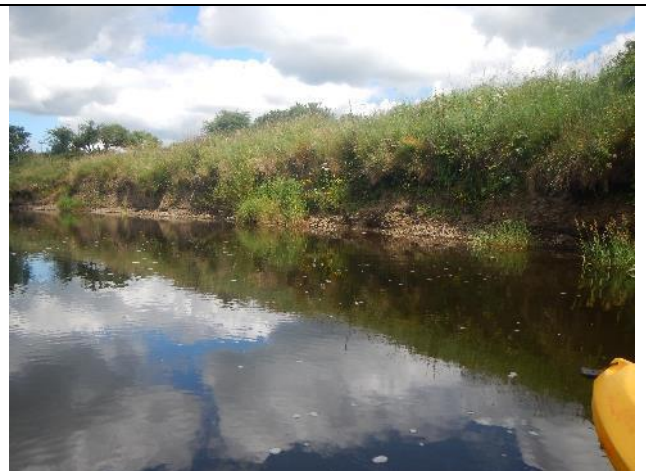
Figure 85: Mo 285. Bank destabilisation, likely to be contributed to by past dredging and bed-lowering. In this instance, the erosion still appeared to be acceptable and was supplying valuable coarse sediment. It is not a major concern for the fishery, but the landowner would be advised to establish a treelined buffer along the watercourse to stabilise the bank longer-term.

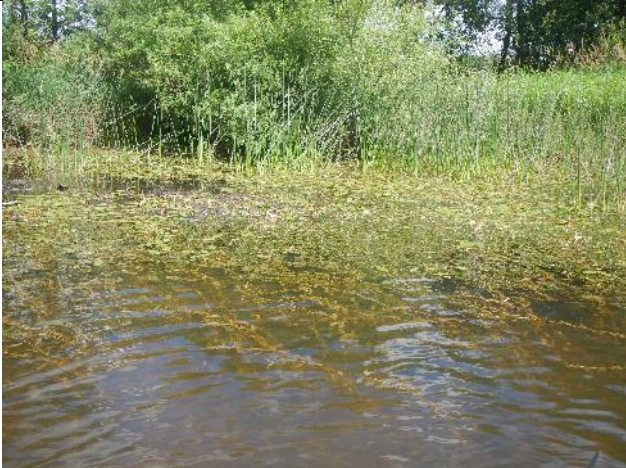
Figure 88: Mo 299. In the over-capacity (likely to be a result of the dredging and impoundment from the bridge footings) channel section u/s of Ballylahan Bridge, aquatic vegetation increased, with what are primarily stillwater species dominating the margins. This is no real issue as the habitat currently is not suitable for the native riverine species and it at least provides some habitat diversity.

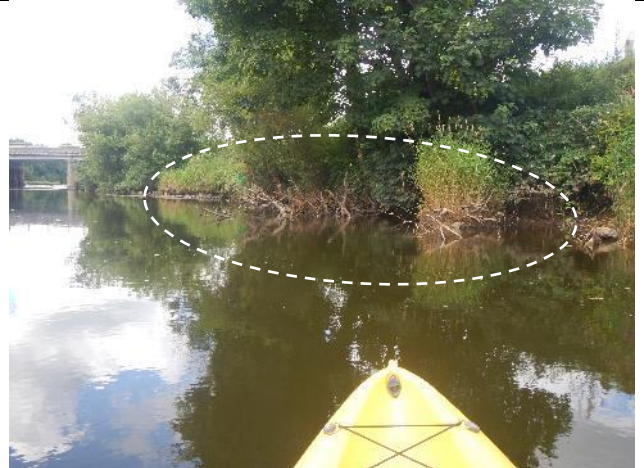
Figure 89: Mo 303 (53.938742, -9.102193). Partially submerged trees in the channel u/s of the bridge create valuable shelter and refuge for fish and should be retained. Such features will greatly aid fish when attempting to evade predators in the otherwise relatively featureless pool.

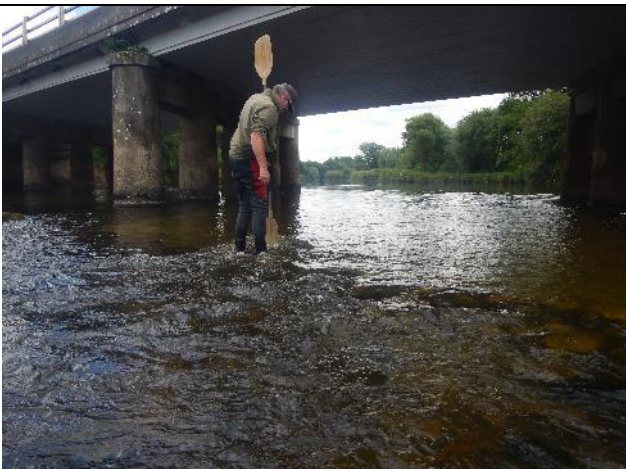
Figure 90: Mo 307 (53.93815, -9.103298). Ballylahan Bridge footings do not create a major obstruction, but they are raised and likely to create a behavioural barrier, particularly in low flow, inhibiting fish movement through the catchment. Best practice would be to have sunken the structure well below bed level. This would also prevent impounding flow u/s.

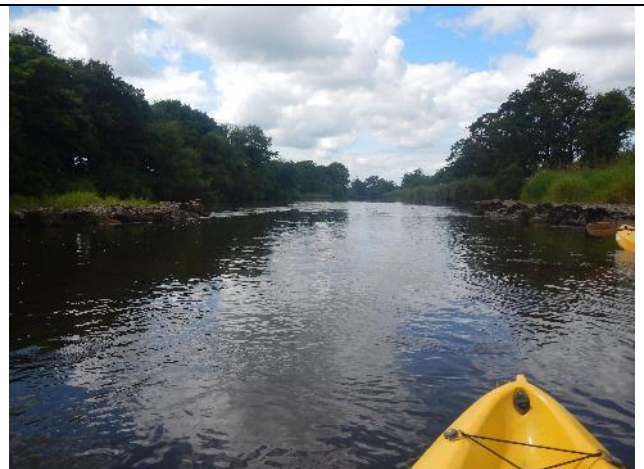
Figure 91: Mo 311 (53.937997, -9.103875). Two sets of paired groyne d/s of the Ballylahan Bridge focussed flow to the centre of the channel, inhibiting natural processes. It is also possible that scour at the focus (<1/2 channel width) could have driven the bed down (unless the level is governed by bedrock), leaving the bridge footings u/s more perched.

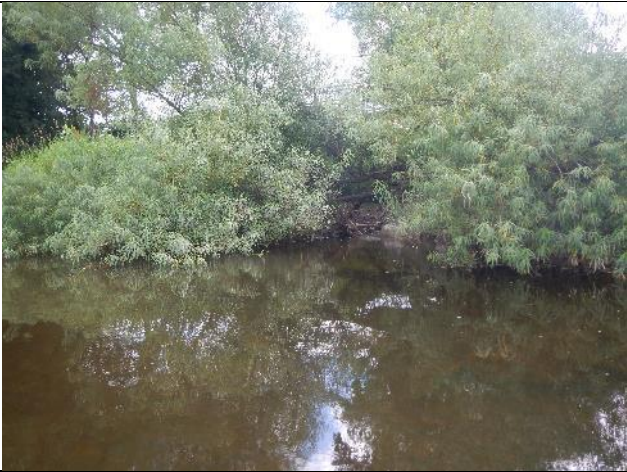
Figure 92: Mo 314 (53.937468, -9.106233). Access to the Cloonlee River was slightly obstructed by branches but appeared to be accessible as a spawning tributary, and the cover will offer some security for juvenile fish descending into the main river.

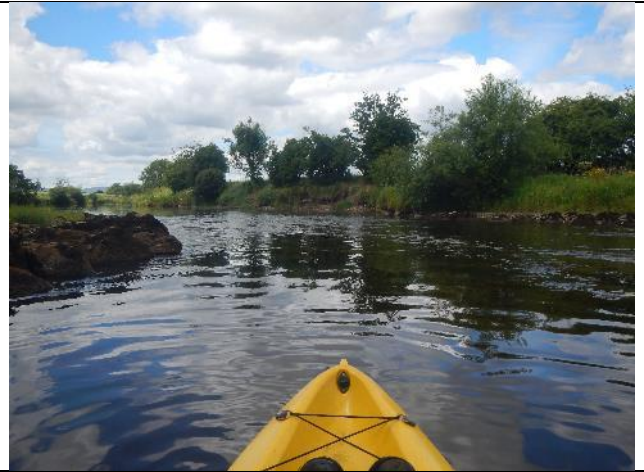
Figure 93: Mo 315 (53.937448, -9.106362). The furthest d/s of the paired groynes (d/s of Ballylahan Bridge) disrupted flow around the outside of the bend. These structures appeared very much to be attempts at fishing structures, rather than river habitat enhancements. Reinstatement of a more natural channel/allowing natural channel recovery would be a better solution.

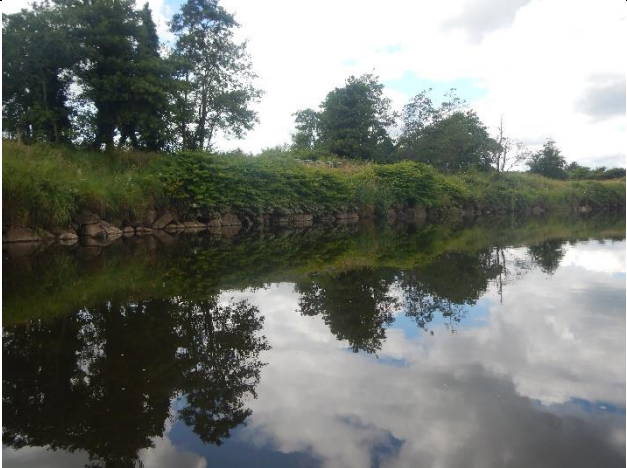
Figure 94: Mo 320 (53.938025, -9.118282). Japanese knotweed on the LB also required treatment. D/s of Ballylahan Bridge was uniform and lacking flow diversity, with minimal juvenile salmonid habitat (should be punctuated by riffles, had it not been dredged). Adult fish will hold there, but it is an extended section of river that is not functioning properly or providing the habitat it should.

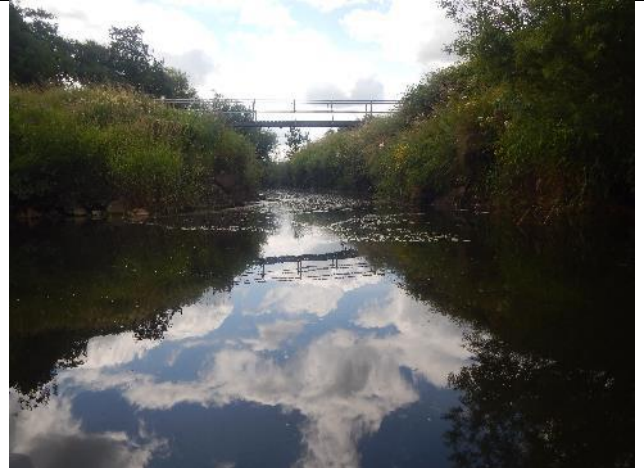
Figure 95: Mo 322 (53.93852, -9.11949). Although significantly realigned in its lower reaches, free access was possible to the Strade River, the size and substrate of which makes it a potentially important spawning tributary.

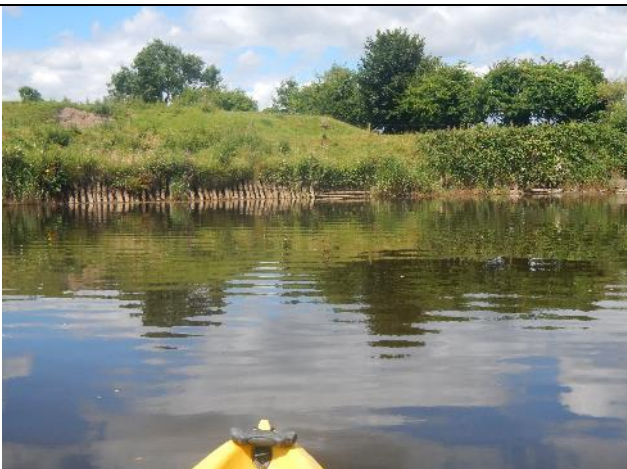
Figure 96: Mo 325 (53.940722, -9.119825). Log piling of the LB. This is counterproductive as the hard, immobile feature will simply deflect erosive forces to the adjacent bed and bank. Moreover, the prevention of tree and vegetation growth among the bank face means that when it fails, there will be nothing to hold the bank together (unlike a naturally well-vegetated bank).

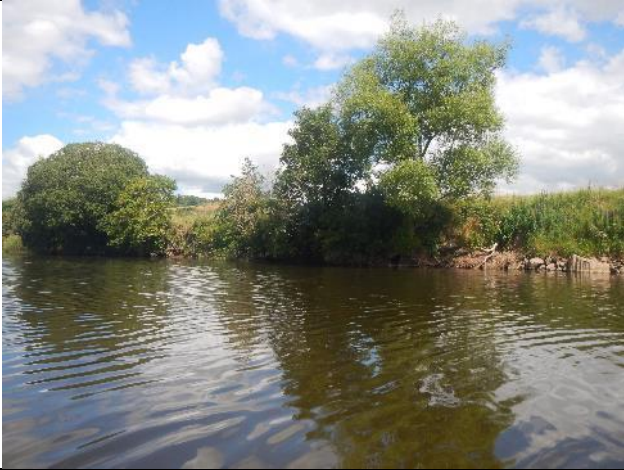
Figure 98: Mo 329 (53.942755, -9.119817). Where present, bankside willows could be hinged into the channel to increase flow diversity and potentially facilitate more areas of deposition. This should be done on the inside of bends, to work with natural processes. The result would be very different to immobile boulder groynes. Any naturally occurring windfallen trees should also be retained.

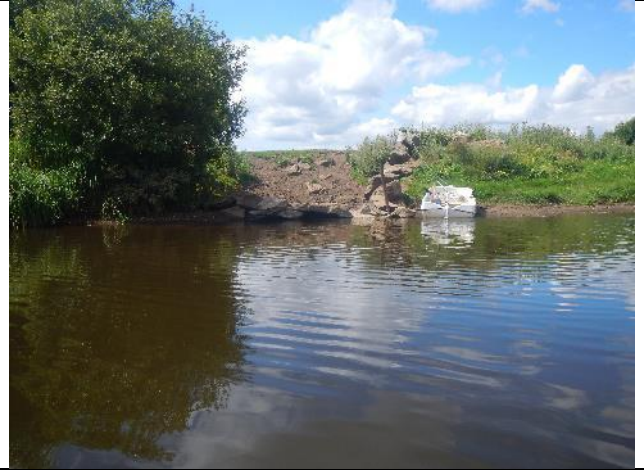
Figure 99: Mo 328 (53.942332, -9.119678). Fine sediment and nutrient input from drinking bay (LB).

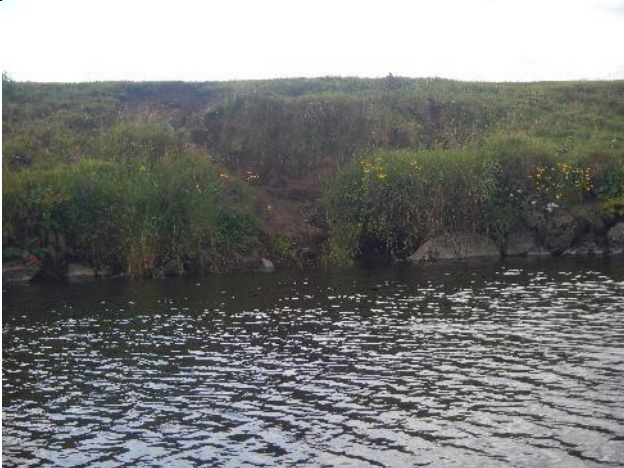
Figure 100: Mo 336 (53.945288, -9.122455). At one of the few sections where livestock had access to the main riverbank, vegetation was denuded, and erosion and fine sediment input were occurring.

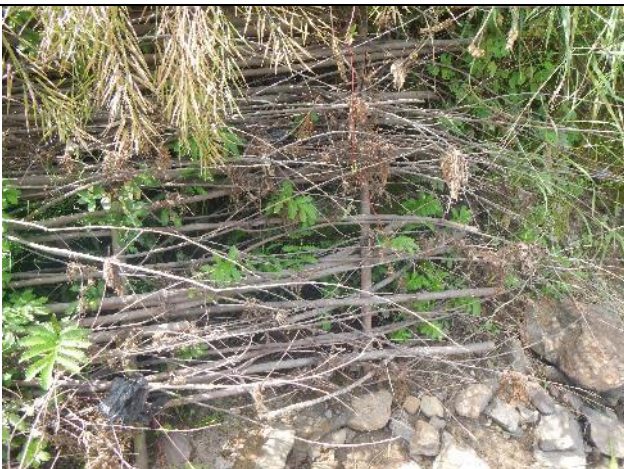
Figure 102: Mo 345 (53.949115, -9.12321). Bank erosion addressed with spilling. Rather than weaving the willow, it is usually beneficial to simply pin down a rough matrix of brash that traps fine sediment and create a growing medium. Horizontal spilling effectively hangs in the air, so will never grow, as the cross pieces receive no water or nutrient, and they create less roughness.

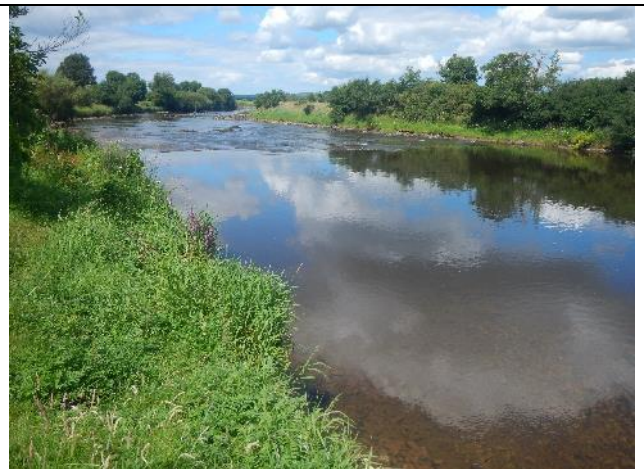
Figure 103: Mo 350. D/s of the overcapacity section the river returned to a more dynamic character, with valuable pools and gravelly riffles and glides. Spawning should take place in these areas but owing to the naturally reducing gradient with progression d/s, they are susceptible to smothering from elevated fine sediment input u/s.

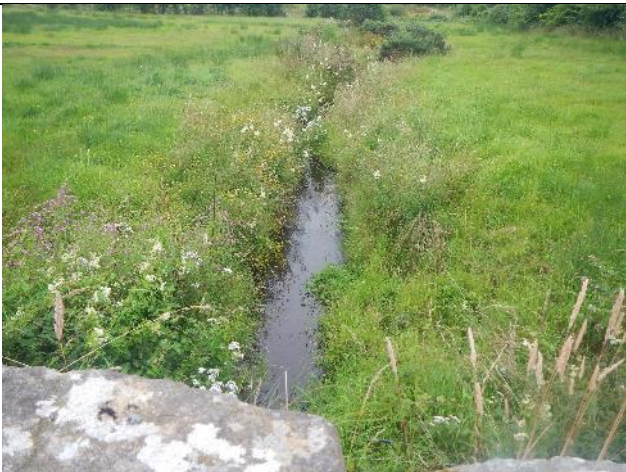
Figure 106: Mo(T1) 001 (53.945853, -9.02228). A spot-check from the first bridge crossing u/s from the Moy revealed a straightened watercourse with healthy riparian zone. Although degraded, this could provide spawning and juvenile areas.

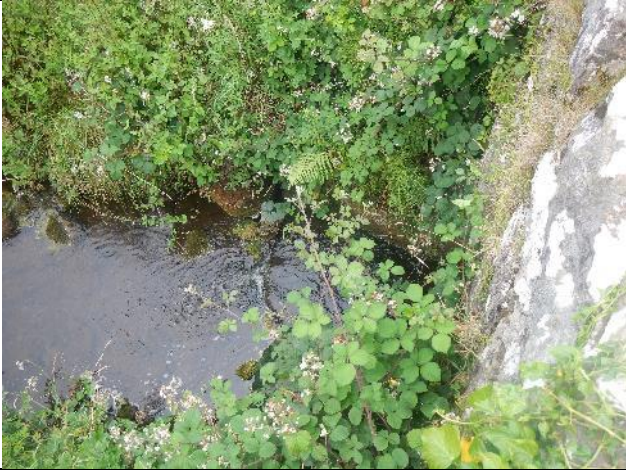
Figure 108: Mo(T1) 004 (53.945848, -9.022352). The footings of the bridge were slightly perched, but passable. They could potentially be improved with an easement.

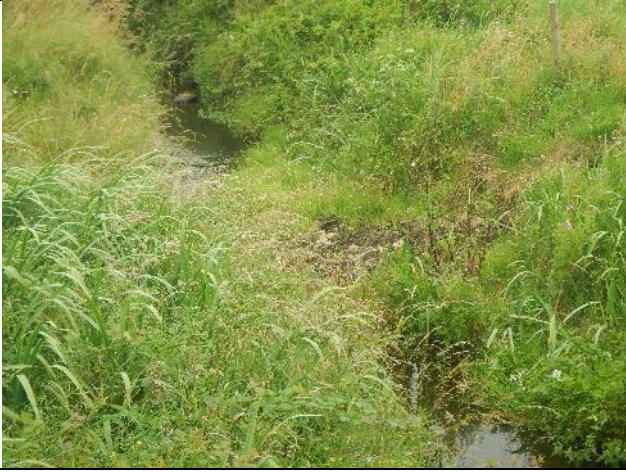
Figure 110: Mo(T1) 007. Livestock access at one point was causing bank slumping and erosion.

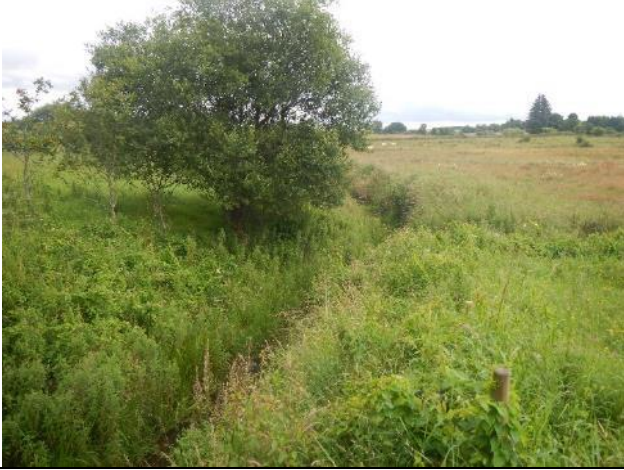
Figure 111: Sw 001 (53.944032, -8.928502). At the u/s limit checked on the Swinford it resembled more of a field drain, but was free from livestock, although fields further u/s appeared to be pasture.

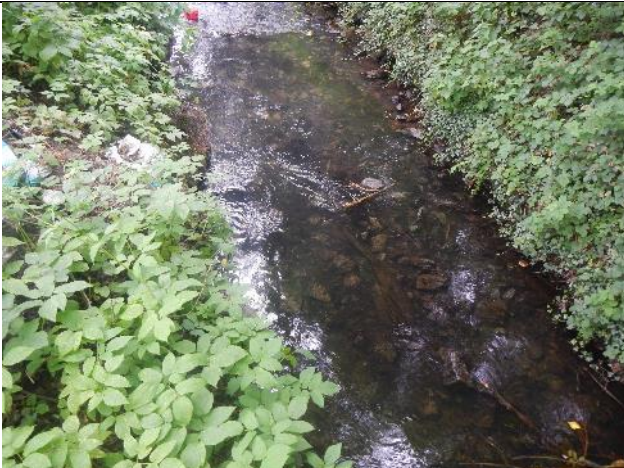
Figure 113: Sw 008. Reasonable quality urban stream habitat was available in Swinford village, although continued fine sediment coating on the substrate highlighted elevated inputs u/s.

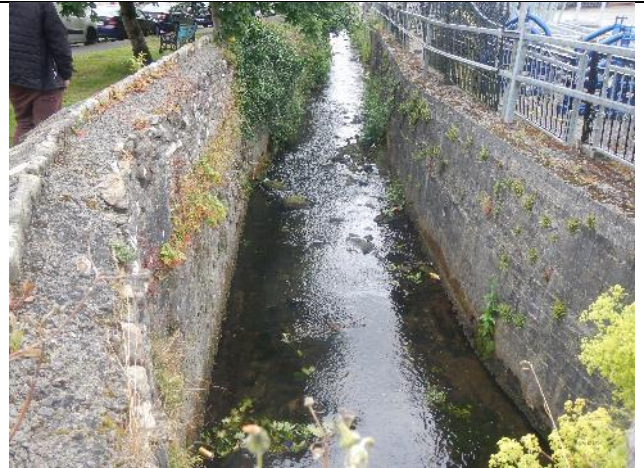
Figure 114: Sw 011. An extended section of walled channel provided poorer habitat quality, but the coarse substrate retained was still capable of supporting flow diversity and invertebrate communities, along with some juvenile salmonids. In such an artificial channel, alternate deflectors could encourage sediment retention and the formation of more discrete gravel bars.

Photo	Observation	Recommendation	Lat/Long	Priority
Sw 005	Elevated fine sediment	Investigate sources u/s of N5 road bridge	53.944378, -8.929267	2
Sw 011	Uniform, artificial channel	Alternate flow deflectors	53.945075, -8.952102	2
Sw 012	Groynes, low weir and dredging	<ul style="list-style-type: none"> • Remove low weir (reducing the impoundment of flow and sediment and hopefully the desire to dredge) • Remove at least the LB groyne to allow flow round the outside bend • Provide alternative water • Seek cessation of dredging that will be inhibiting channel recovery 	53.945103, -8.952145	2
Sw 013	Numerous small weirs disrupting sediment transport and sorting	<ol style="list-style-type: none"> 1. Remove weirs 2. At least remove the outside bend side of the weirs down to bed level to increase flow sinuosity and allow sediment transport/sorting 	53.9497, -8.965723	2
Sw 027	Uniform channel, lacking bankside vegetation and trees	<ul style="list-style-type: none"> • Increase buffer • Install woody material features to sort the substrate 	53.958412, -8.991405	2

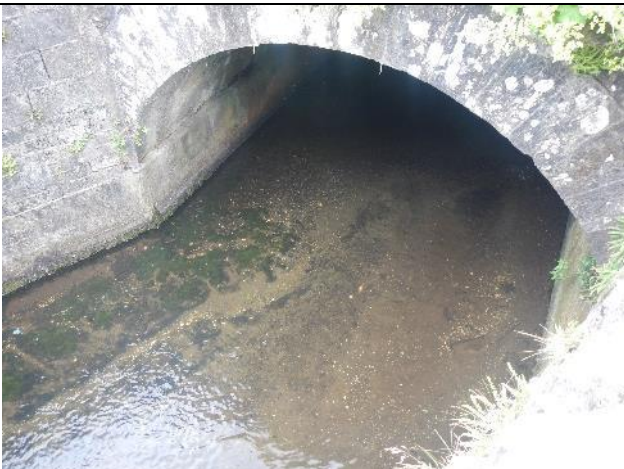
Figure 115: Sw 012 (53.945103, -8.952145). A culvert beneath the road bridge appeared passable, although detailed inspection was not undertaken. Note the fine sediment accumulation within the wider culvert channel. N.B. not all watercourse crossings around Swinford were inspected, so others may pose obstructions.

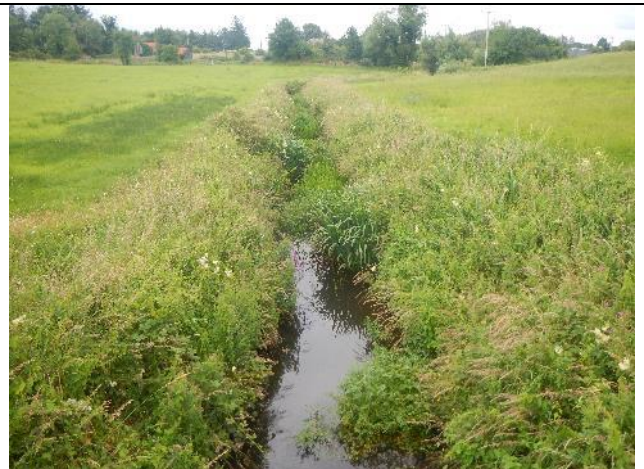
Figure 116: Sw 013 (53.949647, -8.965877). D/s of Swinford, the river is similarly straightened to areas u/s and lacked flow diversity but was buffered.

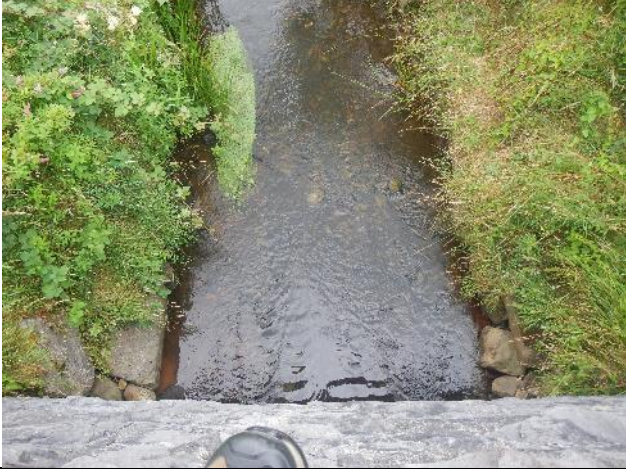
Figure 117: Sw 016 (53.949645, -8.965913). Although shallow with fast flow, fish passage beneath the N26 road bridge appeared possible.

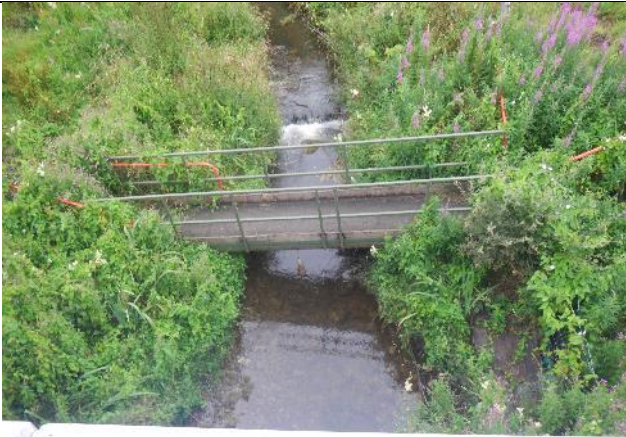
Figure 119: Sw 022 (53.956188, -8.990864). Further small weirs were observed from the new N26 road bridge. The geomorphology of the stream could be greatly improved by removing or at least notching the weirs. From the substrate observed it is likely that the river was capable of supporting large salmonid spawning and could be important for recruitment if naturalised.

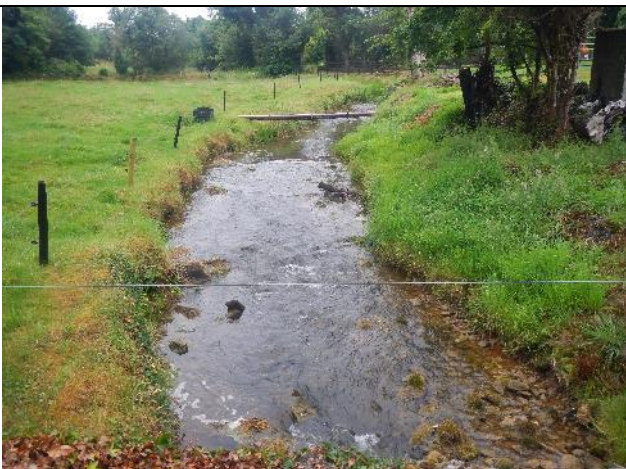
Figure 121: Sw 027. The river appeared to increase in alkalinity throughout the lower reaches, likely to be owing to spring water input from a limestone aquifer. The uniformly dredged channel could be improved by a larger buffer and more in-channel structure to scour and sort the bed.

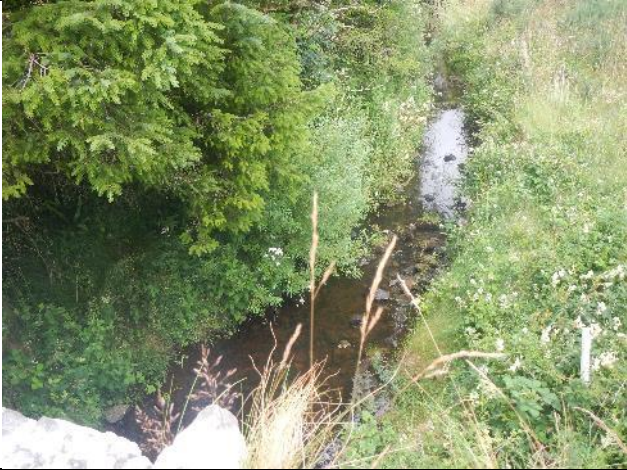
Figure 123: Sp 001 (53.91656, -8.923395). At the u/s limit inspected, the Spaddagh provided reasonable habitat for juvenile salmonids. However, the channel was realigned and the substrate coarse and poorly sorted, but it would support some invertebrate species.

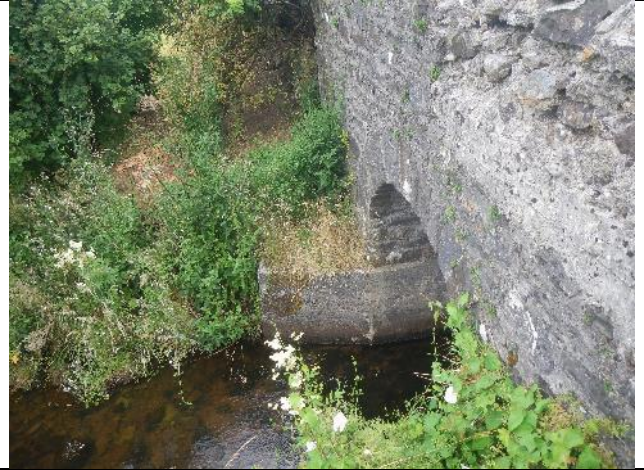
Figure 124: Sp 003 (53.916563, -8.923492). The Derryronan Road crossing was passable by fish.

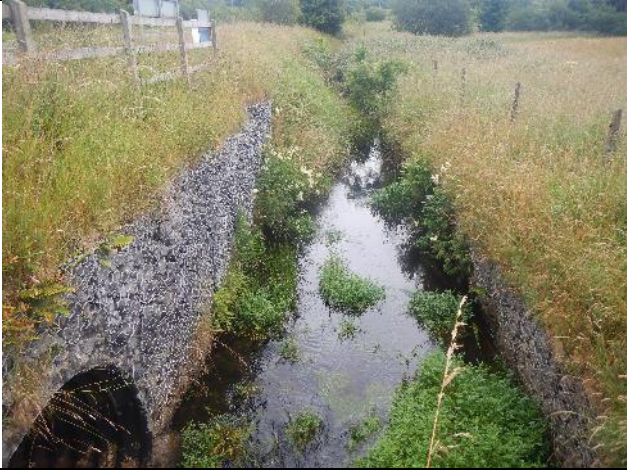
Figure 125: Sp 005 (53.927077, -8.95976). U/s of the N5, the watercourse was realigned, and armoured, but habitat quality was relatively good for a uniform channel, enhanced by vegetation.

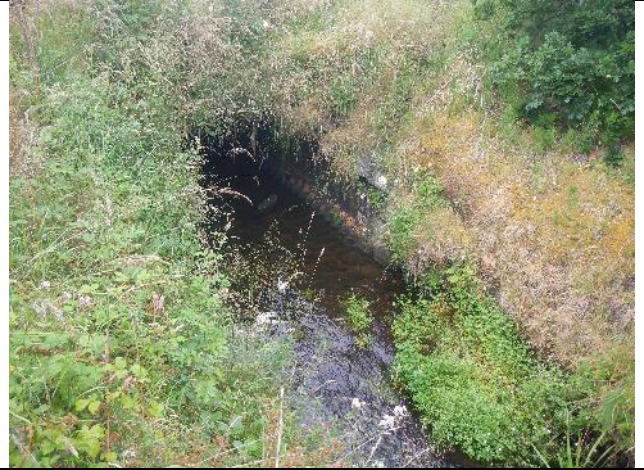
Figure 126: Sp 007 (53.927365, -8.95989). The road culvert appeared to be appropriately sunken and passable by fish.

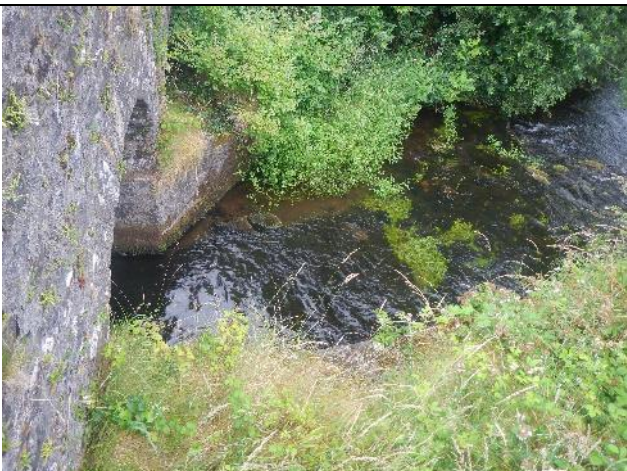
Figure 127: Sp 010 (53.928007, -8.960362). An older bridge just d/s also appeared passable, but the narrow aperture was accelerating flow velocities.

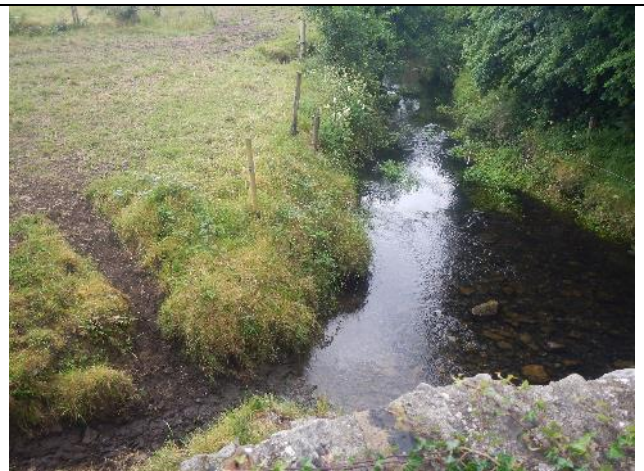
Figure 128: Sp 014 (53.934095, -8.970302). A cattle drink u/s of the next spot-check was supplying fine sediment.

Photo	Observation	Recommendation	Lat/Long	Priority
Sp 014	Drinking bay/fine sediment input	Exclude livestock and provide alternative water source	53.934095, -8.970302	2
Sp 018	Uniform channel	Woody material installation	53.938485, -9.00906	2
Sp 019	Uniform channel	Woody material installation	53.938497, -9.009037	2
Sp 021	Weir and uniform channel	<ul style="list-style-type: none"> • Weir removal (likely by hand) • Woody material installation N.B. this area is a higher priority owing to the existing potential of the habitat for salmonid spawning	53.935952, -9.014033	1
Sp 024	Uniform channel	<ul style="list-style-type: none"> • Woody material installation • Tree planting 	53.935768, -9.016543	1
Sp 025	Drinking bay/fine sediment input	Exclude livestock and provide alternative water source	53.935967, -9.022673	2
Sp 028	Uniform channel	<ul style="list-style-type: none"> • Woody material installation • Tree planting 	53.93591, -9.023483	1

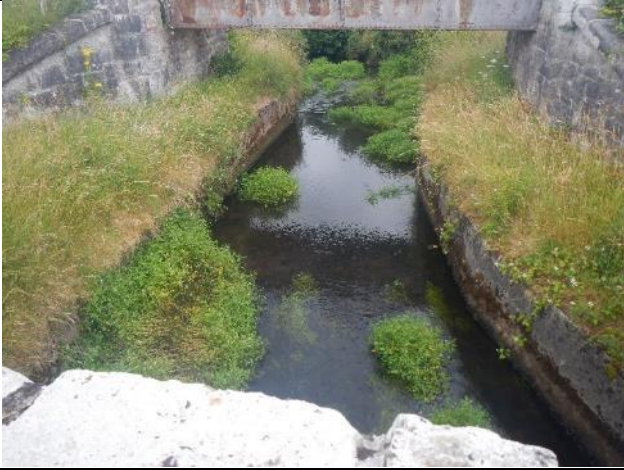
Figure 129: Sp 016. Emergent vegetation added valuable flow diversity to the artificial channel habitat d/s.

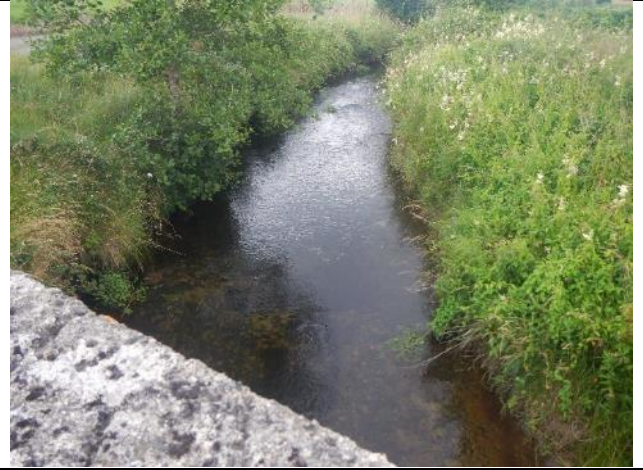
Figure 130: Sp 018 (53.938485, -9.00906). Reasonable quality habitat for juvenile salmonids within a uniform channel, u/s of the next spot-check bridge. Woody material installation could enhance such channel sections.

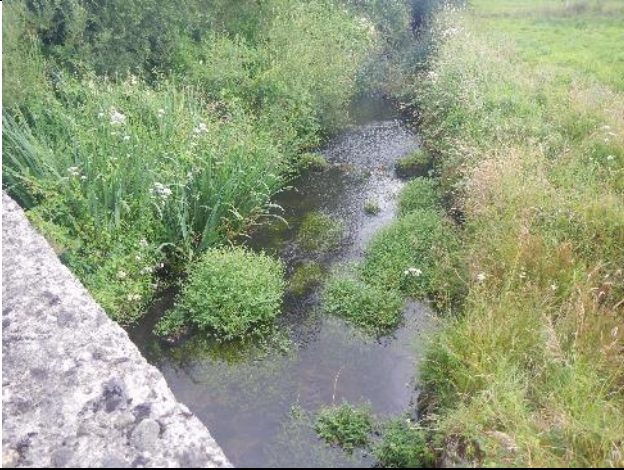
Figure 131: Sp 019. D/s of the bridge, emergent vegetation enhanced the habitat for fish and invertebrates. The bridge structure was passable by fish. Again, the uniform channel could be enhanced by installing habitat features.

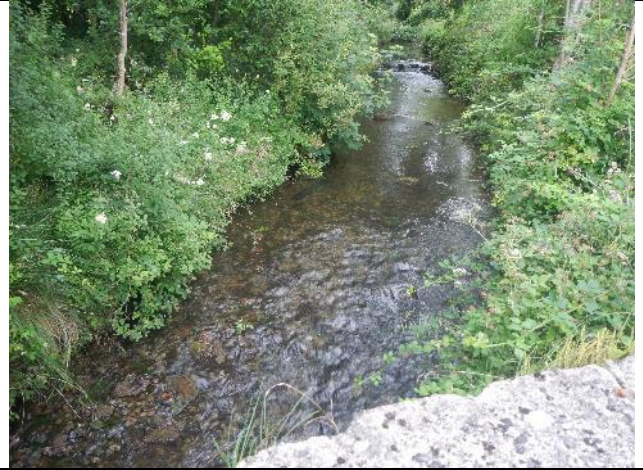
Figure 132: Sp 021 (53.935952, -9.014033). At the next crossing inspected, the gravel riffles provided good opportunities for salmonid spawning, although a low-level weir u/s created an unnecessary impediment to gravel transport and should be removed. It may be worth a more detailed walkover to ascertain whether further weirs also require removal.

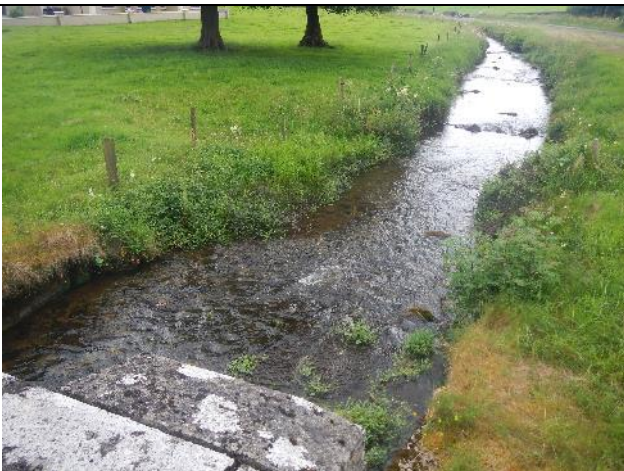
Figure 133: Sp 024 (53.935768, -9.016543). Although clearly dredged to a uniform capacity, habitat at the next location remained reasonably good for juvenile salmonids, particularly fry and 0+ parr, but lacked shade and cover. This area could be greatly enhanced with woody material/flow deflectors and a treelined strip.

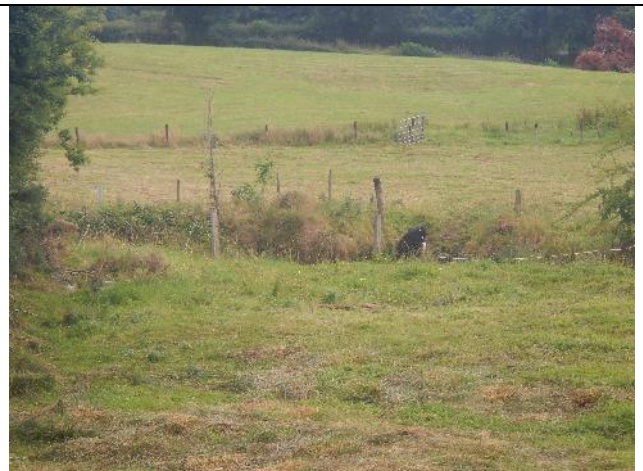
Figure 134: Sp 025 (53.935967, -9.022673). Livestock access to the watercourse at a drinking bay.

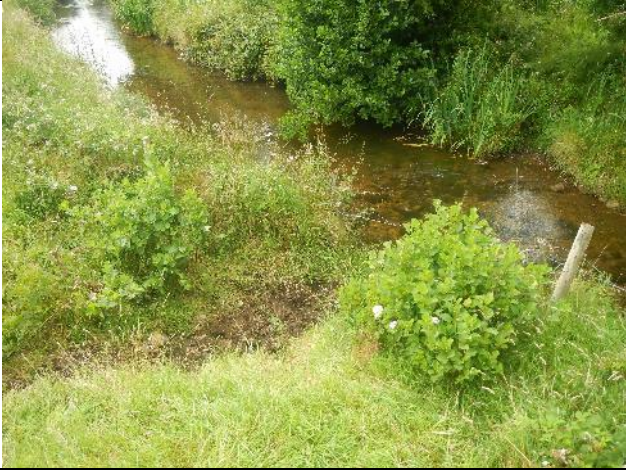
Figure 137: Sp 031 (53.936628, -9.024292). Poaching at a cattle drink d/s of the bridge. Cover from the low-lying alder bough on the RB greatly improves the pool habitat.

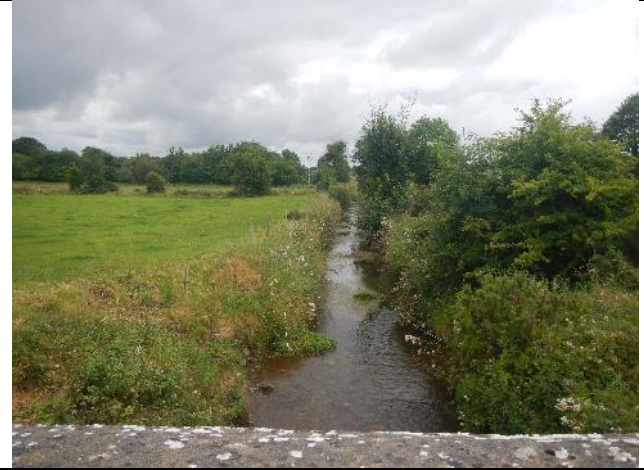
Figure 138: Sp 035 (53.936628, -9.024292). Poaching at a cattle drink. Although ideally requiring re-meandering, the channel could be enhanced with in-channel structures.

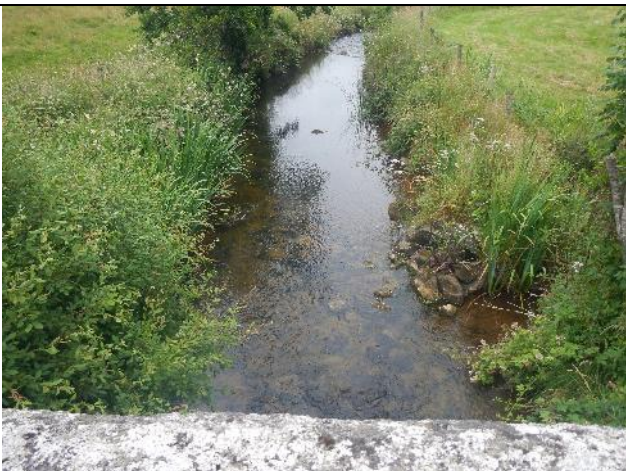
Figure 139: Sp 038. The channel was buffered but remained uniform capacity at furthest d/s spot-check. Increasing the availability of in-channel structure (trailing branches, woody material etc) would be beneficial.

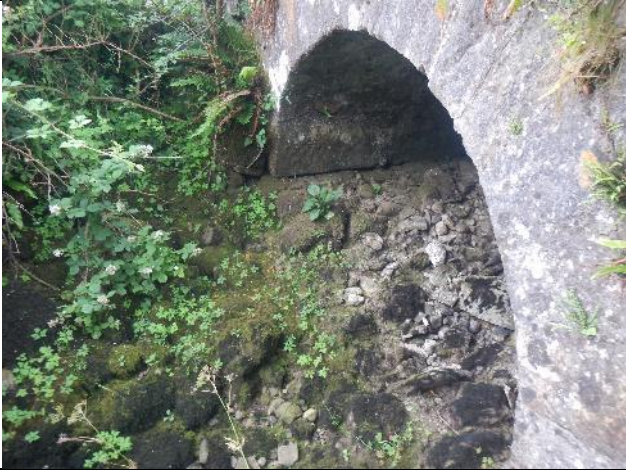
Figure 140: Ki 003 (53.899595, -8.954577). The upper reaches of the Killeen River were dry but appeared to carry a reasonable sized watercourse at times (by the channel morphology). The map shows the watercourse extending further u/s for another 5km, with two small tributaries. Ephemeral watercourses are common in limestone areas, but this can also be due to groundwater abstraction.

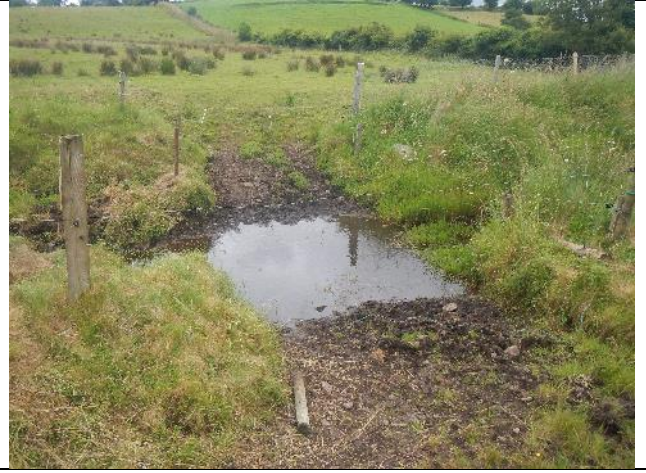
Figure 141: Ki 006 (53.903065, -8.97238). Livestock poaching and fine sediment input at a drinking bay/ford.

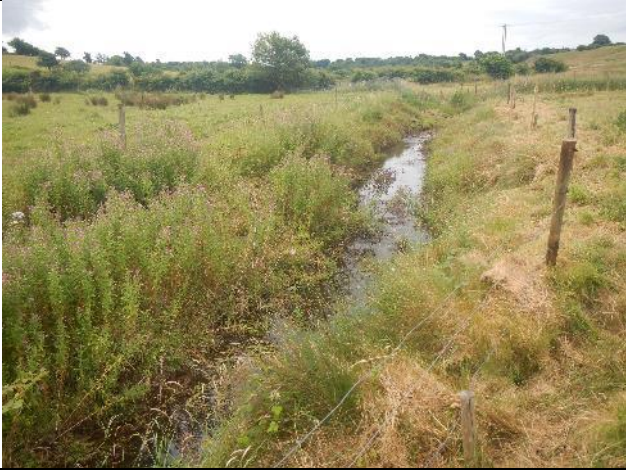
Figure 142: Ki 007 (53.903313, -8.97271). D/s of the ford, cattle had clearly been inside the buffer strip, trampling the bed of the watercourse and denuding the bankside vegetation.

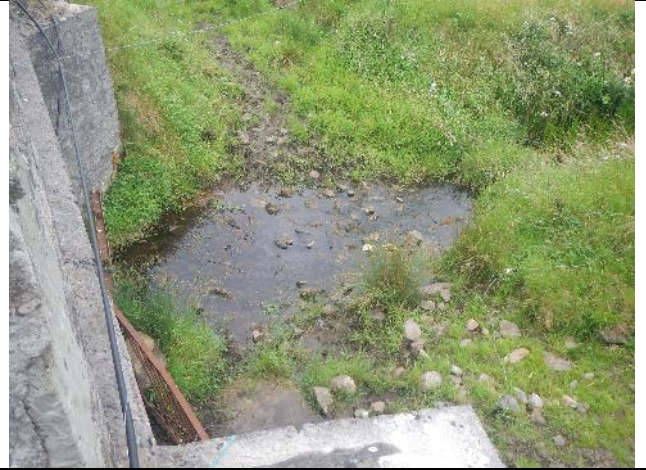
Figure 143: Ki 010 (53.90355, -8.972723). Further poaching was occurring d/s of the R320 road bridge (passable by fish).

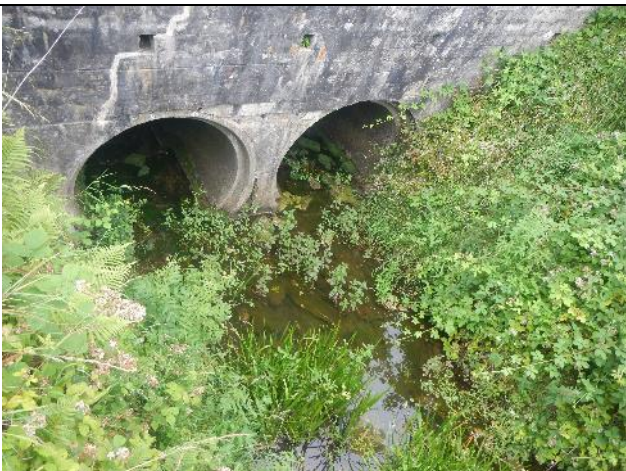
Figure 144: Ki 015 (53.915988, -9.000402). The N5 crossing was passable by fish. Note the significant algal growth/enrichment.

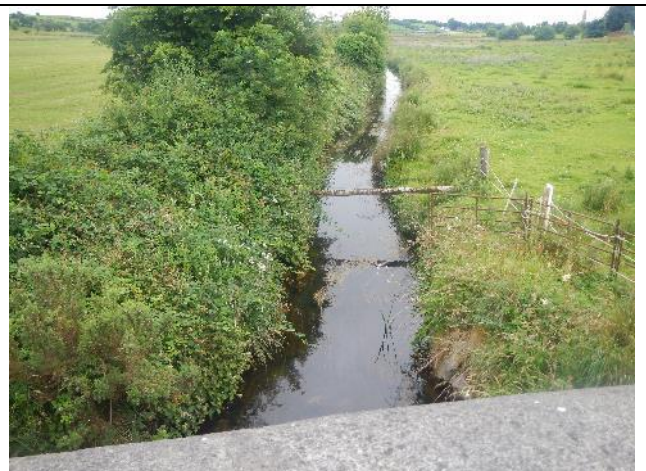
Figure 145: Ki 017 (53.928357, -9.022538). By the next checkpoint the watercourse was certainly capable of supporting juvenile salmonids, but was uniformly overcapacity and lacked a buffer strip on the LB u/s.

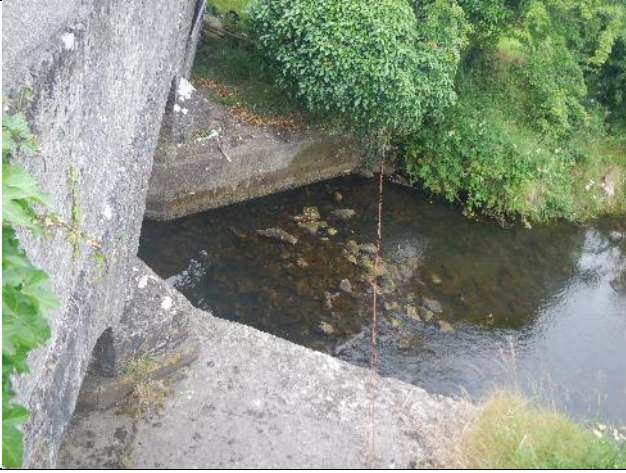
Figure 146: Ki 022 (53.928447, -9.022527). The road crossing/culvert was passable by fish.

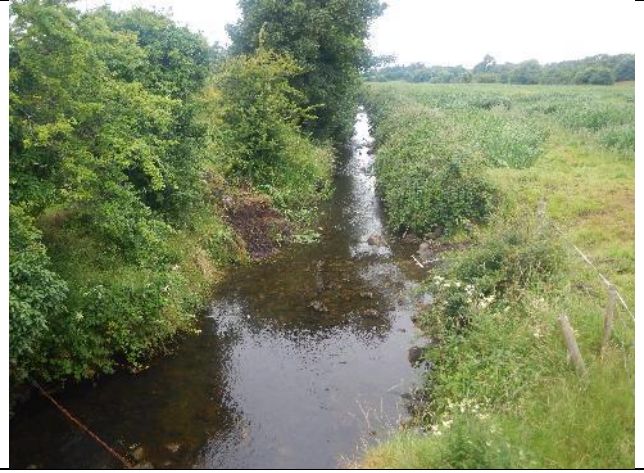
Figure 147: Ki 025 (53.928437, -9.022557). Uniform, straightened channel and livestock access and poaching d/s of the bridge (RB).

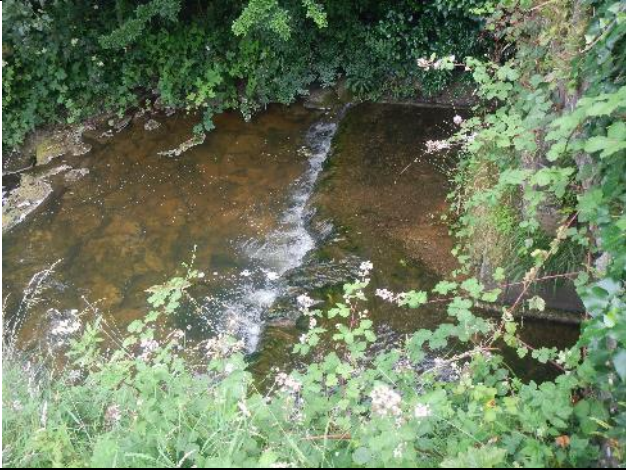
Figure 148: Ki 030 (53.928437, -9.022557). The footings of the furthest d/s road crossing created a small obstruction. However, a series of three boulder weirs/pre-barrages d/s may well be an attempt to ease a bigger step and fish passage issue, probably created by the dredging and lowering of the Moy. Baffles could slow and deepen flow over the footings to ease passage.

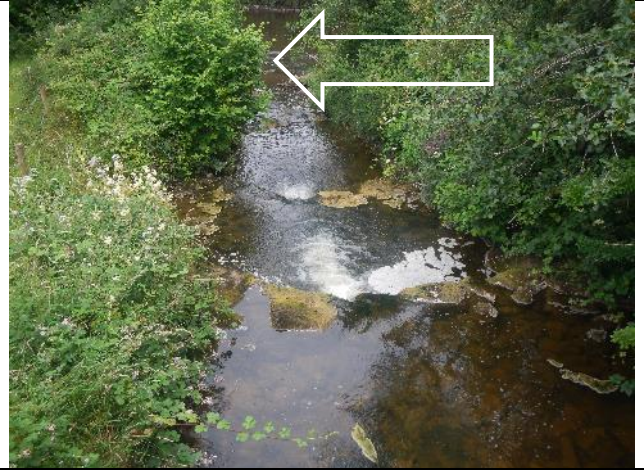
Figure 149: Ki 033. Three boulder weirs d/s of the road bridge. The Moy flows past right to left (white arrow). These still represent an obstruction in most flows but are an improvement over a much larger step. A continual rock ramp easement/bed regrade would be more in keeping with best practice, offering passage in a broader range of flows. This could unnecessarily delay fish entering the trib.

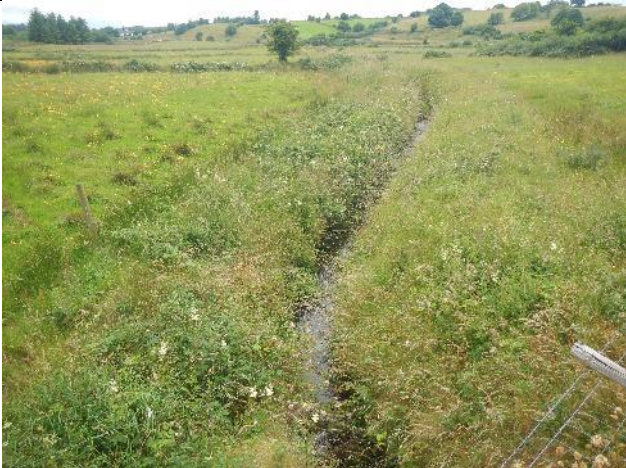
Figure 150: Ki(T1) 005 (53.907705, -8.923238). At the first location the Killen tributary was realigned and incised but protected with a buffer strip; the substrate was coarse, and the watercourse was capable of supporting juvenile salmonids.

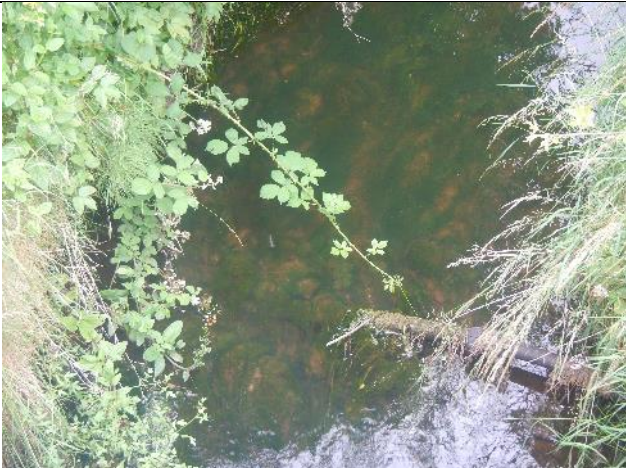
Figure 152: Ki(T1) 008 (53.918818, -8.962088). Immediately d/s of the R320 crossing, excess algal growth was observed on the bed, again highlighting an enrichment issue.

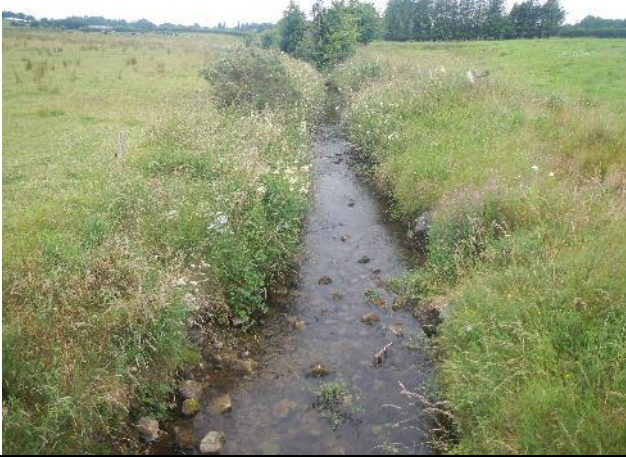
Figure 156: Ki(T1) 023. The substrate was coarse, but the buffered banks provided valuable cover from marginal vegetation – again, re-meandering or at least additional in-channel structure would be beneficial

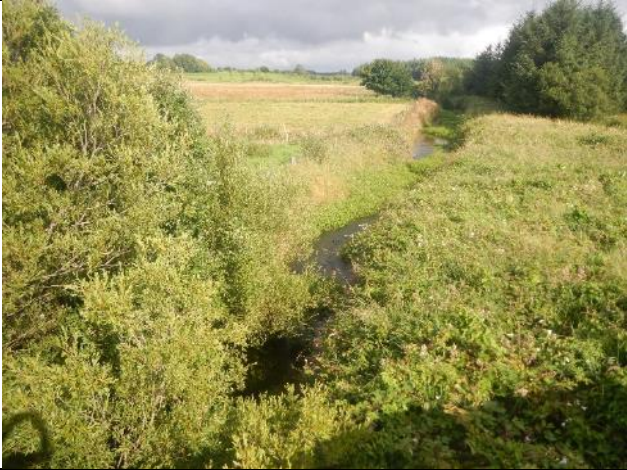
Figure 157: GI 003 (53.807545, -8.766337). At the furthest u/s point inspected, the Gweestion already provided good juvenile salmonid habitat. The uniform, over-capacity channel was beneficially narrowed by emergent vegetation, providing valuable flow diversity. The channel here could potentially be re-meandered within the unused ground adjacent.

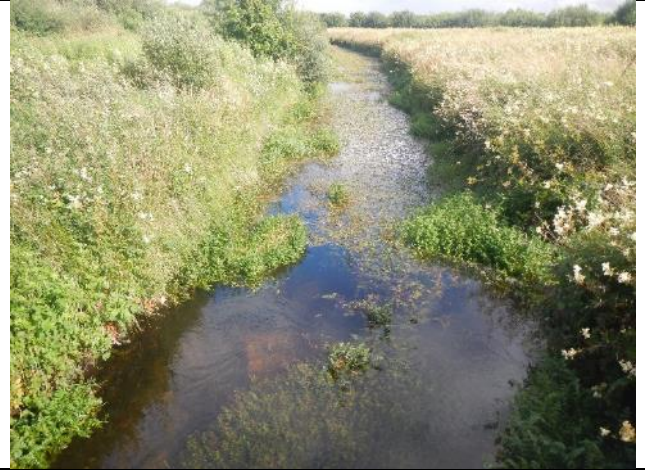
Figure 158: GI 009 (53.797818, -8.755807). Further d/s, the over-wide and over-deep watercourse resembles a canal but was improved by aquatic vegetation and is still capable of supporting fish.
