WILD TROUT TRUST

**River Moy Habitat Assessment
and
Management Plan**

East Mayo Angling Association, Co. Mayo, Ireland

July 2022

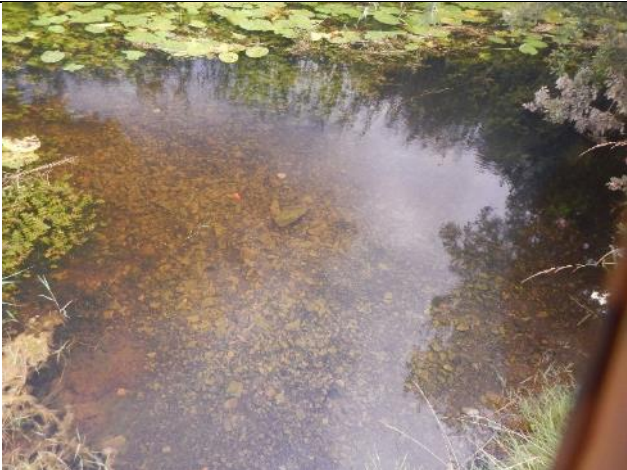
Figure 159: GI 010 (53.785467, -8.765615). At the N83 road crossing, the presence of substrate suitable for salmonid spawning highlights the contribution the watercourse could make. However, the channel dimensions and flow were not conducive to spawning.

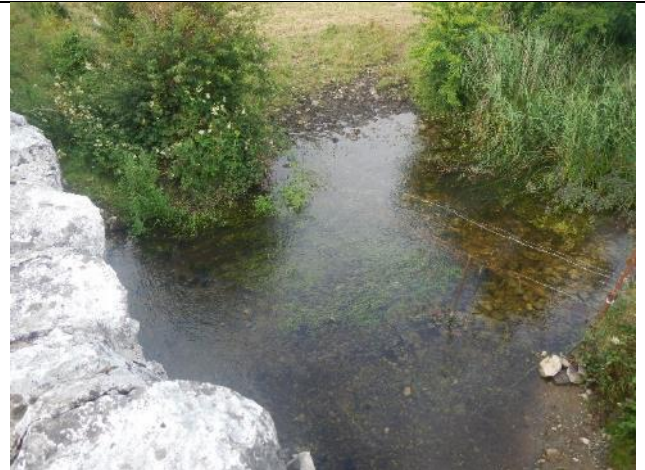
Figure 160: GI 015 (53.777528, -8.781548). Poaching on both banks at drinking bays/fording point u/s of the L1912.

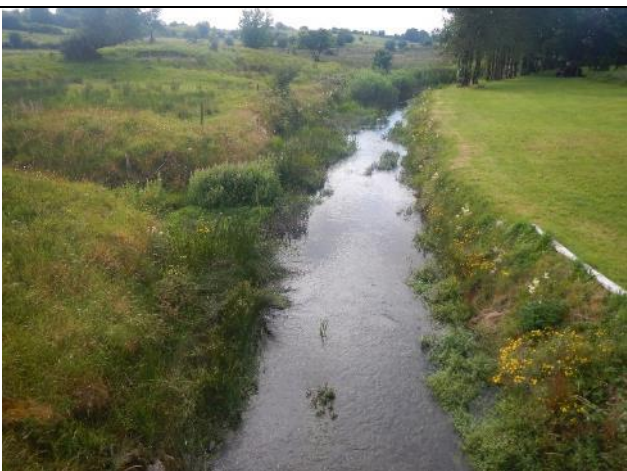
Figure 161: GI 020. Improved juvenile salmonid habitat d/s of the L1912, although the RB could be improved by a larger buffer and greater cover and in-channel structure would be beneficial.

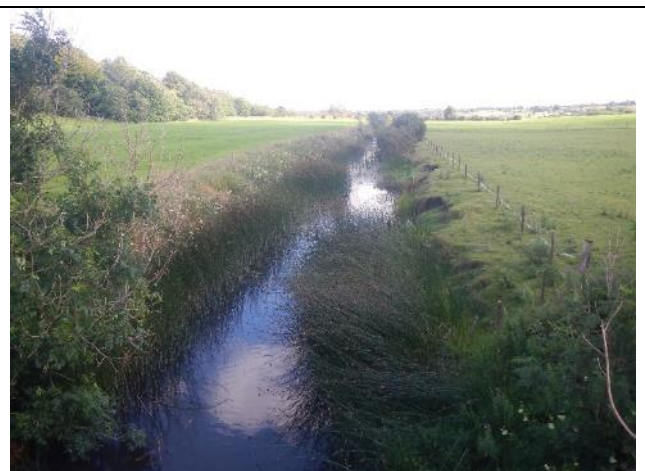
Figure 162: GI 022 (53.813142, -8.83771). U/s of Coogue South Road, the channel was straightened and canal-like. The RB was well buffered, but the LB was sheep-grazed through the fence, denuded of vegetation and suffering erosion/slumping. One field u/s the river appeared to pass through lower grade, boggy land with potential for channel restoration.

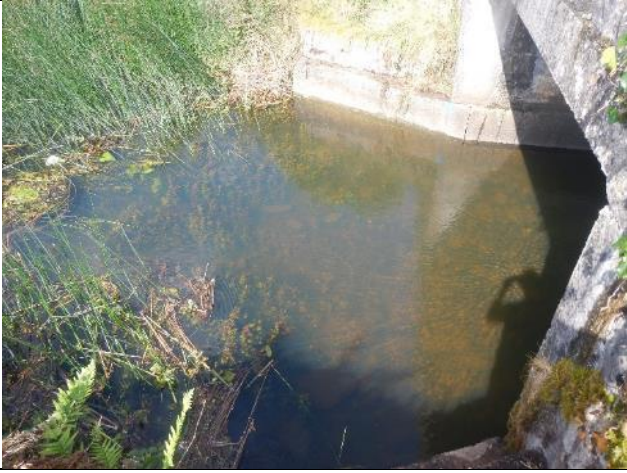
Figure 163: GI 027 (53.813167, -8.837828). D/s of the road bridge, the channel was partially choked with vegetation, but note the lack of excess algae (also see d/s - Figure 166 - where algae is a significant issue).

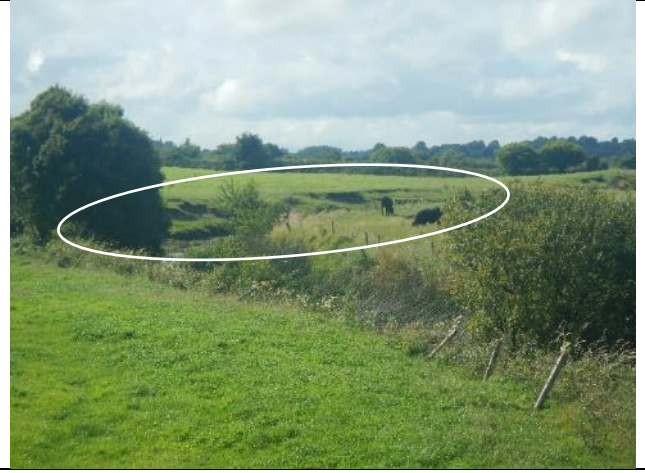
Figure 164: GI 031. Progressing d/s, the LB was unfenced and slumping (white ellipse).

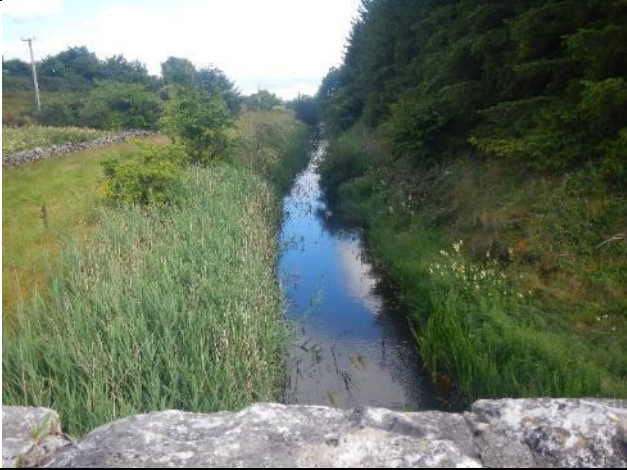
Figure 165: GI 033. U/s of the next bridge the LB was buffered, with a close coniferous plantation on the LB. ideally, a 10m deciduous tree buffer should be maintained alongside the watercourse.

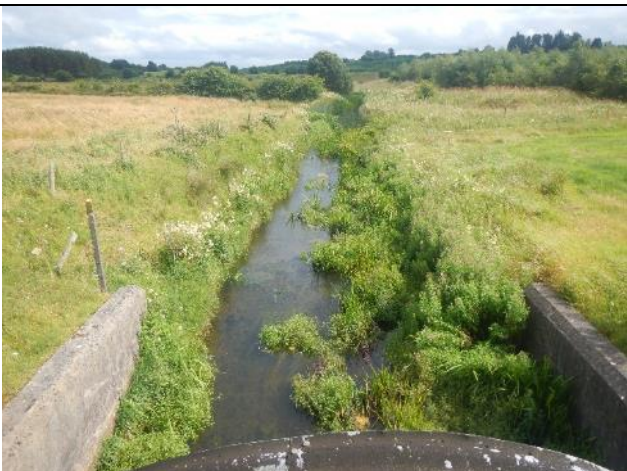
Figure 167: GI 039 (53.828098, -8.87353). U/s of the N17 crossing, the channel appeared less incised, with more natural features and shallow areas. Numerous juvenile salmonids were observed.

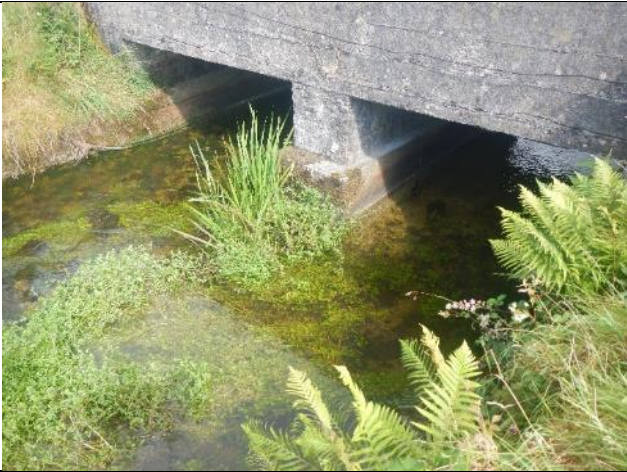
Figure 169: GI 046 (53.84461, -8.898523). The bridge crossing at the next spot-check posed no issues for fish passage and the slight narrowing and shade gave a glimpse of the higher quality habitat that could be achieved with a more naturally varied channel.

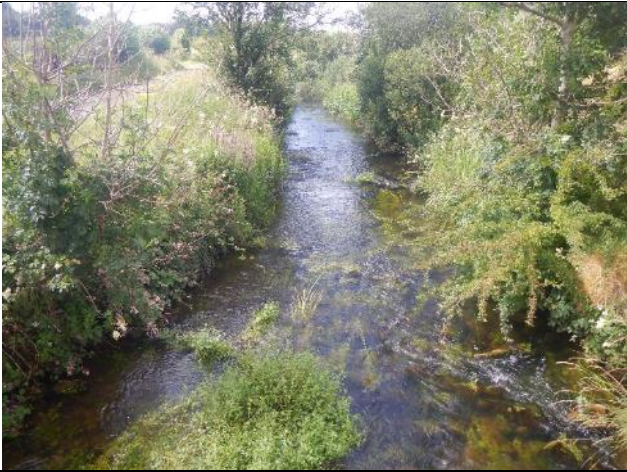
Figure 171: GI 049. Habitat d/s was slightly higher quality owing to increased gradient.

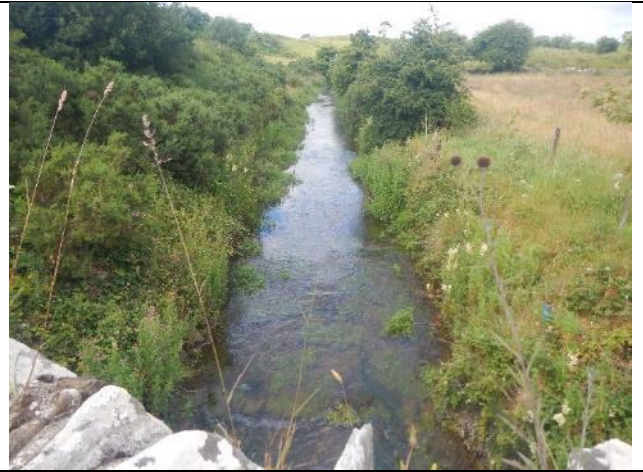
Figure 172: GI 0051 (53.851462, -8.927617). These straightened sections could be greatly enhanced by restoration/re-meandering or, at the very least, increasing variability in flow diversity and channel width with woody material.

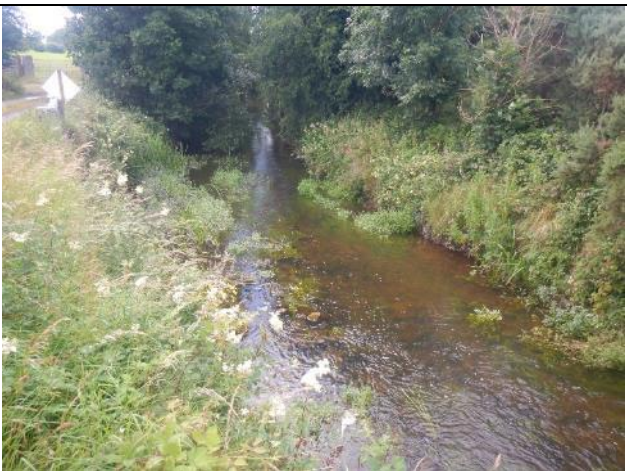
Figure 173: GI 0054. Where trees provided cover/structure and emergent vegetation pinched the channel, habitat diversity greatly improved.

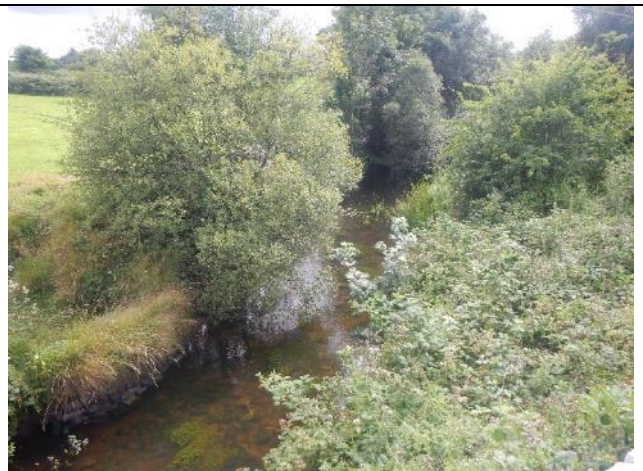
Figure 174: GI 055 (53.85405, -8.93411). With an increased number of bankside trees providing cover and shade, habitat was further improved around the R322 crossing, but the channel remained uniform.

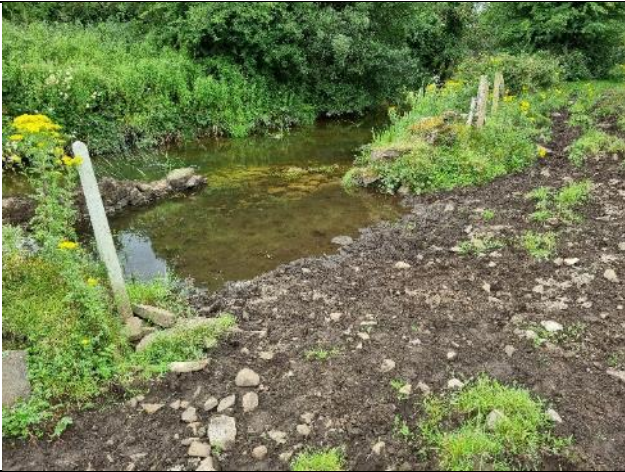
Figure 175: GI 060 (53.854466, -8.933487). Significant cattle poaching at a drinking bay.

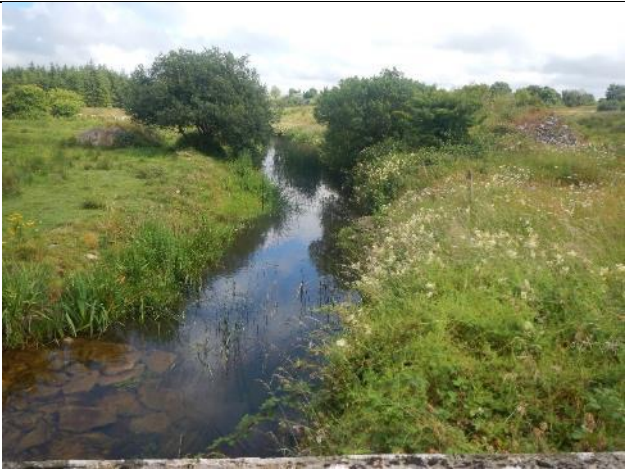
Figure 177: GI 066 (53.855282, -8.9523). Livestock access (LB). The uniform habitat and lack of flow here means the habitat is greatly underperforming for salmonids and many beneficial invertebrates.

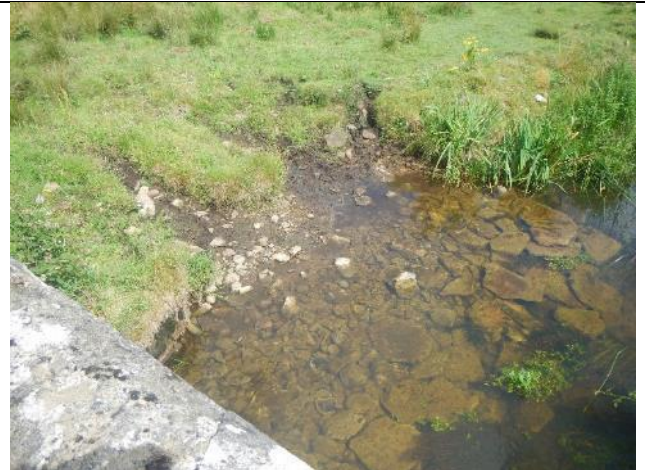
Figure 178: GI 067 (53.855302, -8.952265). Livestock poaching at a drinking point. Much of this area was protected by high, steep banks and/or buffer fencing, but some conspicuously weren't. The placement of stone within the channel does little to mitigate the issue.

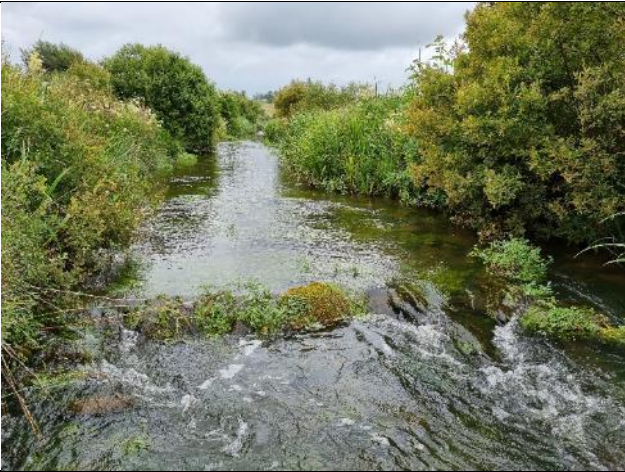
Figure 181: GI 073 (53.860391, -8.966263). Although not inspected in detail, Google Maps aerial imagery shows a 1.5km section u/s of the R320 road bridge is fragmented by weirs. A possible offtake/abstraction is also worth further investigation.

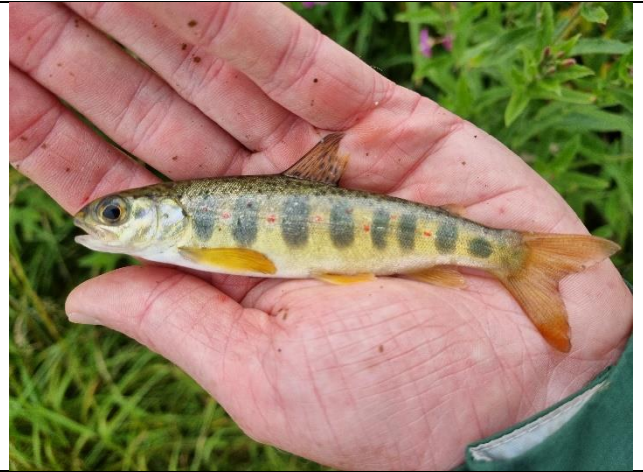
Figure 182: GI 074. Salmon parr are known to be in this area of the catchment, as demonstrated by several that were caught accidentally by the author while fly fishing for trout.

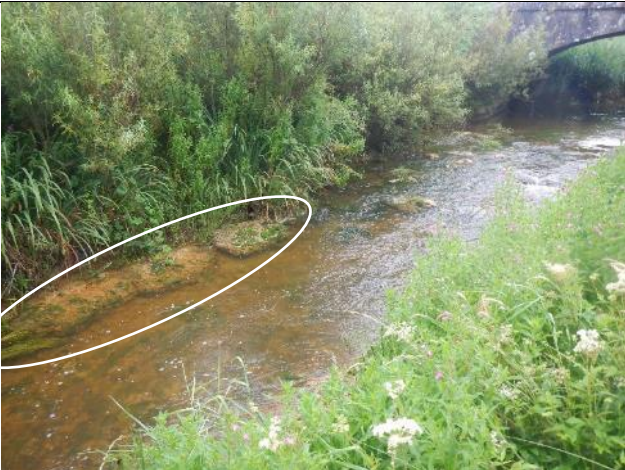
Figure 183: GI 077. From the R320 road, the Glore and then Gweestion were surveyed by kayak. Immediately d/s of the R320, in-channel habitat work had been undertaken, including stone groynes (white ellipse) and weirs.

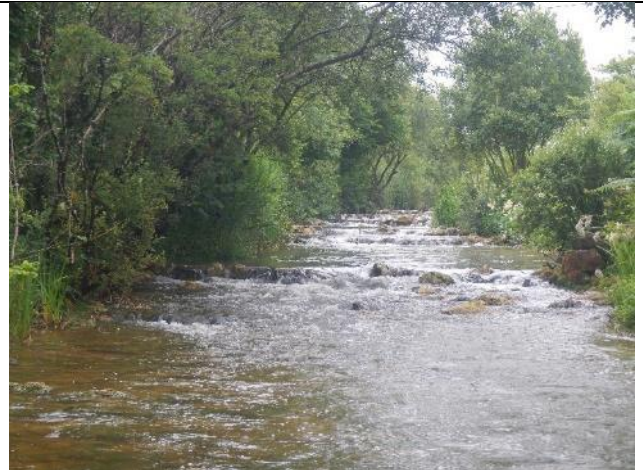
Figure 184: GI 089 (53.86989, -8.985915). Numerous weirs created (apparently relatively recently installed) pools in a long uniform section but, in conjunction with the long section of weirs u/s will have a significant detrimental impact upon sediment transport and habitat utilisation, forming behavioural and in some cases physical barriers.

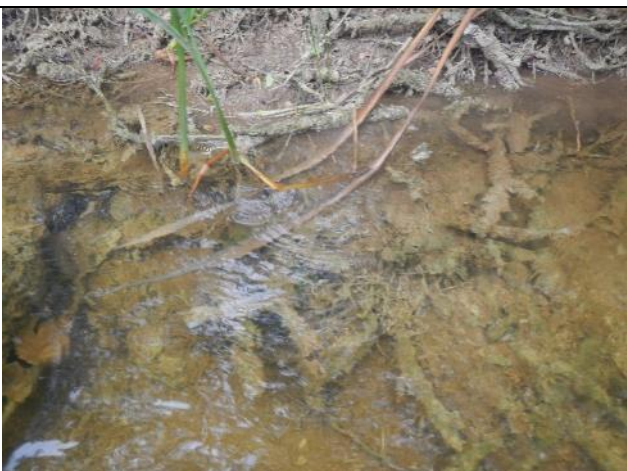
Figure 185: GI 098. From its mid/lower reaches, the Glore became even more calcareous, with extensive calcium carbonate precipitate smothering the bed and any static structure. Weirs exacerbate the binding of substrate by tufa as they reduce the ability of the stream to scour and mobilise the material regularly.

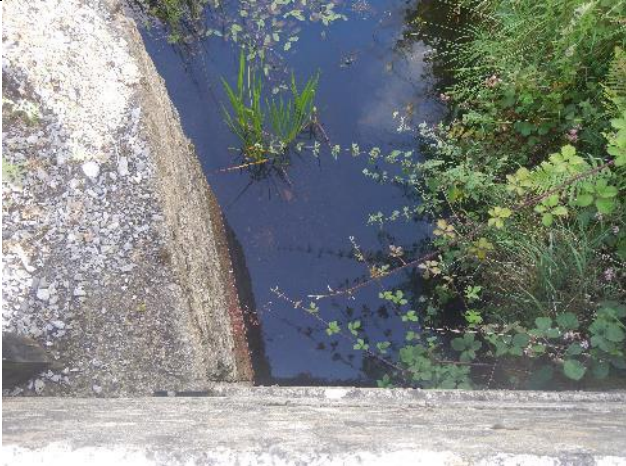
Figure 186: GI(T1) 001 (53.80036, -8.744247). At the u/s spot-check on the Glore tributary, the channel was overcapacity with little flow diversity, but the culvert appeared to be passable by fish.

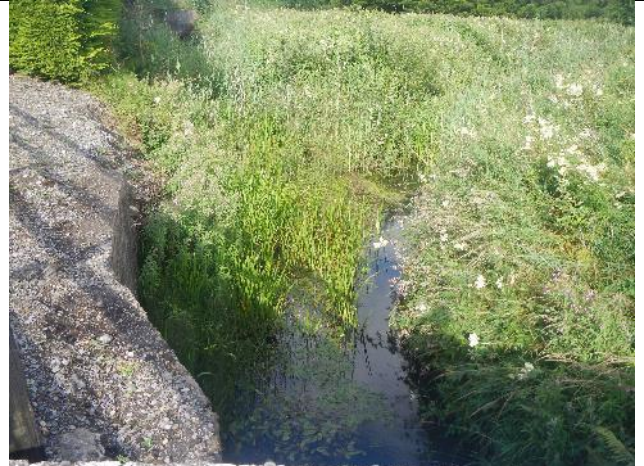
Figure 187: GI(T1) 002. Emergent vegetation choked the channels u/s of the bridge, as often occurs when a channel is dredged wider than the flow can naturally maintain.

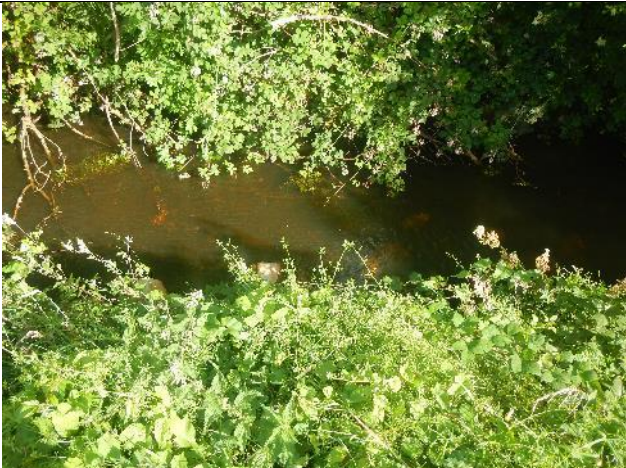
Figure 188: GI(T1) 004. Habitat d/s, where there was greater flow diversity provided much higher quality habitat, further enhanced by valuable trailing vegetation. Even in the upper reaches, this tributary was likely to support juvenile salmonids and could be enhanced for spawning habitat.

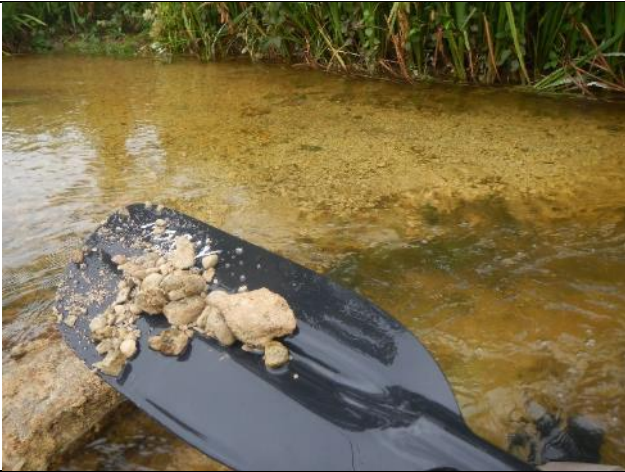
Figure 189: Gw 006. The Gweestion River begins at the d/s end of the Glore River, therefore having the same highly calcareous character. Where not completely impounded and the substrate was still mobile, the river offered good spawning habitat for salmonids.

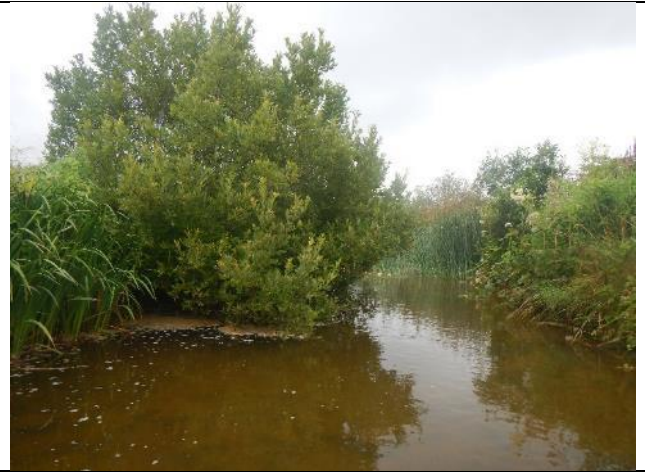
Figure 190: Gw 011. In a deeper impounded section, adult and older trout habitat was enhanced by bankside trees, but still lacked flow diversity.

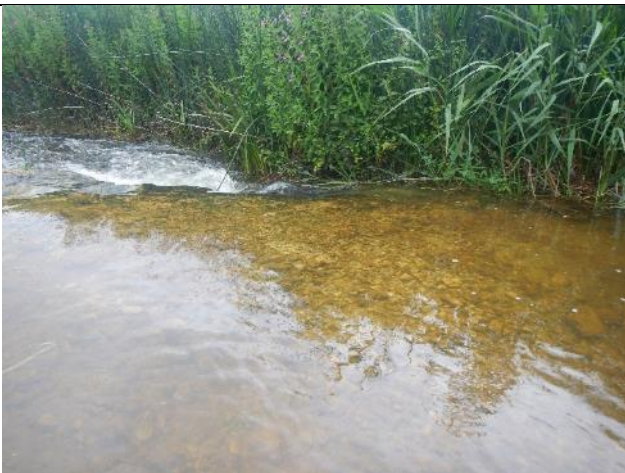
Figure 191: Gw 015 (53.872012, -8.991125). Weirs became less frequent progressing d/s but were present, with some gravel availability, but it would be far higher quality if the weirs were removed or at least notched to allow more natural sediment transport and flow diversity, and to prevent the substrate from becoming unnecessarily consolidated by tufa (preventing salmon

Photo	Observation	Recommendation	Lat/Long	Priority
Gw 015	Continued weirs	Remove to reduce the potential of substrate consolidation by tufa	53.872012, -8.991125	1
Gw 029	Access track/surface runoff (LB)	Reduce use of vehicular access	53.874827, -8.993235	3
Gw 030	Drinking bay/fine sediment input (RB)	Alter fence line to exclude livestock and provide alternative water source	53.874828, -8.993243	2
Gw 034	Drinking bay/fine sediment input (LB)	Exclude livestock and provide alternative water source	53.876387, -8.994587	2
Gw 038	Unfenced (LB), over-wide channel	<ul style="list-style-type: none"> • Install buffer fencing • Undertake tree planting • Install in-channel structures/material 	53.87696, -8.995015	1
Gw 061	Drinking bay/fine sediment input (LB)	Exclude livestock and provide alternative water source	53.881442, -9.00089	2
Gw 069	Drinking bay/fine sediment input (LB)	Exclude livestock and provide alternative water source	53.882535, -9.002925	2

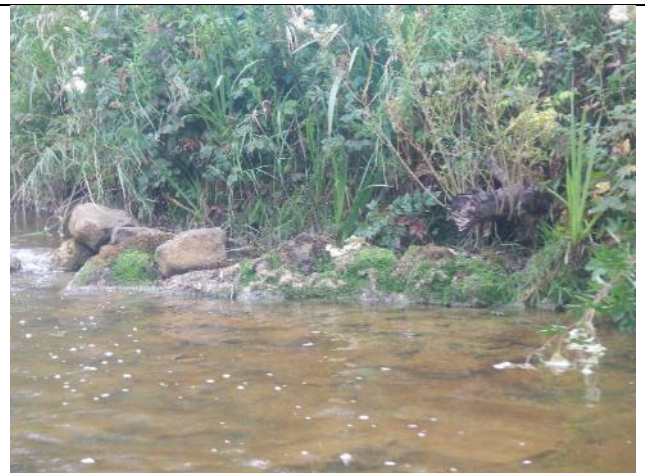
Figure 192: Gw 021 (53.872908, -8.991167). A sprouting willow stump, suggesting someone may have been unnecessarily pruning valuable bankside trees. Alternatively, someone could have planted it as a stake.

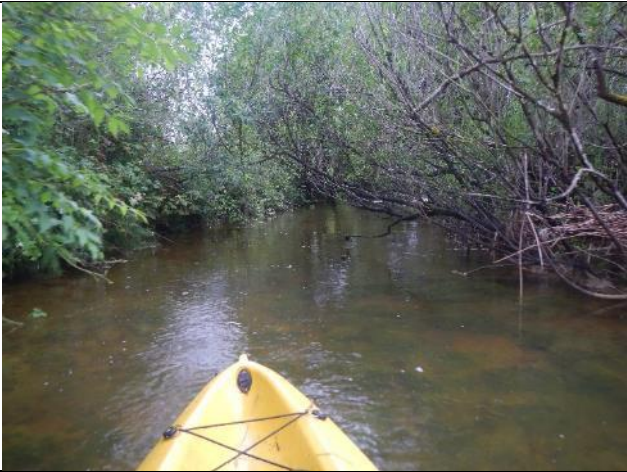
Figure 193: Gw 025. Occasional treelined and enclosed sections offered valuable habitat diversity and sanctuary for larger fish which were seen among the structure.

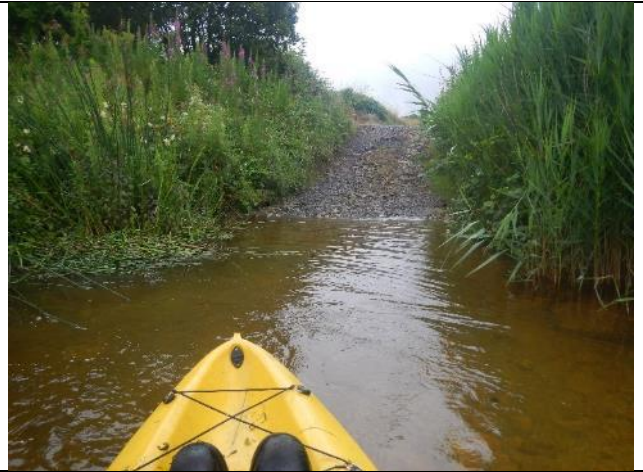
Figure 194: Gw 029 (53.874827, -8.993235). A track and vehicle access point to the river created a small input of fine sediment. Vehicles use in the watercourse could also lead to pollution.

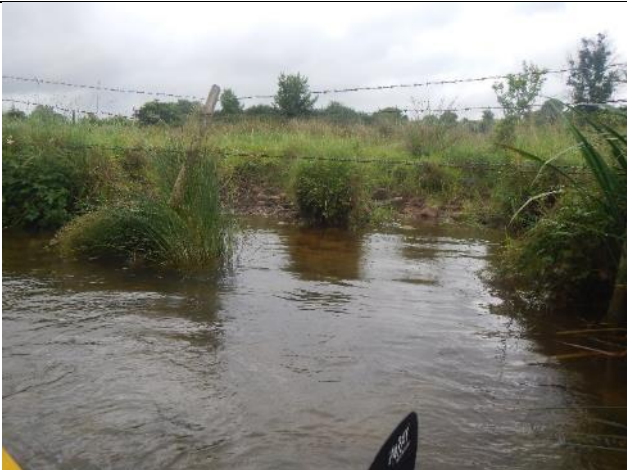
Figure 195: Gw 030 (53.874828, -8.993243). Drinking bay, bank erosion and associated inputs.

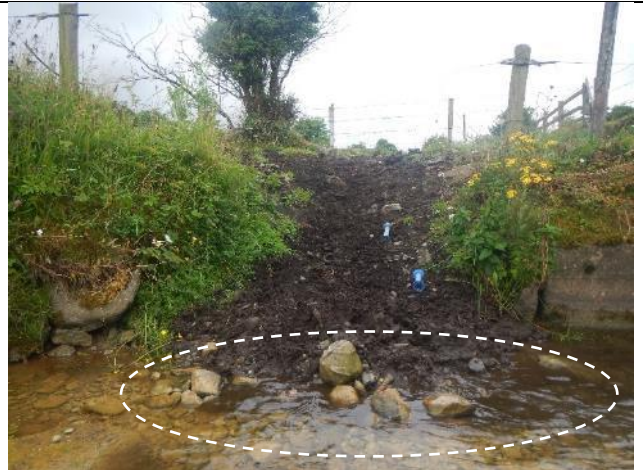
Figure 196: Gw 034 (53.876387, -8.994587). Drinking bay, bank erosion and associated inputs. Note the plume of earth/fine sediment washing d/s (white ellipse).

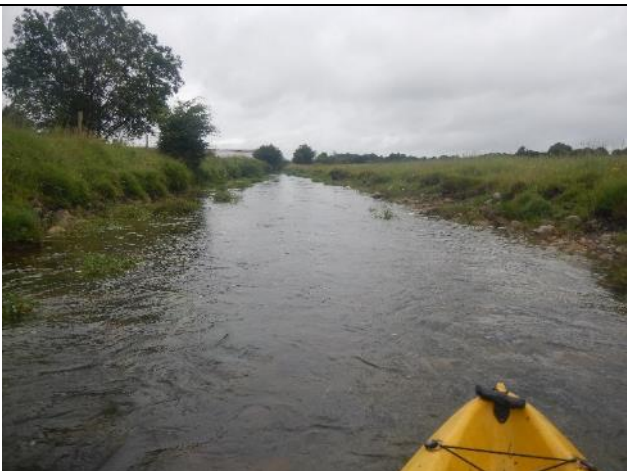
Figure 197: Gw 038 (53.87696, -8.995015). Unfenced section, with a corresponding lack of bankside vegetation. This over-wide and uniform channel could be greatly improved with in-channel structure like large woody material and/or gravel, even if full re-meandering isn't possible.

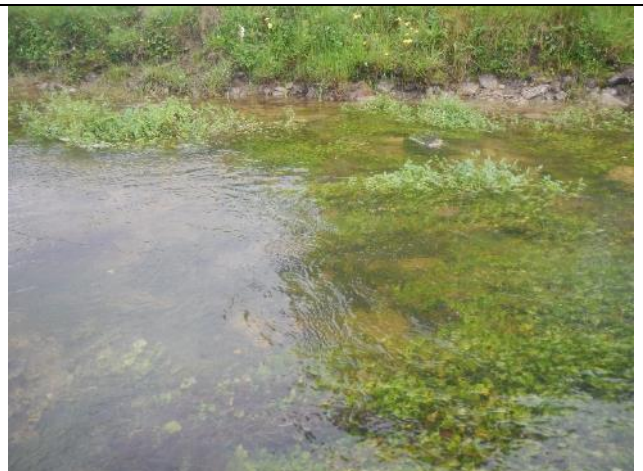
Figure 198: Gw 041. In more open areas, the productivity of the stream showed in the diversity and abundance of bankside vegetation, with faster-flowing areas providing good juvenile salmonid habitat.

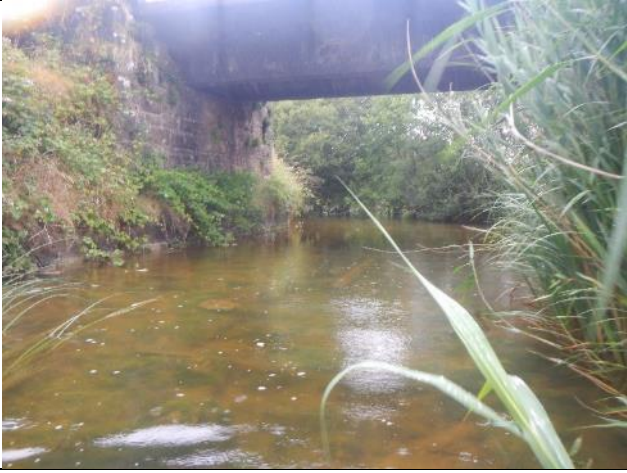
Figure 199: Gw 050 (53.879515, -8.997023). The disused railway line crossing posed no major habitat issues, other than being an artificial bank structure.

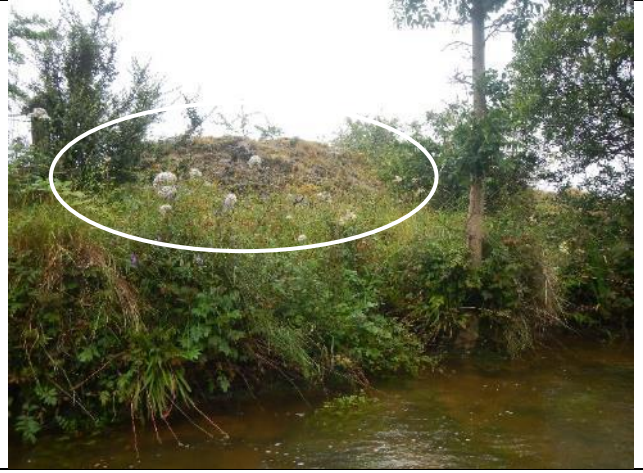
Figure 200: Gw 055. Heaps of spoil (white ellipse) previously dredged from the channel were a common occurrence along the river in adjacent fields.

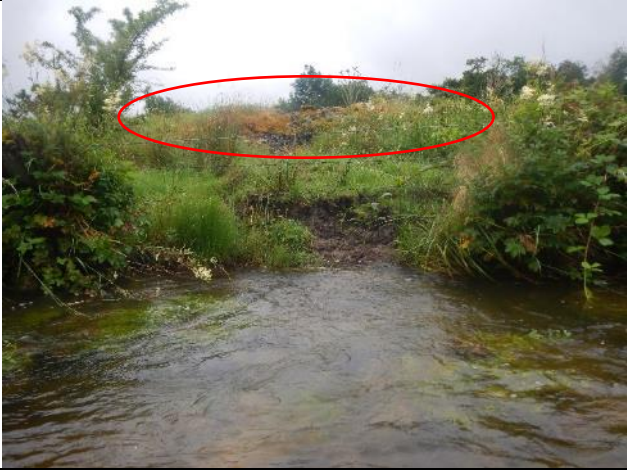
Figure 201: Gw 061 (53.881442, -9.00089). Drinking bay, bank erosion and associated inputs. Also note the dredged spoil in the background (red ellipse).

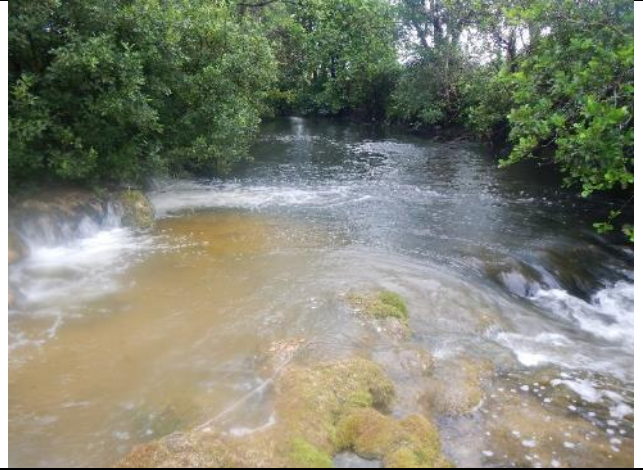
Figure 202: Gw 066. The stark contrast in water quality between the highly calcareous River Gweestion (with tufa barrages) and the darker River Pollagh (background), which although having significant limestone in its catchment also has a greater influence of peat, sandstone and shale.

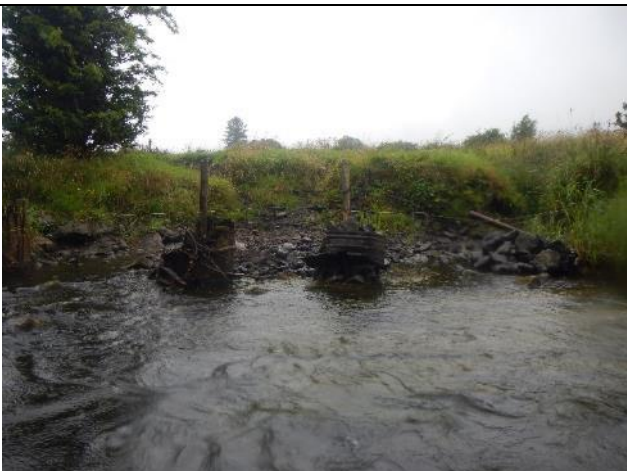
Figure 203: Gw 069 (53.882535, -9.002925). Drinking bay, bank erosion and associated inputs.

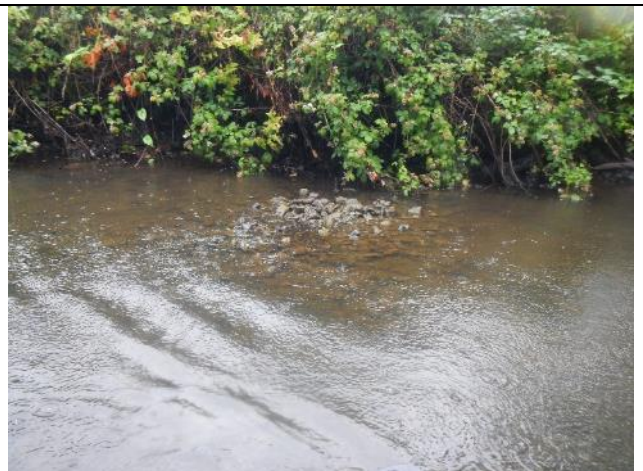
Figure 204: Gw 071. Remains of a large salmonid redd in the river margin. The reduced impoundment, greater substrate supply and mobility all mean that spawning opportunities in the Gweestion improved d/s of the Pollagh confluence, but this doesn't preclude the upper Gweestion and Glore and as important nursery areas, particularly with removal of the weirs.

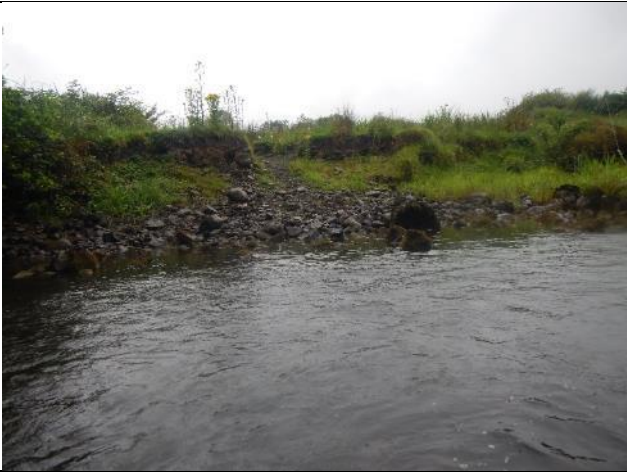
Figure 205: Gw 074 (53.88313, -9.004902). Lack of buffer fencing and consequent bank erosion.

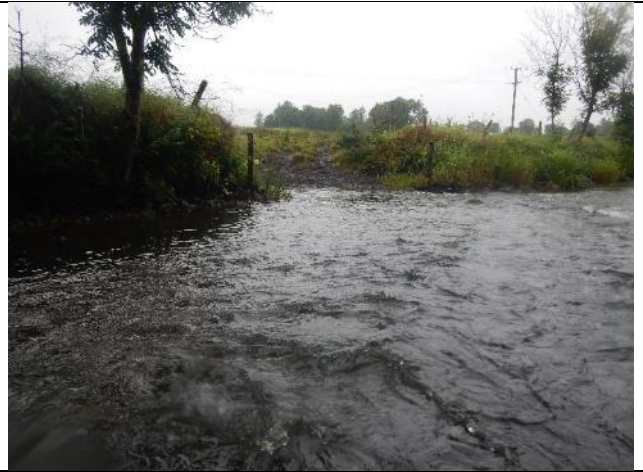
Figure 206: Gw 081 (53.884068, -9.007188). Drinking bay, bank erosion and associated inputs.

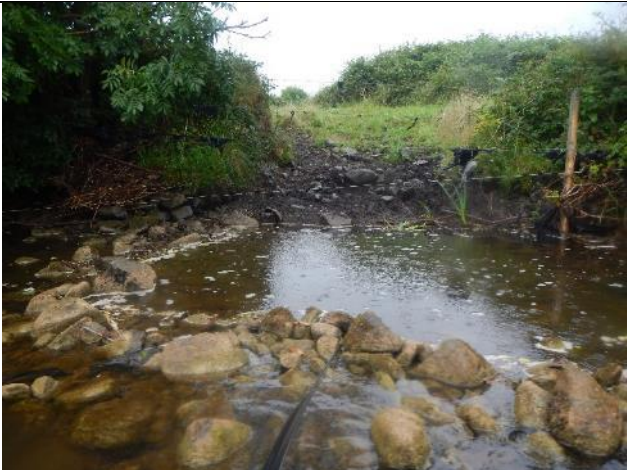
Figure 207: Gw 082 (53.88415, -9.007507). Drinking bay, bank erosion and associated inputs.

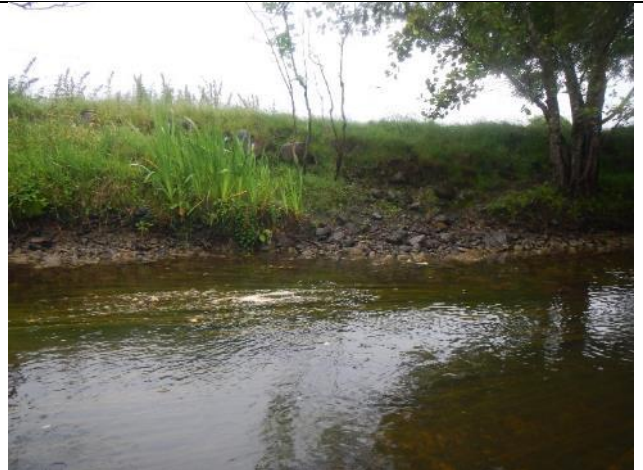
Figure 208: Gw 086 (53.884665, -9.008967). Lack of buffer fencing and increased bank erosion.

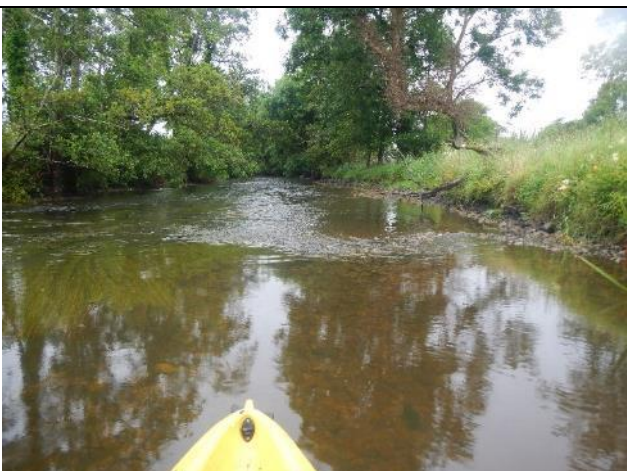
Figure 209: Gw 088. As in areas on the Pollagh (and main river Moy), the uniformly dredged and often incised channel appeared less recovered and/or capable of retaining coarse substrate mid-channel in many areas, but deposition in the river margins had supported spawning activity.

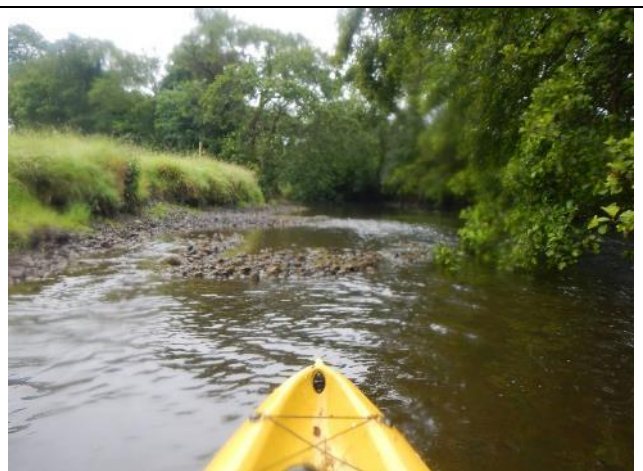
Figure 210: Gw 092. Depressions in the gravel bars often appeared to be the remains of old redds, which were usually distinguishable from the shape/form of purely depositional features.

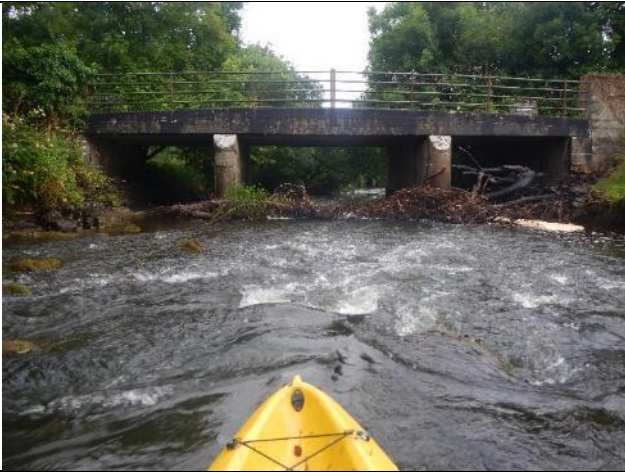
Figure 211: Gw 098 (53.8873, -9.007168). Debris at the L1919 road bridge may elevate flood risk somewhat but posed no real issue for fish passage.

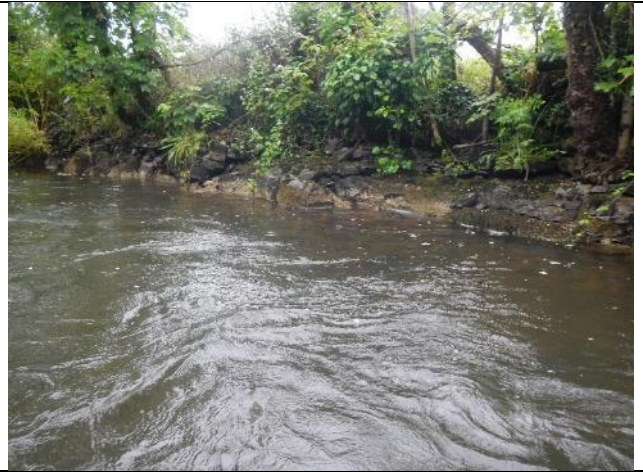
Figure 212: Gw 100. Despite being less calcareous than the upper river, areas of tufa (likely facilitated by calcareous springs in the bed and banks) did facilitate some tufa growth.

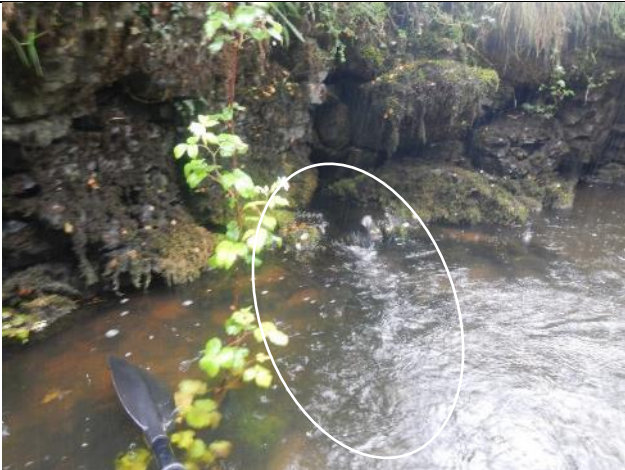
Figure 213: Gw 106. Where the river was incised into the bedrock, occasional springs were visible, some with a significant flow (white ellipse).

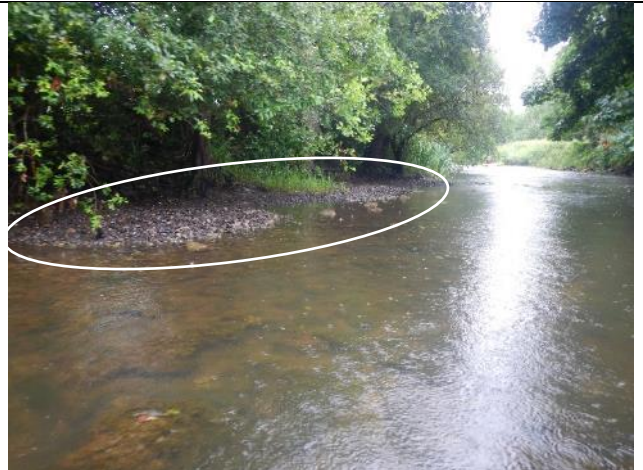
Figure 214: Gw 122. Roughness of the river margin that helped facilitate gravel deposition (white ellipse).

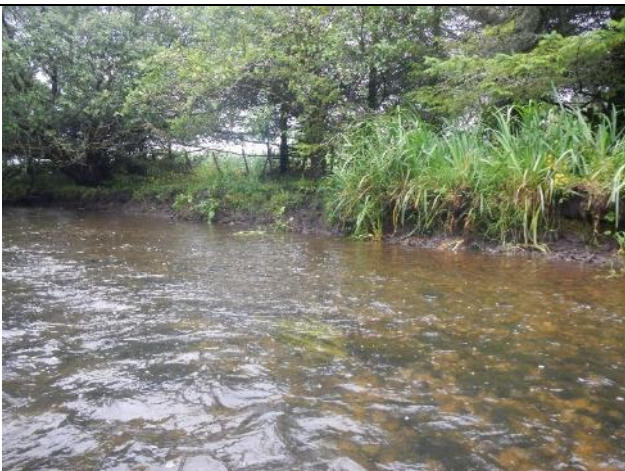
Figure 215: Gw 125 (53.89642, -9.01836). Livestock access/unmaintained field boundary and bank erosion.

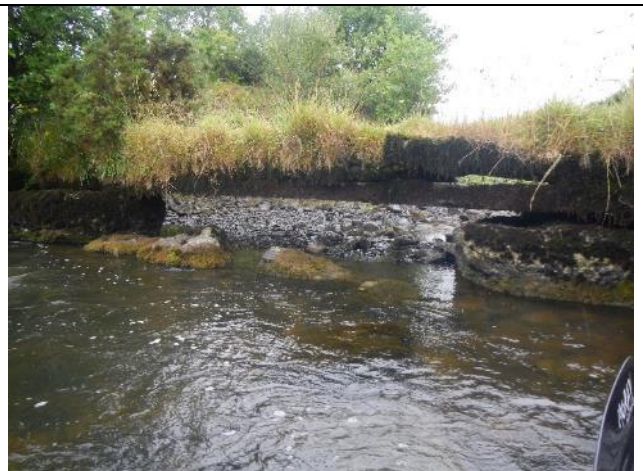
Figure 216: Gw 126 (53.897113, -9.019465). Drinking bay that appeared to be reasonably protected with a gravel bed, but as water levels rise, any fine sediment and excreta will wash into the river.

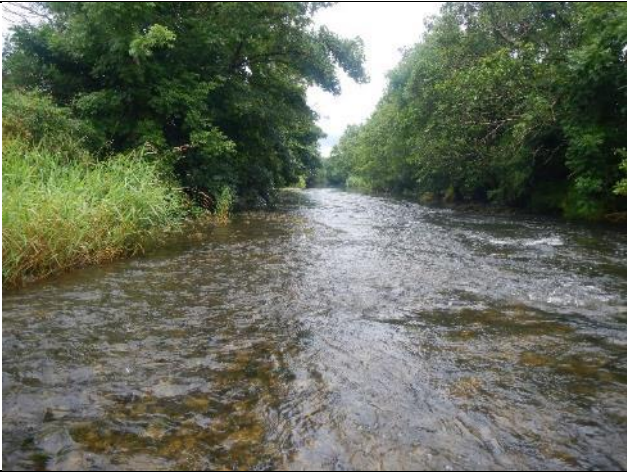
Figure 217: Gw 141. In straighter sections, gravel deposition helped to add flow diversity and provided reasonably good habitat for juvenile salmonids. Further roughness within the channel (low/trailing branches and woody material) could facilitate additional deposition.

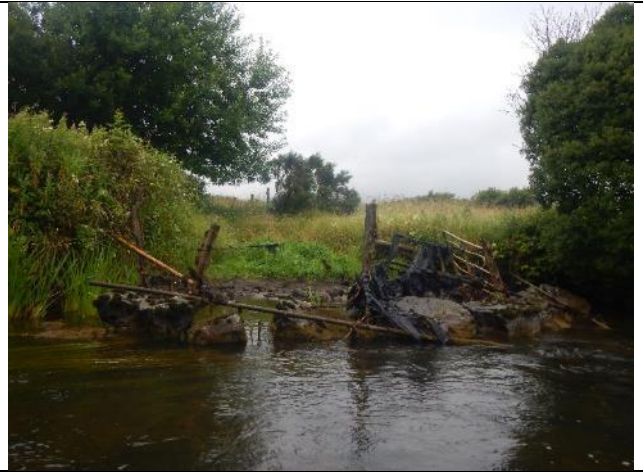
Figure 218: Gw 142 (53.904398, -9.023517). Drinking bay, bank erosion and associated inputs.

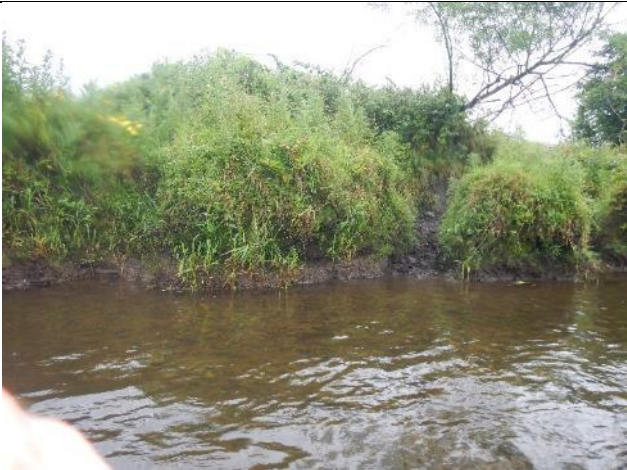
Figure 219: Gw 144 (53.904545, -9.023667). Lack of buffer fencing and increased bank erosion.

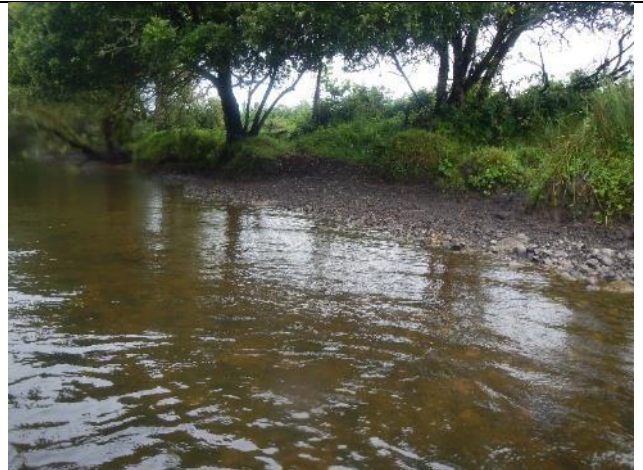
Figure 220: Gw 145 (53.904588, -9.023648). Lack of stock-proof fencing and increased bank erosion. The increasing land management issues in the lower Gweestion are not conducive to optimising the habitat quality of what is likely to be an important spawning area.

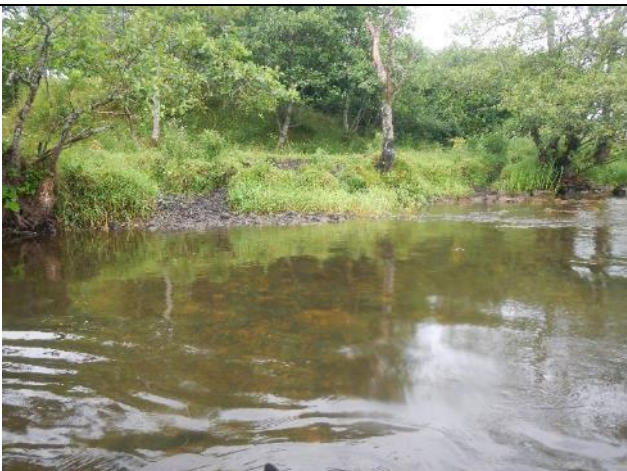
Figure 221: Gw 148 (53.905565, -9.023078). Lack of buffer fencing and increased bank erosion.

Photo	Observation	Recommendation	Lat/Long	Priority
Gw 148	Livestock access (RB)	Exclude livestock and provide alternative water source	53.905565, -9.023078	2
Gw 156	Livestock access (LB)	Exclude livestock and provide alternative water	53.906933, -9.021245	2
Gw 160	Drinking bay/nutrient input (LB)	Exclude livestock and provide alternative water source	53.90941, -9.02183	2
Gw 178	Drinking bay/nutrient input (RB)	Exclude livestock and provide alternative water source	53.914165, -9.031747	2
Gw 180	Drinking bay/nutrient input (RB)	Exclude livestock and provide alternative water source	53.914493, -9.033745	2
Gw 192	Artificial groynes	Remove groyne to facilitate more natural recovery	53.91717, -9.037095	2
Gw 195	Drinking bay/nutrient input (LB)	Exclude livestock and provide alternative water source	53.917498, -9.038495	2
Gw 203	Livestock access (LB)	Exclude livestock and provide alternative water source	53.919413, -9.046042	2

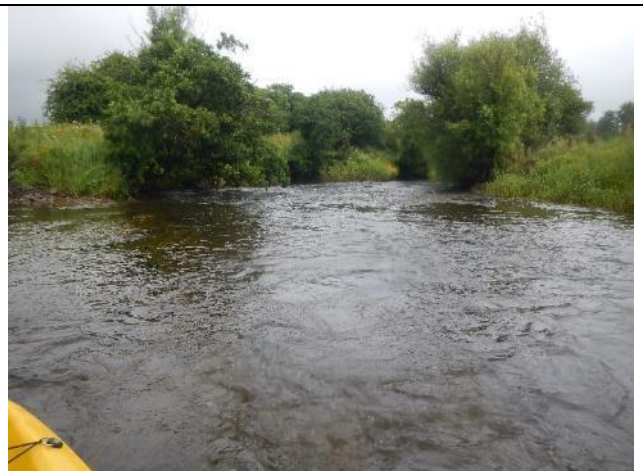
Figure 222: Gw 149. Very occasional wider channel sections facilitated more natural gravel deposition as riffles, creating high quality salmonid spawning and juvenile habitat, but they were far fewer than would occur on a channel of more natural sinuosity and dimensions.

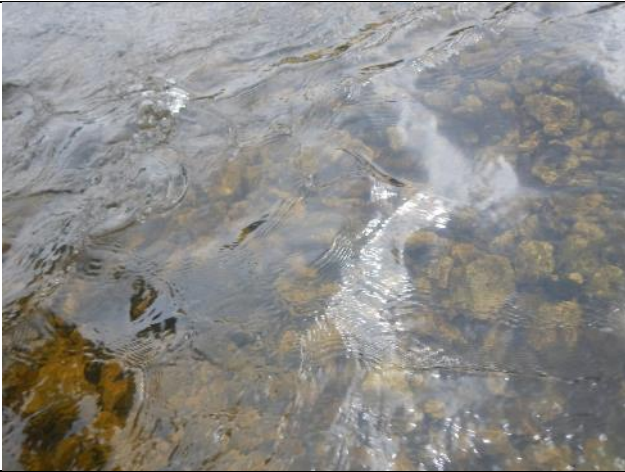
Figure 223: Gw 150. The quality of gravel/cobble substrate in the more natural channel areas was well sorted and relatively free from fines.

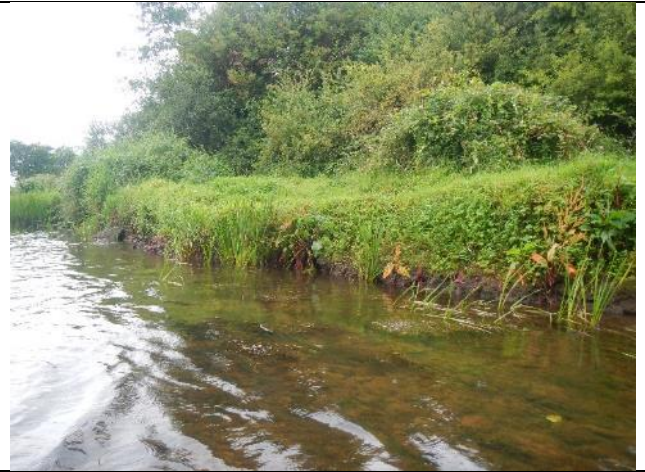
Figure 224: Gw 156 (53.906933, -9.021245). Lack of buffer fencing, reduced vegetation and increased susceptibility to bank erosion.

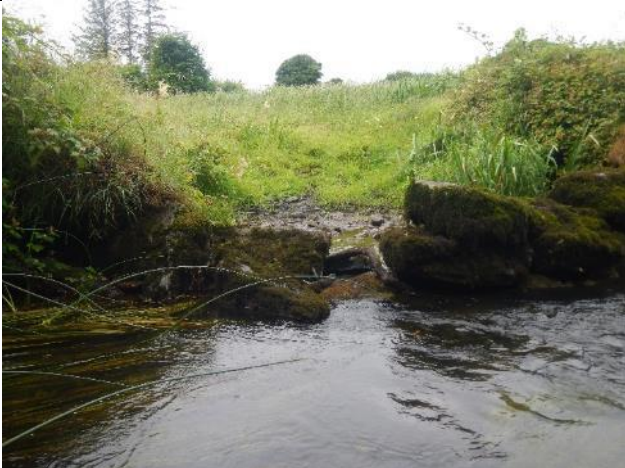
Figure 225: Gw 160 (53.90941, -9.02183). Drinking bay, bank erosion and associated inputs.

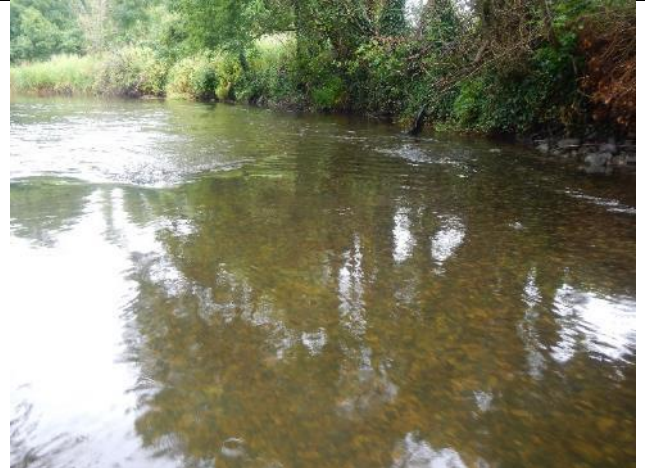
Figure 226: Gw 165. Glide and riffle habitat with areas of spawning substrate suitable for salmonids.

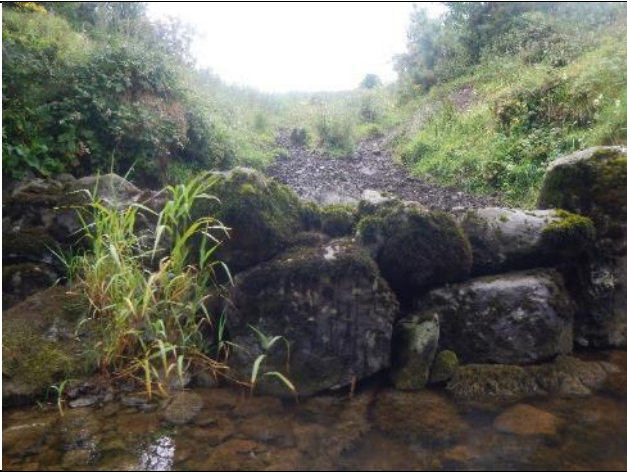
Figure 229: Gw 180 (53.914493, -9.033745). Drinking bay, bank erosion and associated inputs.

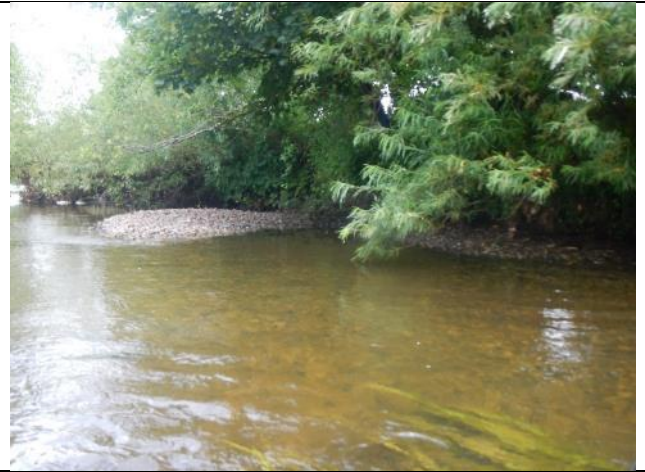
Figure 230: Gw 183. Note how trailing willow boughs greatly assisted the retention of gravel within the river margins, which had then clearly supported spawning activity.
