WILD TROUT TRUST

**River Moy Habitat Assessment
and
Management Plan**

East Mayo Angling Association, Co. Mayo, Ireland

July 2022

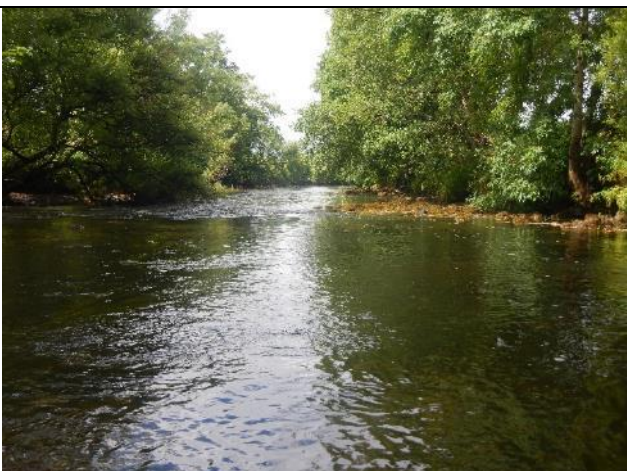
Figure 233: Gw 192 (53.91717, -9.037095). Artificial groynes had been installed in several areas and as on the Moy, while they may have provided some habitat diversity within the more recently dredged channel, they are now more often likely to inhibit natural deposition and channel recovery.

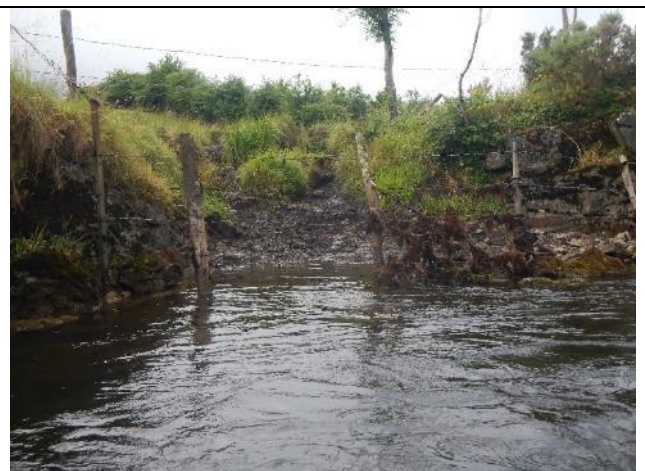
Figure 234: Gw 195 (53.917498, -9.038495). Drinking bay, bank erosion and associated inputs.

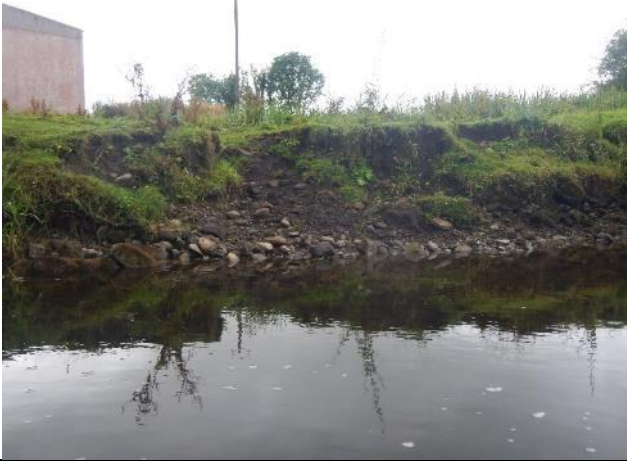
Figure 235: Gw 203 (53.919413, -9.046042). Lack of buffer fencing, increased bank erosion and sediment input.

Photo	Observation	Recommendation	Lat/Long	Priority
Gw 148	Livestock access (RB)	Exclude livestock and provide alternative water source	53.905565, -9.023078	2
Gw 156	Livestock access (LB)	Exclude livestock and provide alternative water	53.906933, -9.021245	2
Gw 160	Drinking bay/nutrient input (LB)	Exclude livestock and provide alternative water source	53.90941, -9.02183	2
Gw 178	Drinking bay/nutrient input (RB)	Exclude livestock and provide alternative water source	53.914165, -9.031747	2
Gw 180	Drinking bay/nutrient input (RB)	Exclude livestock and provide alternative water source	53.914493, -9.033745	2
Gw 192	Artificial groynes	Remove groyne to facilitate more natural recovery	53.91717, -9.037095	2
Gw 195	Drinking bay/nutrient input (LB)	Exclude livestock and provide alternative water source	53.917498, -9.038495	2
Gw 203	Livestock access (LB)	Exclude livestock and provide alternative water source	53.919413, -9.046042	2

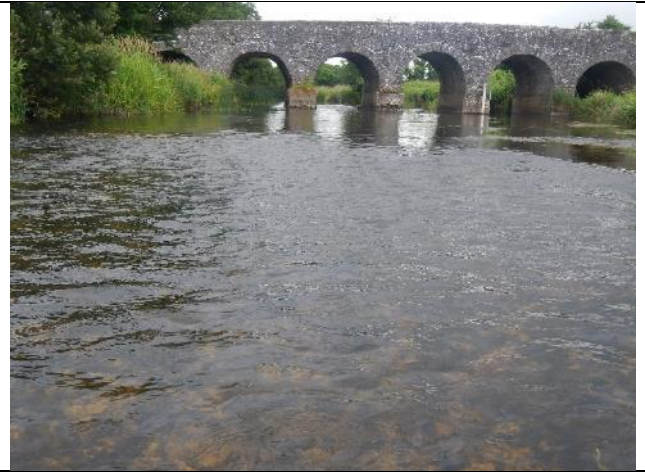
Figure 236: Gw 232. The wider, less incised channel and associated gravel deposition at the furthest d/s bridge on the river offered good salmonid spawning habitat, with areas of juvenile habitat nearby.

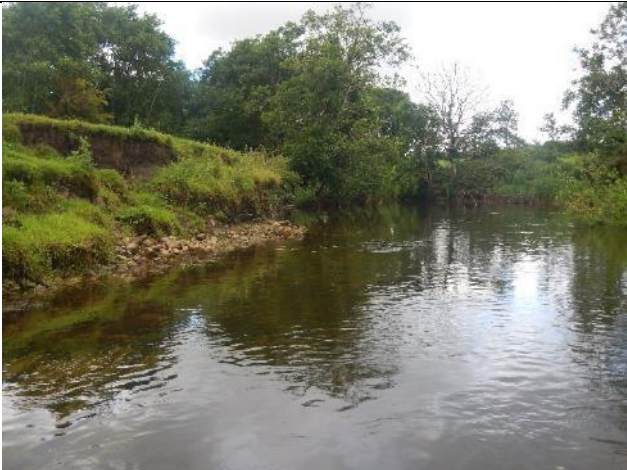
Figure 237: Gw 244 (53.927367, -9.062973). Lack of buffer fencing and increased bank erosion.

Gw 244	Livestock access (LB)	Exclude livestock and provide alternative water source	53.927367, -9.062973	2
Gw 294	Willow collapsing into the channel	Retain such valuable habitat features	53.929942, -9.073555	1
Gw(T1) 005	Lack of woody material in channel	Install woody material	53.887487, -9.033818	3
Gw(T1) 008	Lack of woody material in channel	Install woody material	53.898557, -9.022697	2
Gw(T2) 004	Highly degraded channel	Restoration/re-meandering low priority owing to cost-benefit	53.908543, -9.034637	3
Gw(T3) 001	Highly degraded channel	Restoration/re-meandering low priority owing to cost-benefit	53.916402, -9.054425	3
Gw(T3) 002	Shallow water over smooth concrete created an obstruction	Install baffles to slow flow and increase depth	53.916445, -9.054422	3
Tr 004	Uniform, realigned channel	Investigate potential for channel restoration (particularly lower value LB land)	U/s and d/s of 53.863782, -8.796017	2

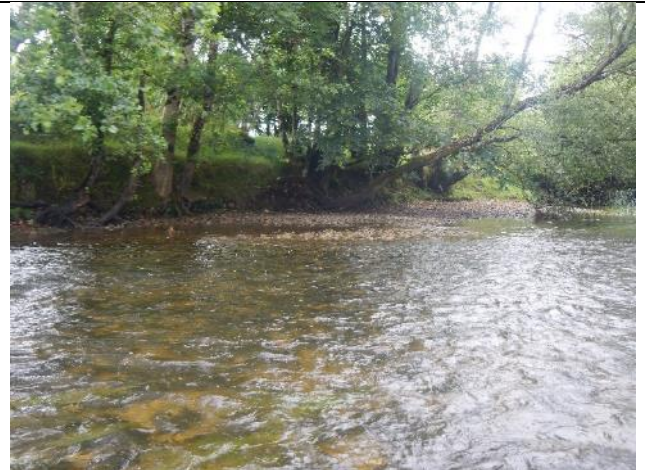
Figure 238: Gw 250. Throughout the lower reaches of the Gweestion, river margin spawning appeared to have occurred. The overhanging tree boughs greatly enhance the area, offering cover and increased security to vulnerable spawning fish.

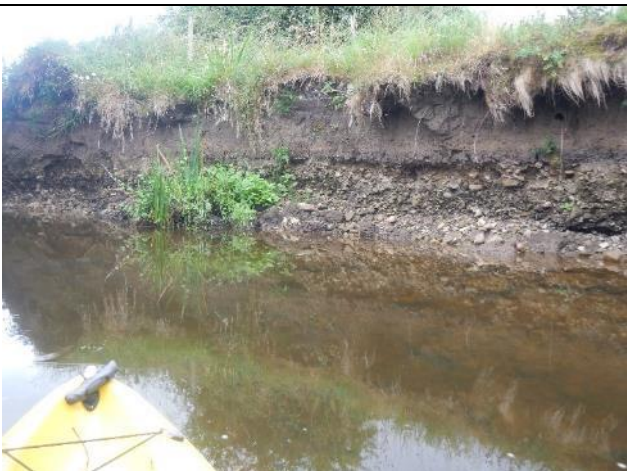
Figure 239: Gw 261. In some areas, slow, natural erosion should be seen as a positive process, providing additional coarse substrate to the river. This is in stark contrast to the exacerbated erosion around drinking bays and unfenced banks.

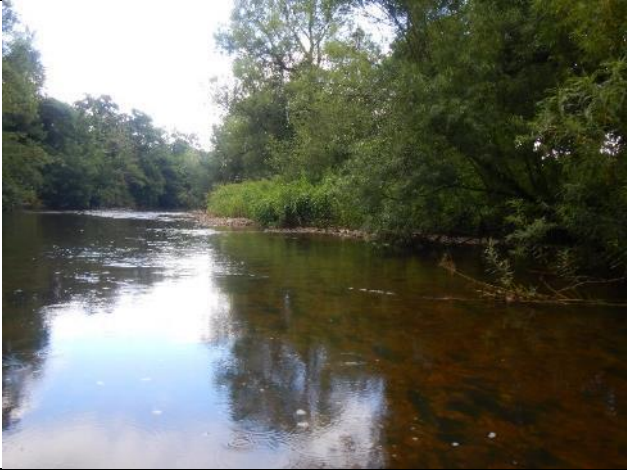
Figure 241: Gw 287. Bankside shrubs in the lower Gweestion enhancing spawning areas by increasing gravel retention and providing low cover for fish. These features also enhance the flow diversity and angling interest of the area.

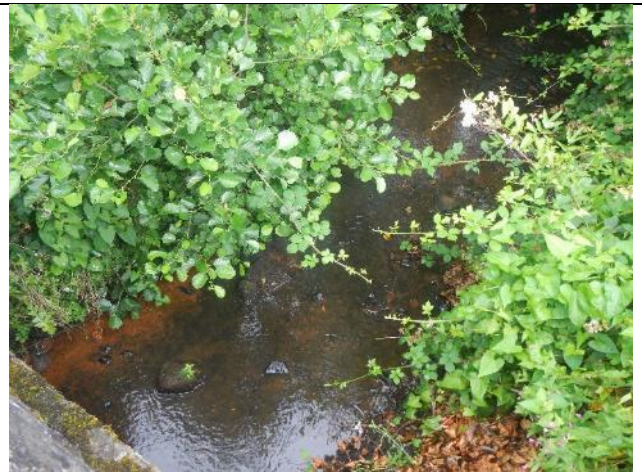
Figure 244: Gw(T1) 005 (53.887487, -9.033818). The channel and substrate supported opportunities for salmonid spawning but would benefit from more woody structure to assist natural morphological recovery.

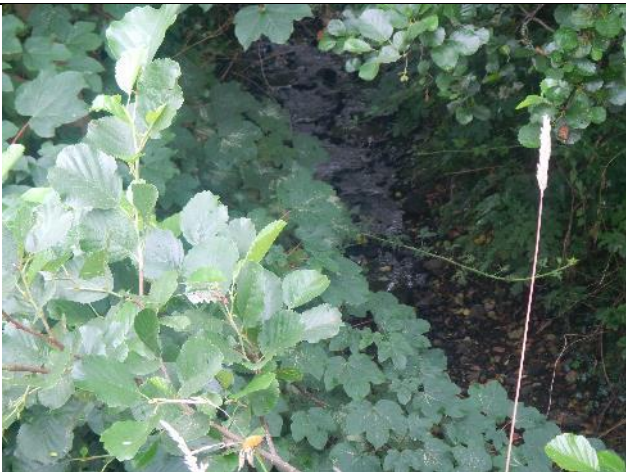
Figure 247: Gw(T2) 001. It was difficult to gain access to the second tributary, which was inspected from the R321, where it appeared to be small but potentially capable of holding salmonids in more natural channel sections.

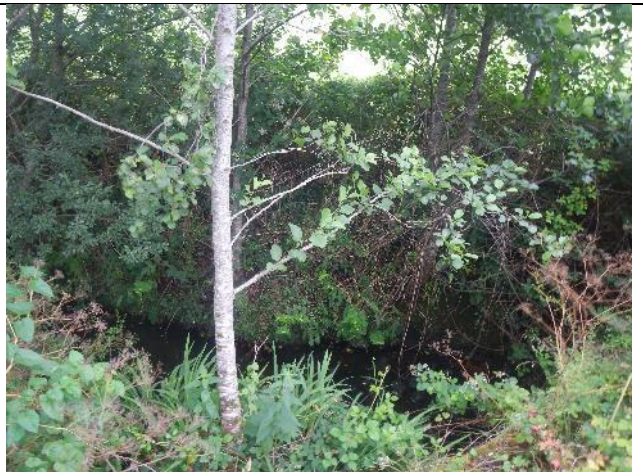
Figure 248: Gw(T2) 002. A scour pool d/s of the road offered habitat for larger juvenile salmonids.

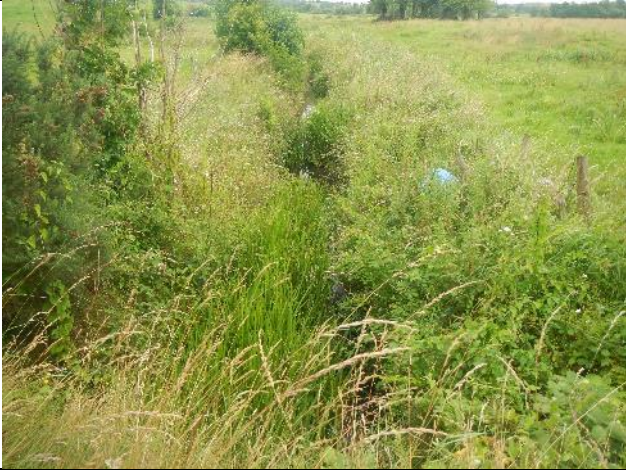
Figure 249: Gw(T2) 004. Further d/s, the channel was lower gradient and uniform, but almost certainly capable of supporting fry and parr. Emergent vegetation encroachment was beginning to win back some sinuosity and flow diversity, but the channel required re-meandering.

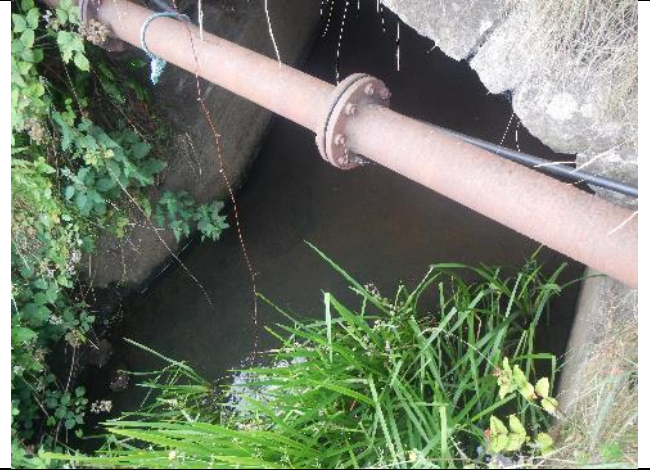
Figure 250: Gw(T2) 005 (53.908555, -9.03464). The road culvert posed no issues for accessibility from the main Gweestion.

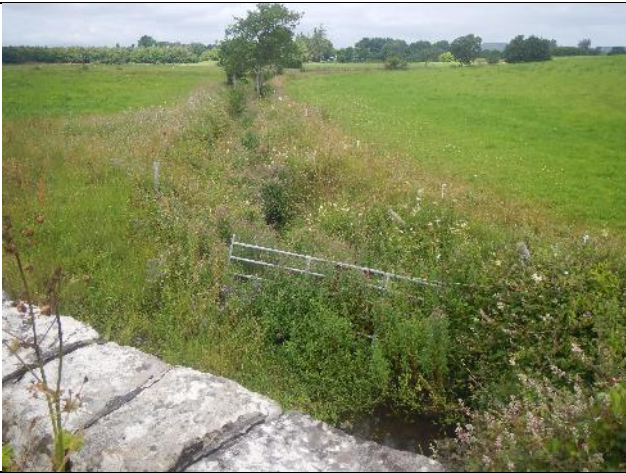
Figure 251: Gw(T3) 001. The third small tributary of the Gweestion that was inspected was of a similar character to the lower reaches of the second (Gw(T2)), being similarly straightened and set within the lower gradient areas of the valley. Again, emergent vegetation somewhat improved a uniform, over-capacity channel that really required major restoration.

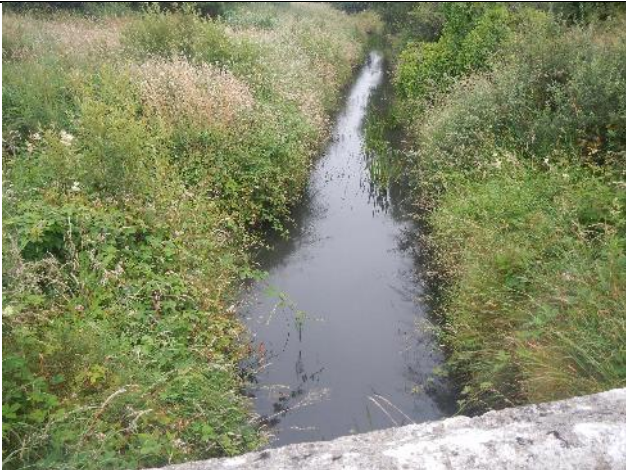
Figure 253: Tr 001 (53.86378, -8.795908). The Trimoge River is a sizeable lower tributary of the Gweestion that should provide good spawning and juvenile areas, but was severely dredged, uniform and degraded at the furthest u/s road crossing inspected.

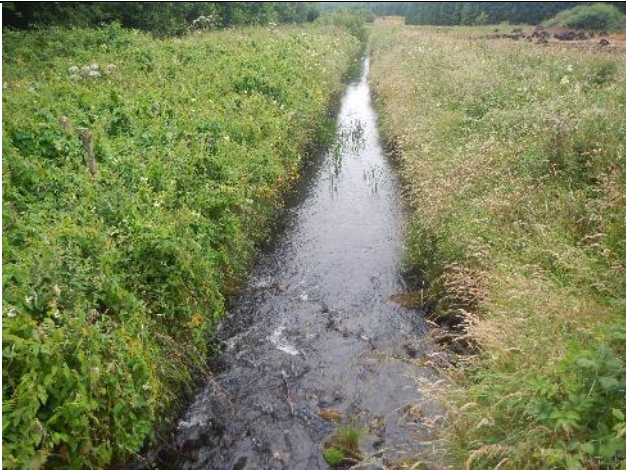
Figure 255: Tr 008 (53.865933, -8.809827). The next spot-check revealed similar habitat to the first. Even the installation of alternating structures within the channel (like woody material) to increase flow diversity would be an improvement, but channel restoration, riffle installation or woody material installation should be the hierarchy of options, respectively.

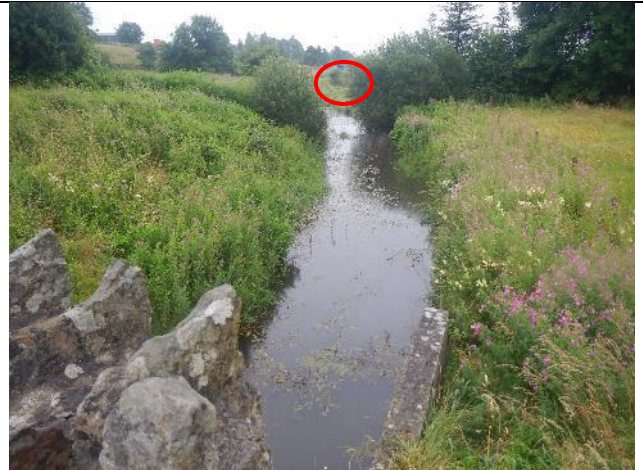
Figure 256: Tr 010 (53.87095, -8.846848). U/s of the N17 road, the channel was slightly more sinuous but similarly uniform capacity. A blue excavator was observed along the riverbank a short distance further u/s (red circle).

The road crossing/culvert appeared to be appropriately sunken, allowing free fish passage.

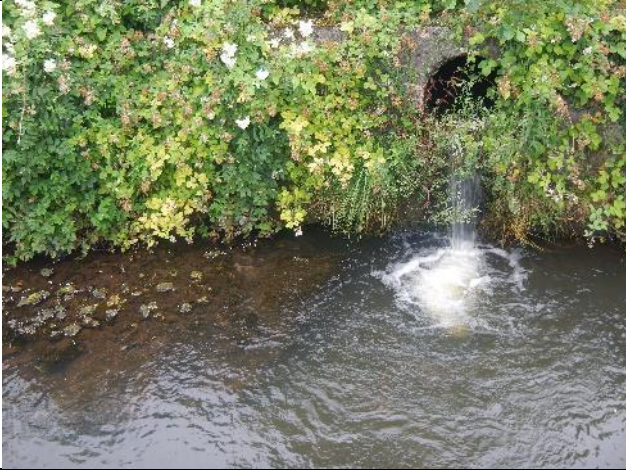
Figure 257: Tr 015 (53.870595, -8.849042). In Kilkelly, a sizeable discharge appeared to be negatively impacting upon the river, with sewage fungus and excess algal growth observed on the gravel bar(s) d/s.

Photo	Observation	Recommendation	Lat/Long	Priority
Tr 015	Polluting/high-nutrient discharge	Investigate the source and seek improvement to water quality	53.870595, -8.849042	1
Tr 016	Groynes	Adjustment to improve flow characteristics	53.870488, -8.849417	3
Tr 028	Uniform, realigned channel	<ul style="list-style-type: none"> Investigate potential for channel restoration Undertake tree planting 	53.864027, -8.871305	2
Tr 036	Unenclosed trap	Cover the trap to improve efficacy Restrict the entrance to prevent otters being trapped	53.865812, -8.886607	1
Tr 037	Boulder weir	Remove	53.865813, -8.88662	2
Tr 041	Drinking bay/nutrient input (RB)	<ul style="list-style-type: none"> Exclude livestock and provide alternative water source Install fish easement 	53.866442, -8.891247	2
Tr 046	Uniform, realigned channel	Investigate potential for channel restoration Install cobble and gravel riffles	U/s and d/s of 53.870838, -8.908473	1

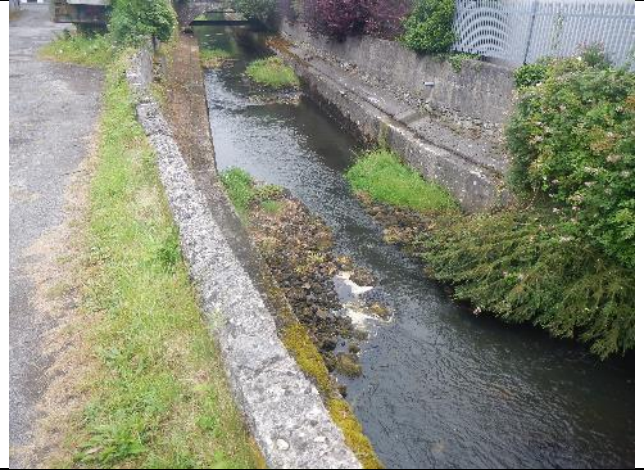
Figure 258: Tr 016. Habitat work immediately d/s: but as with many of the groynes on the Moy catchment, some were paired, reducing their benefit by unnecessarily constraining flow to the centre of the channel, rather than promoting sinuosity; they are also too closely spaced longitudinally. In this highly modified channel, they are an improvement, but the impact could be far more positive.

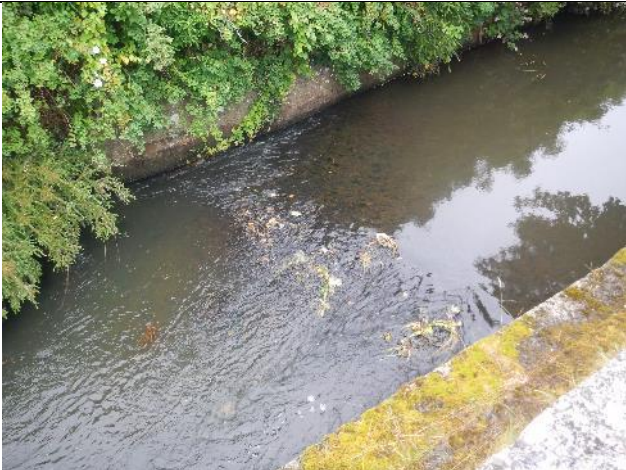
Figure 259: Tr 018. Occasional gravel bars had formed, demonstrating the requirement for width to facilitate coarse sediment retention, as well as narrower areas to create scour and depth. This demonstrates an issue with channel uniformity, rather than excess capacity. Increased flow sinuosity would facilitate more natural diagonal riffles that would better accommodate a range of flows.

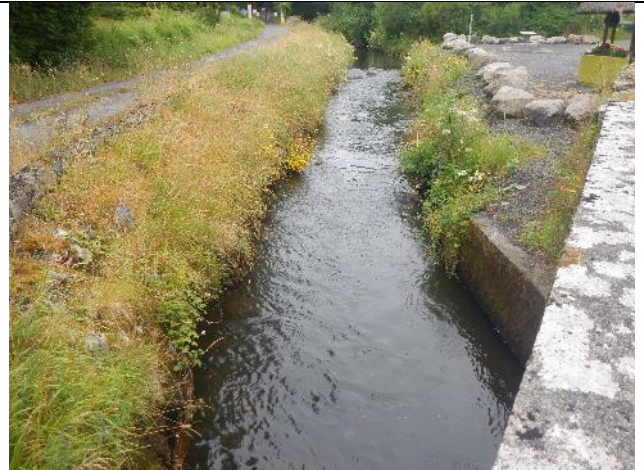
Figure 260: Tr 023. D/s of the village, the channel was still significantly modified, but had begun to improve naturally, with depositional features diversifying the bed and healthy bankside vegetation. The habitat continued to improve d/s. Numerous juvenile salmonids were observed u/s and d/s, demonstrating the potential value of this tributary.

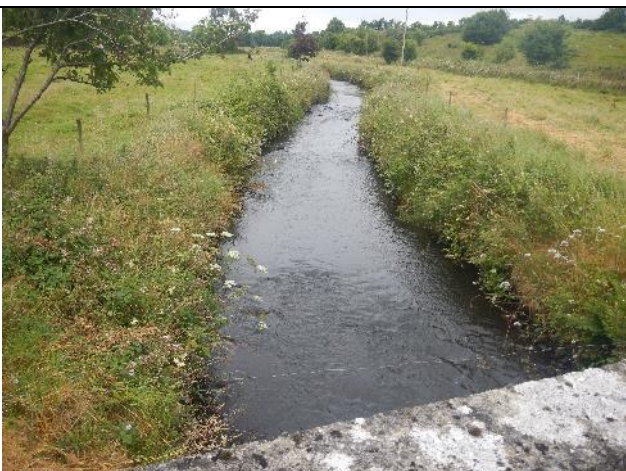
Figure 261: Tr 028 (53.864027, -8.871305). The river retained some sinuosity u/s of the next spot-check, with a semblance of a pool and riffle sequence, if still straighter and more uniform than natural. The higher value improved pasture in this area may reduce the potential for channel restoration, but it would be worth investigating, along with tree planting.

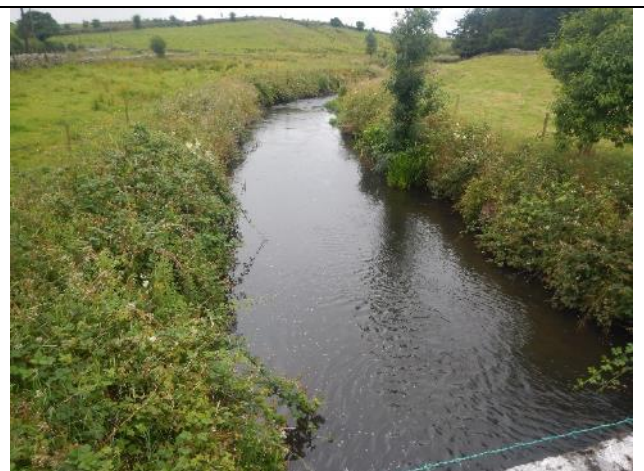
Figure 262: Tr 030. The habitat d/s was also reasonably good, with the first pool capable of supporting adult trout and valuable riffle features d/s. However, note the uniform width and incision of the channel below the adjacent land, strongly suggesting it had been dredged to those dimensions.

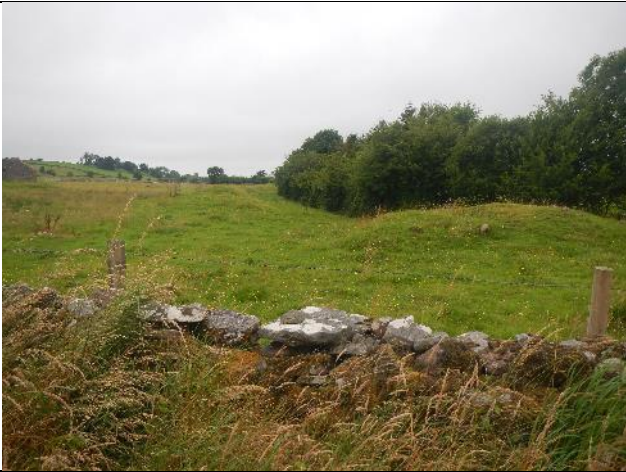
Figure 263: Tr 032 (53.865175, -8.88761). At the next spot-check, clear signs of past channel dredging were evident by the numerous spoil heaps alongside the river.

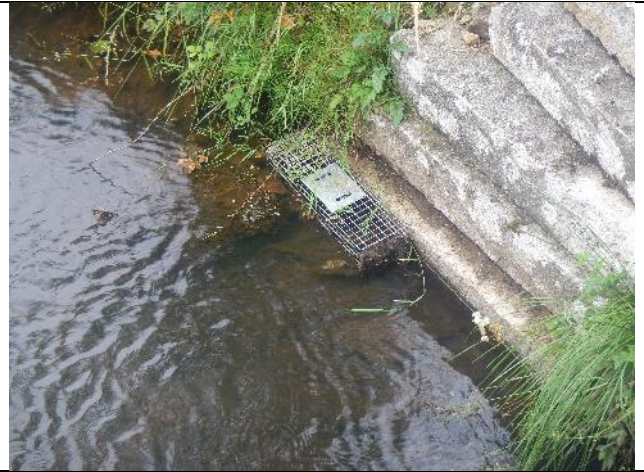
Figure 264: Tr 036. Someone appeared to be attempting to trap mink at the site. If so, the trapping of mink is commendable, but it is generally beneficial to trap within a tunnel/under cover to disguise the trap and increase the likelihood of mink entering. A 100mm restrictor should also be installed at the entrance to prevent others inadvertently being trapped, constituting an offence.

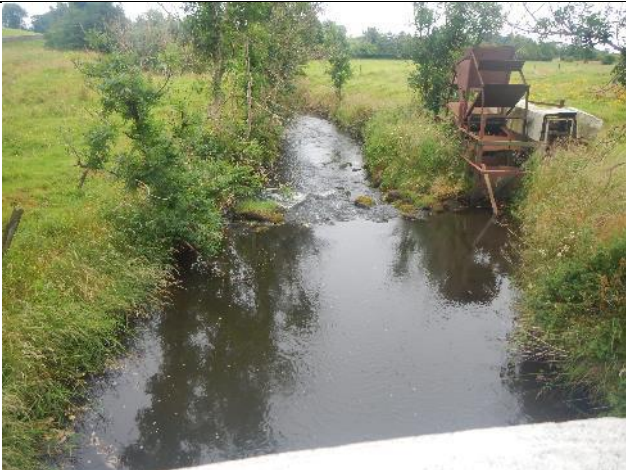
Figure 265: Tr 037 (53.865813, -8.88662). Signs of a small defunct hydropower installation, coupled with the mink trapping, suggests the landowner has an interest in the environment and may be open to river habitat improvements. Even removing the weir would be an improvement.

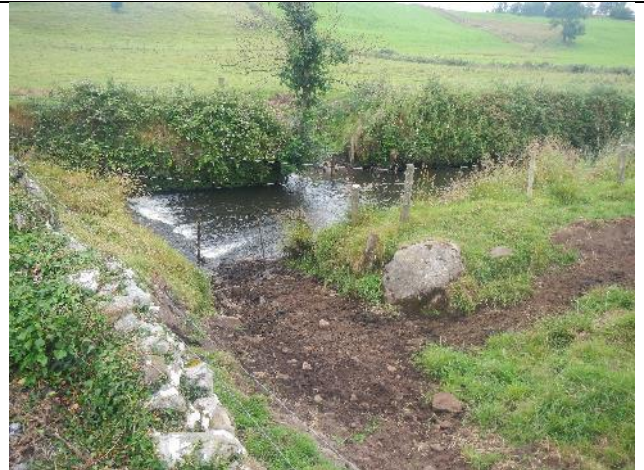
Figure 266: Tr 041 (53.866442, -8.891247). At the next spot-check d/s, significant poaching of cattle drinks at both bank sides created an issue. The perched bridge footings also created an obstruction which could be eased with baffles and/or a rock ramp d/s.

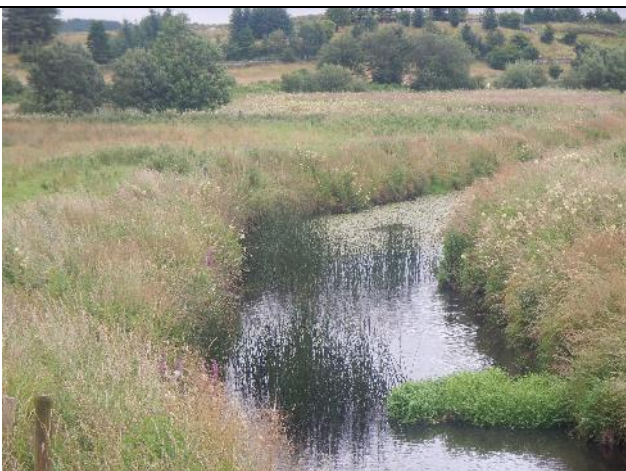
Figure 267: Tr 046 (53.870838, -8.908473). U/s at the next spot-check, the uniform and over-capacity channel had great potential for improvement through gravel riffle installation. D/s the channel was incredibly straight and would benefit from re-meandering but could still be improved with gravel introduction.

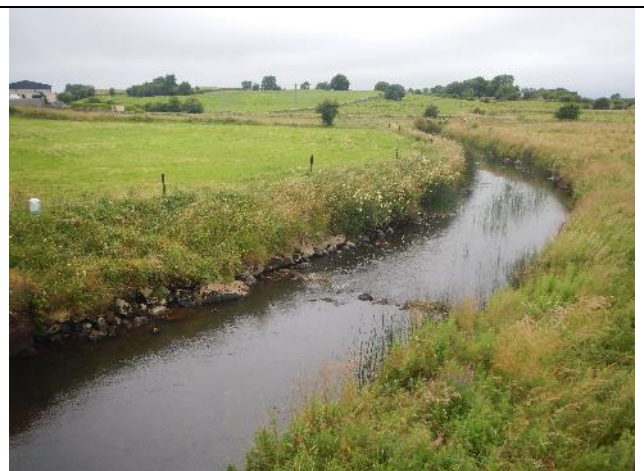
Figure 268: Tr 052 (53.86442, -8.924645). The next location was very similar and could be greatly improved with strategic riffle installation, being careful to work with the remaining bends and in-channel features. Removing the low-level weir would also be beneficial.

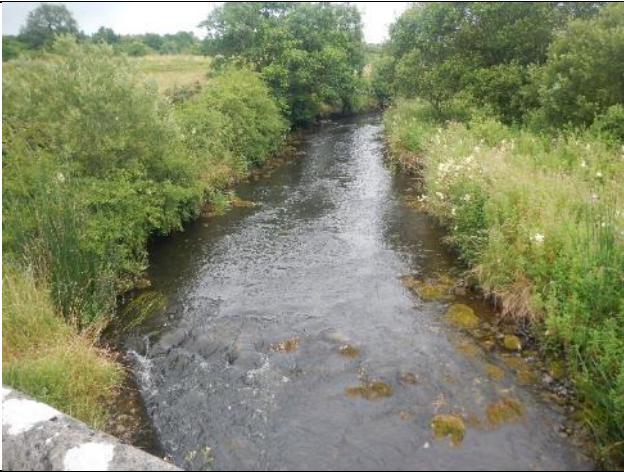
Figure 269: Tr 055 (53.874825, -8.95656). Looking u/s: by the next location the channel supported coarse cobble features and provided some reasonable quality juvenile salmonid habitat. The rougher, less improved ground further u/s may provide increased potential for restoration.

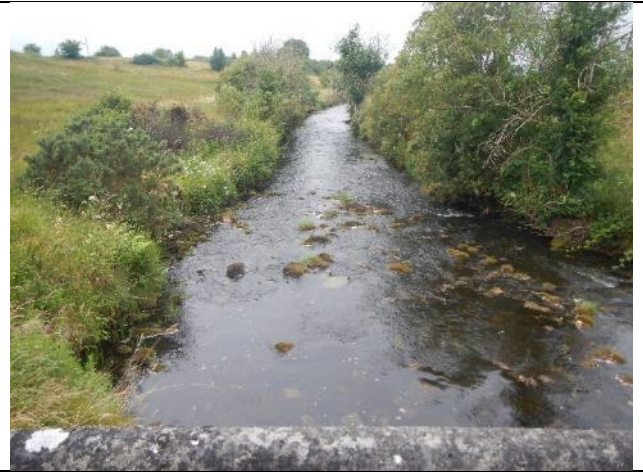
Figure 270: Tr 058. D/s, the habitat was similar and although juvenile salmonid habitat was present, it appeared that there was a shortage of smaller gravel/spawning substrate – likely to be owing to a lack of retention within the modified channel and probably a lack of supply.

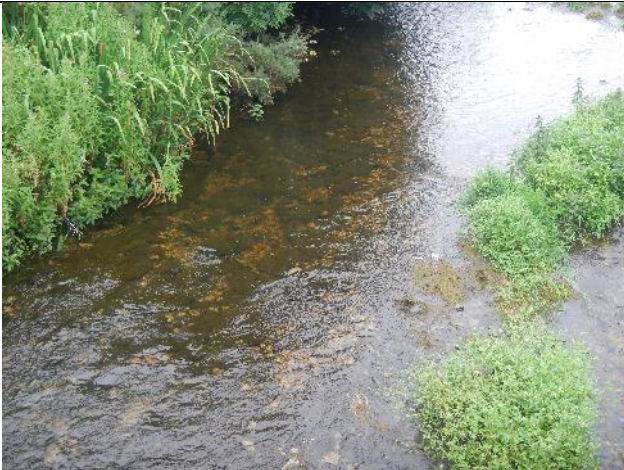
Figure 271: Tr 061. Around the R320 road crossing, gravel substrate was observed, with the potential for supporting salmonid spawning, although the lack of channel diversity and scouring/sorting had allowed moss and emergent vegetation to colonise many areas.

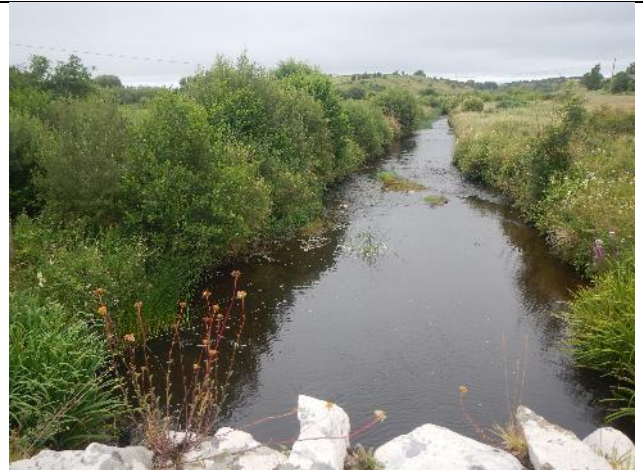
Figure 272: Tr 065. D/s, habitat had recovered about as well as could be hoped for within the confines of a straightened channel and will improve further as bankside trees grow in. However, what looked like lower, wet ground on the RB d/s could offer restoration potential. Failing that, some trees could be hinged into the channel to aid flow diversity/gravel retention.

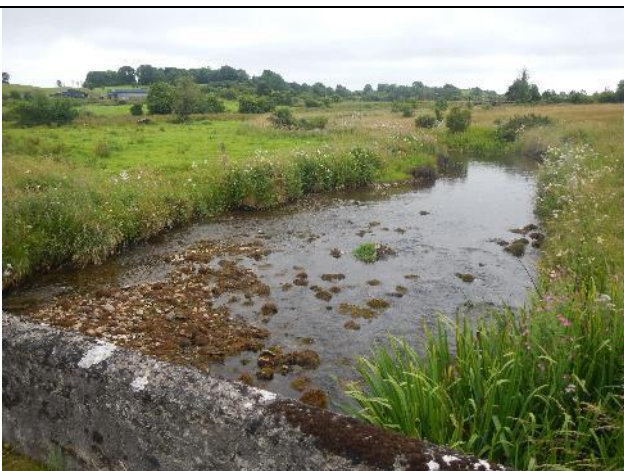
Figure 273: Tr 072 (53.904217, -8.998083). Towards the lower end of the Trimoge catchment, where the gradient was lower and the channel was much wider and less incised, with a few more bends, more gravel substrate was present and the river had a more natural feel. Increasing the channel sinuosity would still be beneficial to make the most of the improved sediment resource.

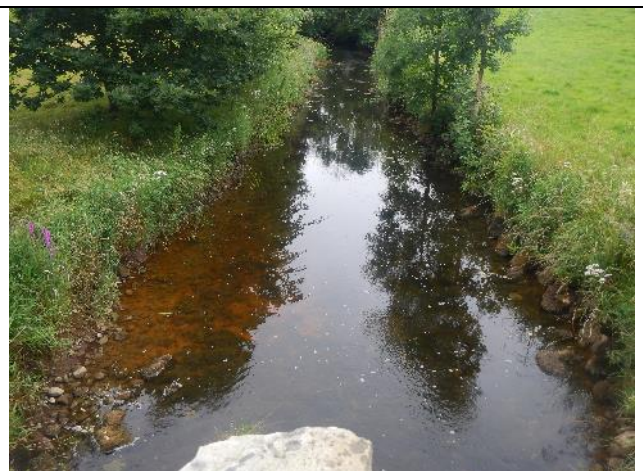
Figure 274: Tr 082. Although the channel remained uniform, numerous trout were observed at the furthest d/s bridge (and indeed throughout the catchment).

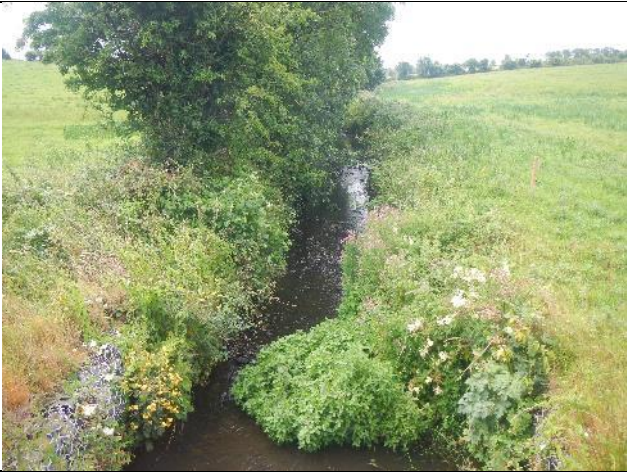
Figure 275: Ca 001 (53.904818, -9.064223). U/s of the N5 road, the Carroward River was significantly straightened but appeared to be buffered and the abundant coarse sediment provided potential salmonid spawning alongside reasonable juvenile habitat.

Photo	Observation	Recommendation	Lat/Long	Priority
Ca 001	Uniform, realigned channel	Investigate potential for channel restoration	53.904818, -9.064223	2
Ca 009	Increased turbidity and raised bridge footings	Investigate water quality between (53.904957, -9.063948 & 53.909758, -9.066288) Install fish easement (ideally small rock ramp d/s)	53.909758, -9.066288	2
Ca 017	Drinking bay (RB)	Exclude livestock and provide alternative water source	53.914252, -9.066257	2

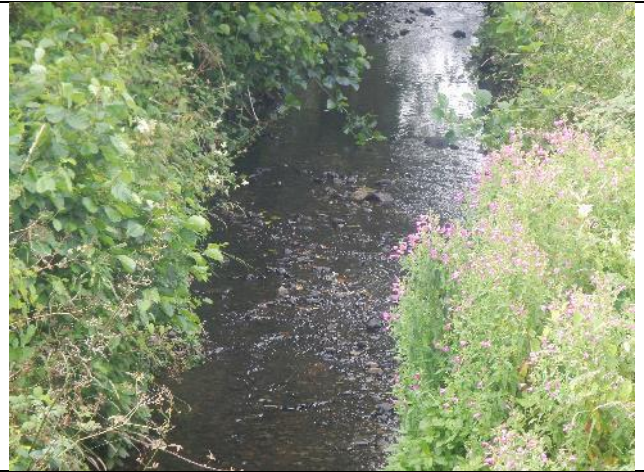
Figure 276: Ca 002. The abundance of mobile, coarse substrate observed in places means that this watercourse can more readily adapt to the past channel degradation and provides areas of improved spawning habitat in contrast to many other tributaries inspected. However, the dimensions of the straightened channel are not conducive to the maintenance of optimal pool and gravel riffle.

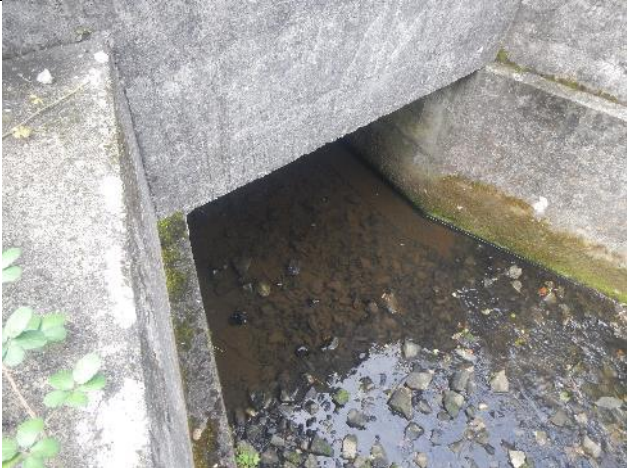
Figure 277: Ca 003. Despite being a large structure, the N5 road culvert was appropriately sunken and passable, with a somewhat natural bed.

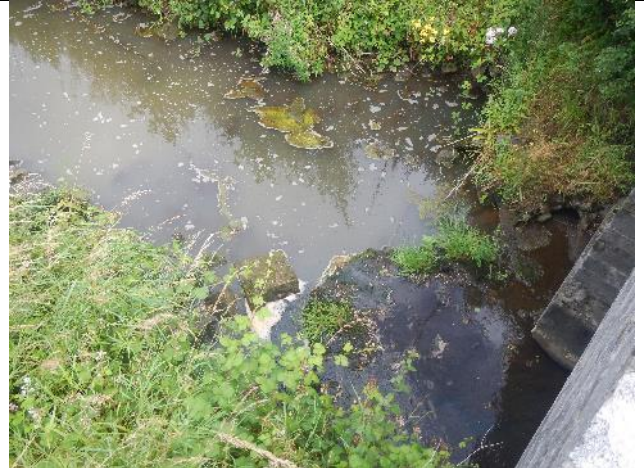
Figure 278: Ca 009 (53.909758, -9.066288). By the next spot-check, turbidity had significantly increased, suggesting a notable issue/input (53.904957, -9.063948 & 53.909758, -9.066288), where further investigation would be worthwhile. The raised footings of the bridge/culvert created an obstruction to fish passage in most flows.

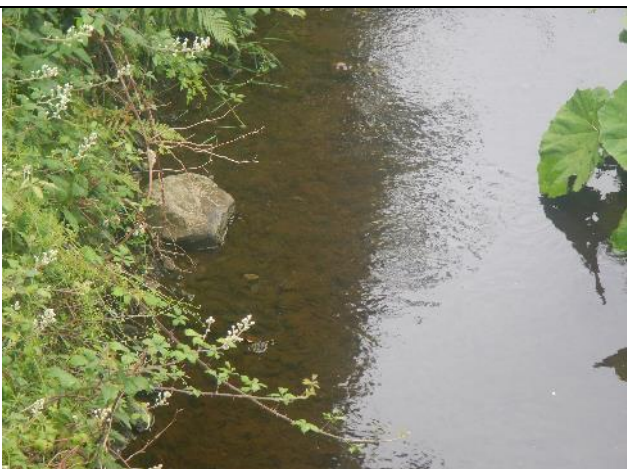
Figure 279: Ca 015 (53.914232, -9.066365). By the next road crossing d/s, there was an obvious impact of fine sediment deposition and algal growth upon the substrate.

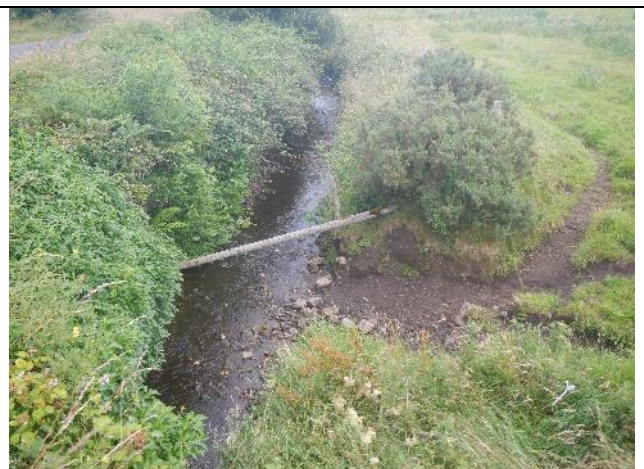
Figure 280: Ca 017 (53.914252, -9.066257). D/s of the crossing, livestock had access to the watercourse, leading to poaching.

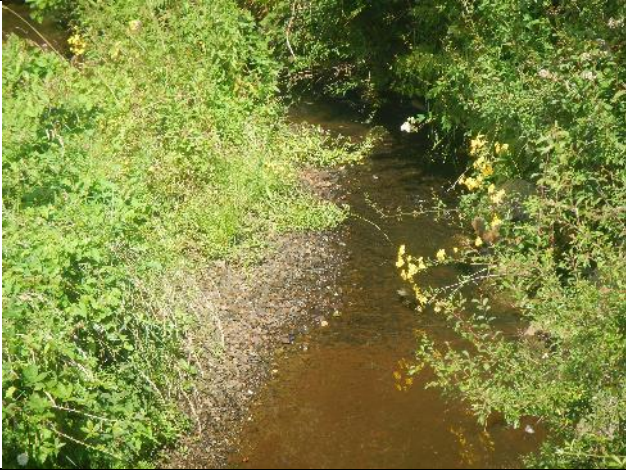
Figure 281: Ca 023. At bends in the river, where more natural coarse sediment retention was facilitated, gravel bars suitable for salmonid spawning were present. Also note the fine sediment reducing substrate habitat quality.

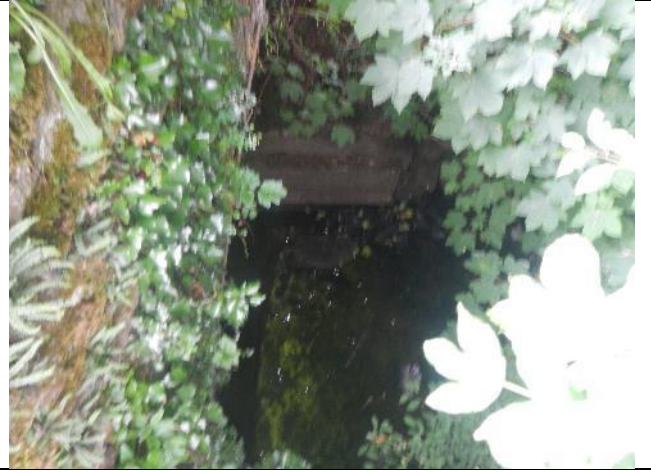
Figure 282: Ca 025 (53.929545, -9.082583). The furthest d/s road crossing was passable by fish, meaning that the only obstruction observed was at the u/s most R321 road crossing.

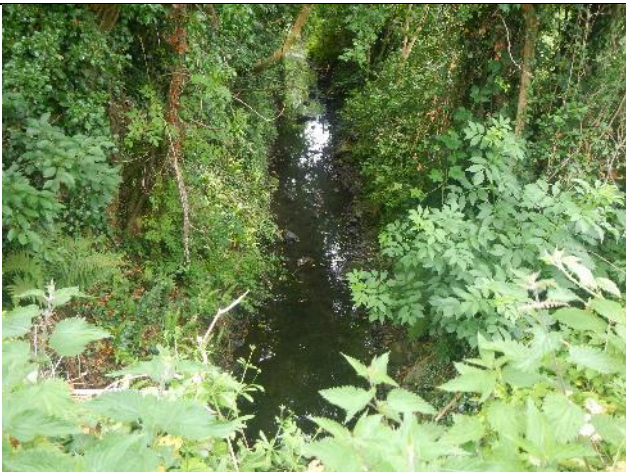
Figure 283: Ca(T1) 001 (53.91763, -9.076283). Low flow in the first tributary inspected reduced its value for fish, particularly low summer flow, but the natural coarse substrate it supplies to the system will contribute to habitat d/s.

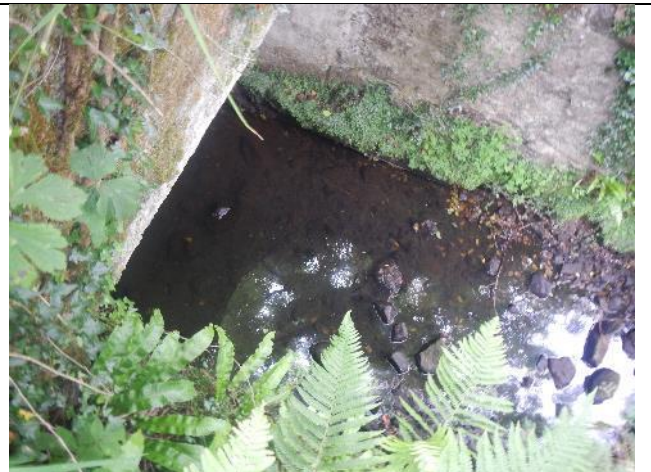
Figure 284: Ca(T1) 002. The tributary was accessible by fish, so spawning could occur there and some utilisation as a juvenile nursery area is possible.

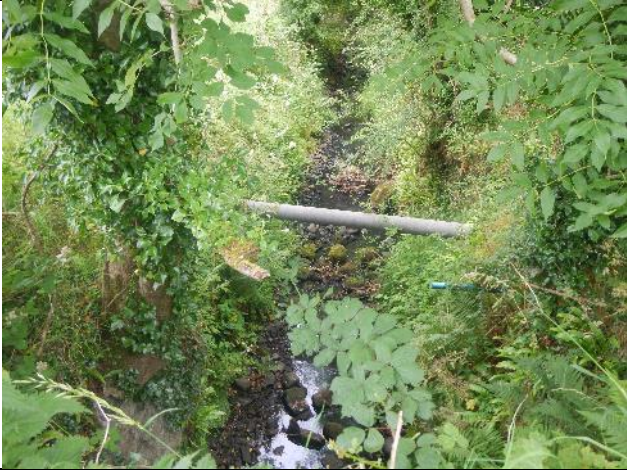
Figure 285: Ca(T1) 003. The overgrown vegetation offered a good balance of light and shade, and it may be capable of supporting trout in the deeper areas.

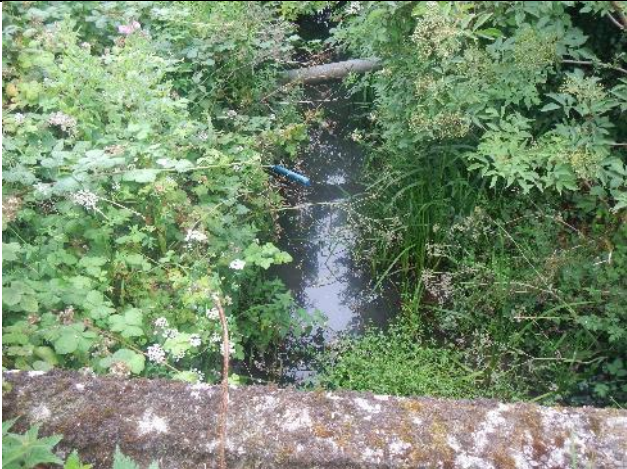
Figure 286: Ca(T2) 001 (53.921173, -9.082703). The second Carroward tributary was similarly small, but with less coarse substrate visible.

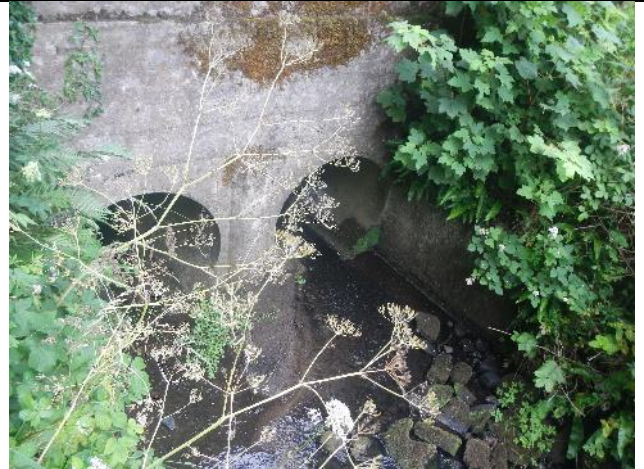
Figure 287: Ca(T2) 002. Accessibility for fish was not good owing to a pipe culvert with shallow water.

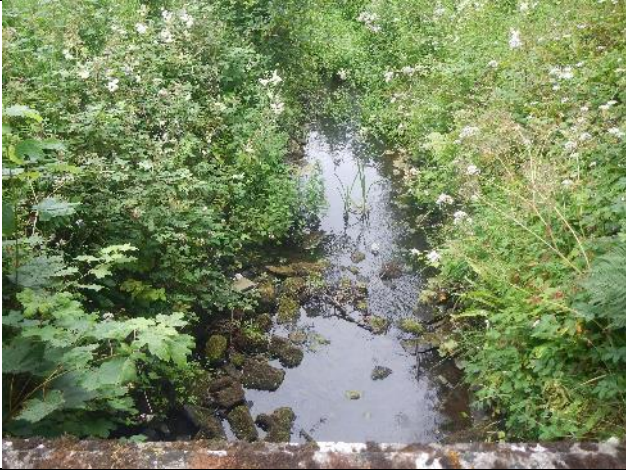
Figure 288: Ca(T2) 003. In the more natural sections, the tributary may have potential to support low densities of juvenile trout, particularly early in the year when flows are elevated. The riparian habitat was relatively good, and the watercourse appeared to be reasonably well protected from fine sediment inputs.

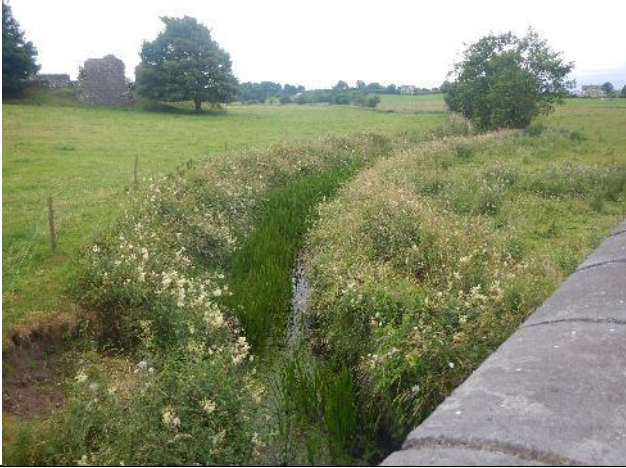
Figure 289: Ou 001 (53.935622, -9.105347). At the first spot-check, the Oughtagh River was uniform and over-capacity, with emergent vegetation encroaching into the channel. While this is a symptom of the issues, the channel narrowing was accelerating flow velocities and the watercourse would be expected to hold some juvenile trout.

Photo	Observation	Recommendation	Lat/Long	Priority
Ou 001	Uniform, realigned channel	Investigate potential for channel restoration. N.B. low priority owing to minimal cost-benefit in comparison to larger watercourses.	Entire catchment, particularly immediately u/s and d/s of 53.935622, -9.105347	3

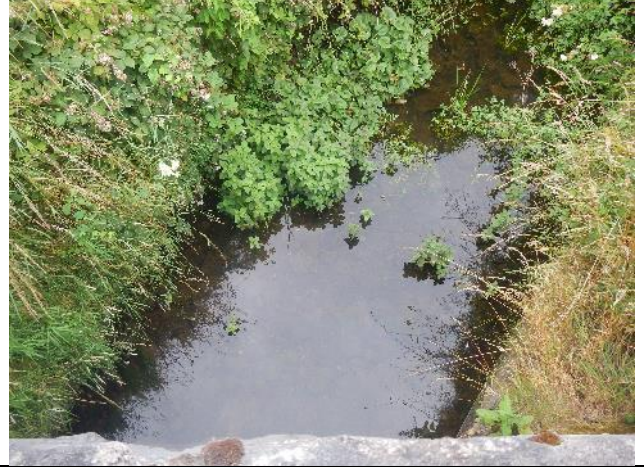
Figure 290: Ou 004 (53.935812, -9.105405). Where visible, the substrate was coarse, but with a similar gravel component to the Carroward (as it should), it could provide salmonid spawning and juvenile habitat.

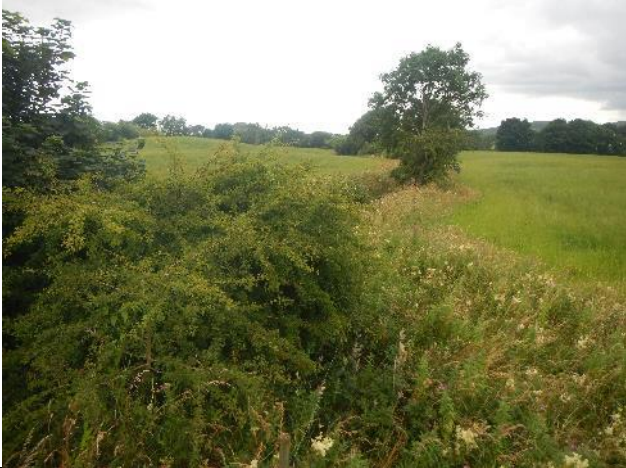
Figure 291: Ou 005. The Oughtagh appeared to be reasonably well buffered, with at least some riparian strip and vegetation, but even in the lower reaches it was a small watercourse.

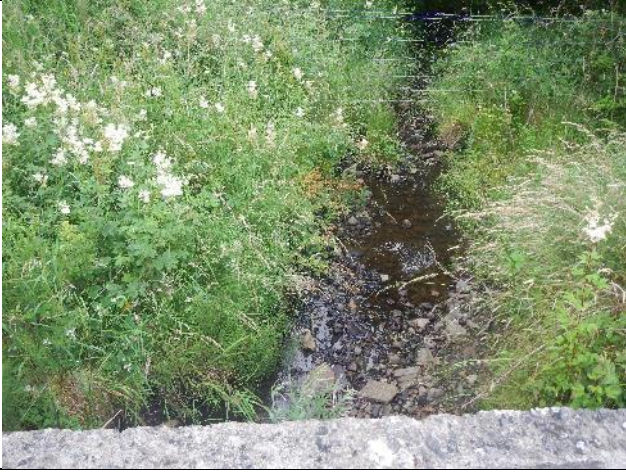
Figure 292: St 002 (53.873292, -9.119395). At the first spot-check, the Strade was small but protected by woodland u/s and supported valuable coarse substrate. When flows are elevated, sea trout often spawn in minor tributaries, from which fry disperse d/s as water levels reduce through the spring/summer. Similarly, juvenile salmonids may also disperse up tributaries.

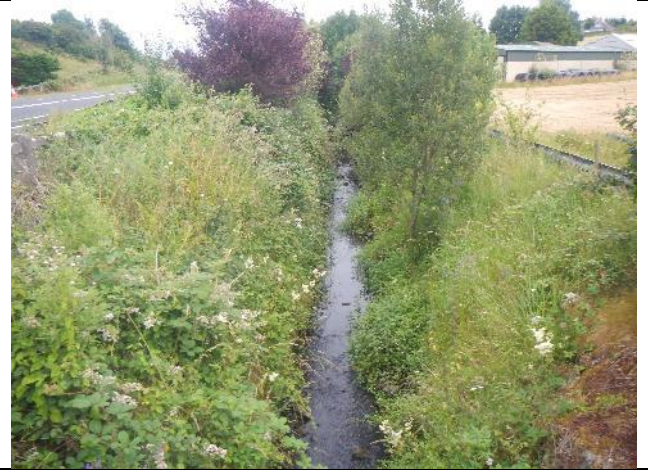
Figure 293: St 005 (53.890502, -9.131433). By the second site, where the watercourse was straightened alongside the N5 road, it had gained flow and juvenile salmonids were observed in the vicinity.

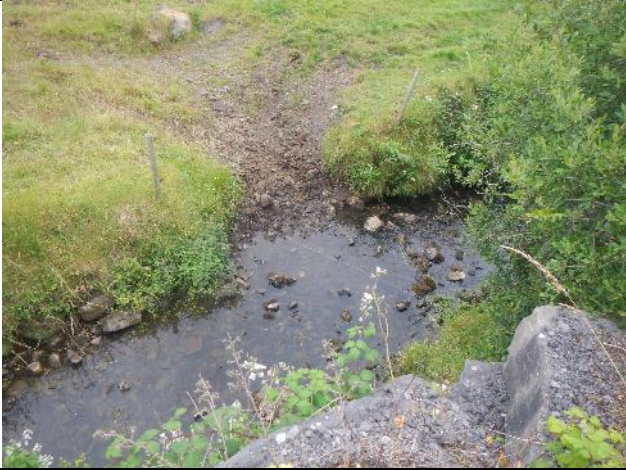
Figure 294: St 009 (53.891185, -9.132725), Livestock were gaining access from the LB, via a drinking bay.

Photo	Observation	Recommendation	Lat/Long	Priority
St 009	Drinking bay (RB)	Exclude livestock and provide alternative water source	53.891185, -9.132725	2
St 012	Livestock access	Exclude livestock and provide alternative water source	53.891553, -9.133018	2
St 013	Uniform, realigned channel	Investigate potential for channel restoration. N.B. low priority owing to minimal cost-benefit in comparison to larger watercourses.	53.893103, -9.13288	2-3
St 016	Uniform, realigned channel	Investigate potential for channel restoration. N.B. low priority owing to minimal cost-benefit in comparison to larger watercourses.	53.893105, -9.132817	2-3
St 018	Drinking bay (RB)	<ul style="list-style-type: none"> Exclude livestock and provide alternative water 	53.915868, -9.132168	1
		<ul style="list-style-type: none"> Investigate restoration options 	53.902514, -9.130792	
St 035	Uniform, realigned channel	Investigate potential for channel restoration	53.92857, -9.12446	2

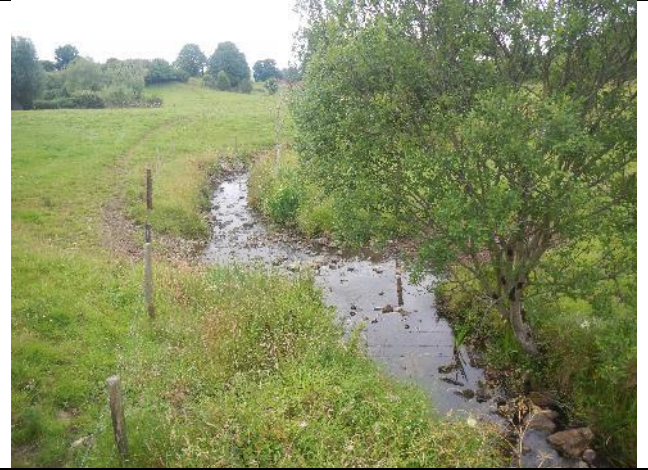
Figure 295: St 012 (53.891553, -9.133018). Livestock had access to both banks d/s of the N5 road, via a drinking bay/fording point. Keeping livestock away from the watercourse and providing alternative watering would be beneficial.

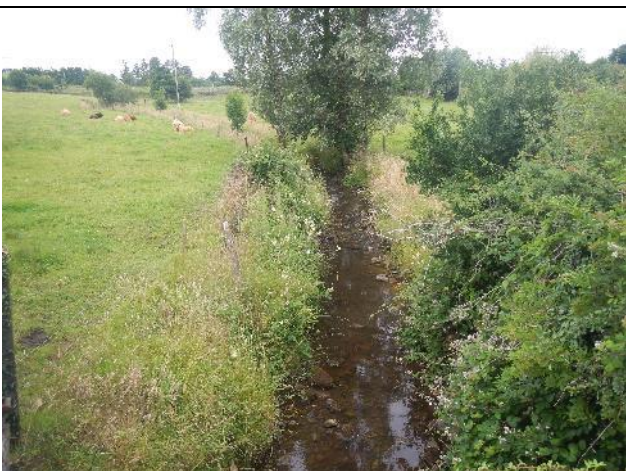
Figure 296: St 013. The river was buffer fenced u/s of the Old Road bridge and habitat appeared capable of supporting juvenile salmonids, although the channel was straightened and substrate was coarse and poorly sorted, with and increased algal covering. Livestock access at one or two drinking bays/crossings u/s could cause this enrichment on such a small watercourse.

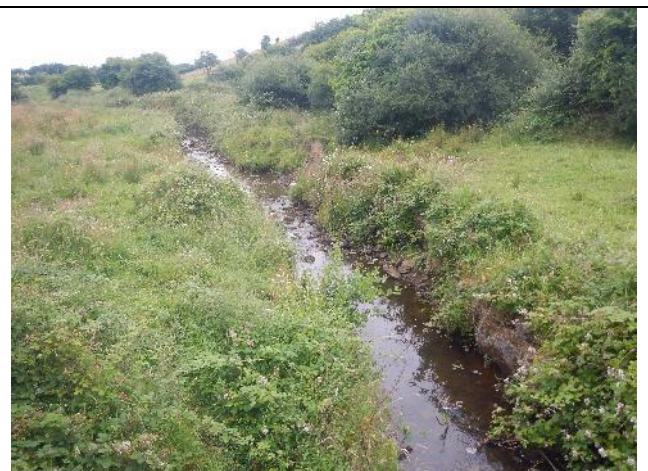
Figure 297: St 016 (53.893105, -9.132817). D/s of the Old Road, the river remained straightened and lacked buffer fencing, but the banks appeared to be reasonably well vegetated, apart from at crossing points. Fencing would be beneficial and restoration could be a possibility within the unimproved grassland.
