WILD TROUT TRUST

**River Moy Habitat Assessment
and
Management Plan**

East Mayo Angling Association, Co. Mayo, Ireland

July 2022

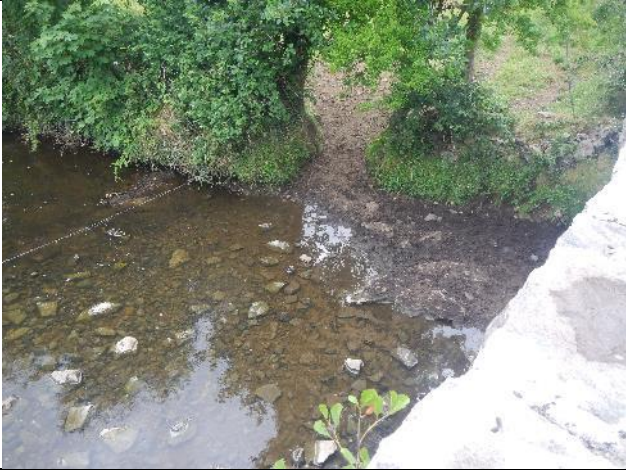
Figure 298: St 018 (53.915868, -9.132168). Significant poaching and fine sediment input were occurring at the L17141 road crossing. A long section u/s was inaccessible, in which water from the larger Little Strade River had bolstered the flow. Aerial photography shows past river channels in wet ground around 53.9025143, -9.1307923 may offer potential for restoration.

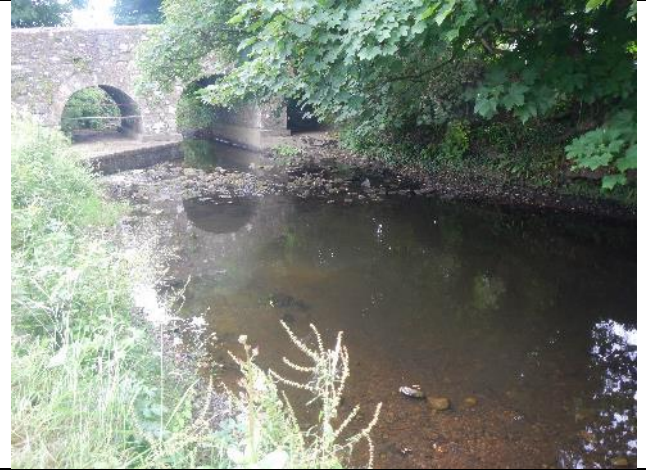
Figure 299: St 024 (53.921438, -9.130137). With the additional flow, the river was capable of supporting good numbers of salmonids, although the river was clearly at a low summer level. It is likely that fish from u/s (or d/s) had moved into deeper pools like this, where >20 juvenile salmonids were observed - showing the river's importance and potential.

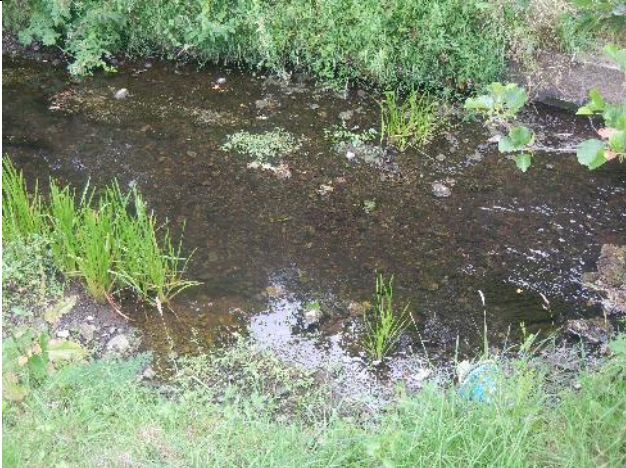
Figure 300: St 025. Areas of unconsolidated gravel bed suggests that scouring and active sediment transport occurs at higher flows; an important factor in keeping gravels free from fine sediment and maintaining habitat quality.

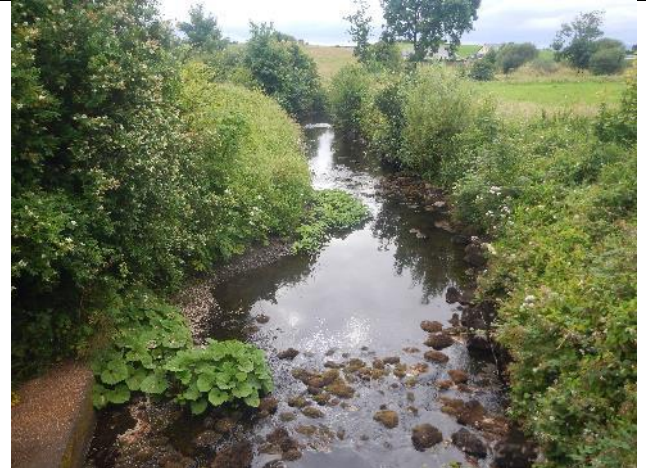
Figure 301: St 030. D/s of the N58, the substrate was largely coarse cobble and boulder (likely owing to significant straightening and steepening d/s), with fewer opportunities for spawning, but pool and riffle habitat suitable for adult trout, parr and fry was available.

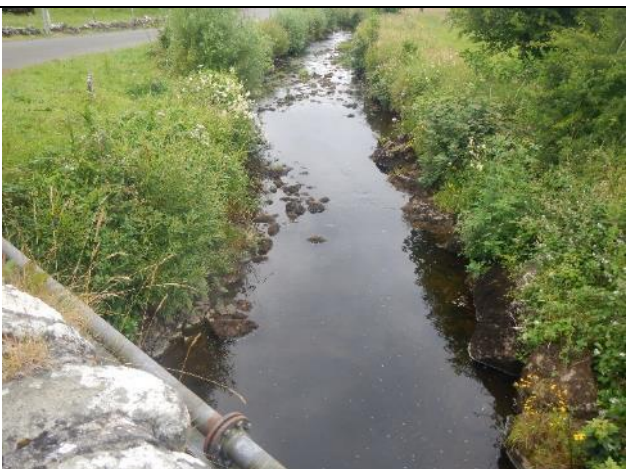
Figure 302: St 035 (53.92857, -9.12446). Habitat remained similar around the u/s most of L1715 road crossings, with a predominance of cobble and boulder, with pools holding good numbers of older juvenile salmonids. The lack of gravel retention could be at least partially addressed by increasing structure like woody material within the channel or full restoration.

Photo	Observation	Recommendation	Lat/Long	Priority
St 009	Drinking bay (RB)	Exclude livestock and provide alternative water source	53.891185, -9.132725	2
St 012	Livestock access	Exclude livestock and provide alternative water source	53.891553, -9.133018	2
St 013	Uniform, realigned channel	Investigate potential for channel restoration. N.B. low priority owing to minimal cost-benefit in comparison to larger watercourses.	53.893103, -9.13288	2-3
St 016	Uniform, realigned channel	Investigate potential for channel restoration. N.B. low priority owing to minimal cost-benefit in comparison to larger watercourses.	53.893105, -9.132817	2-3
St 018	Drinking bay (RB)	<ul style="list-style-type: none"> Exclude livestock and provide alternative water 	53.915868, -9.132168	1
		<ul style="list-style-type: none"> Investigate restoration options 	53.902514, -9.130792	
St 035	Uniform, realigned channel	Investigate potential for channel restoration	53.92857, -9.12446	2

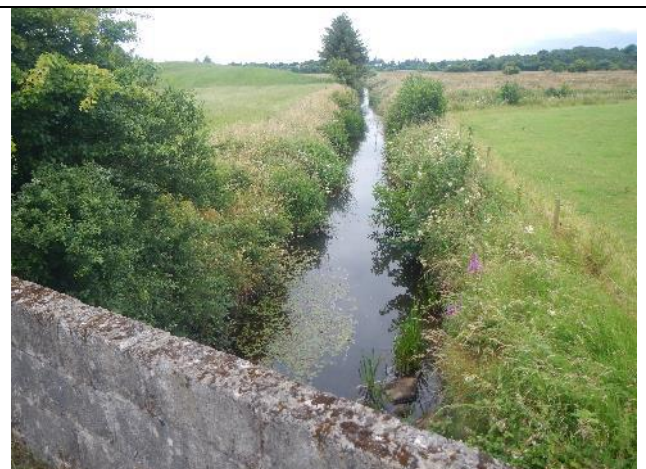
Figure 303: St 036 (53.936575, -9.120133). Around the d/s L1517 crossing, the channel was incredibly straight, uniform and lacking diversity. The entire lower ~800m of the Strade was straightened, degrading prime lower tributary salmon spawning areas. Paleo channels in the wet, LB fields (visible on aerial photography) offer opportunities for channel restoration.

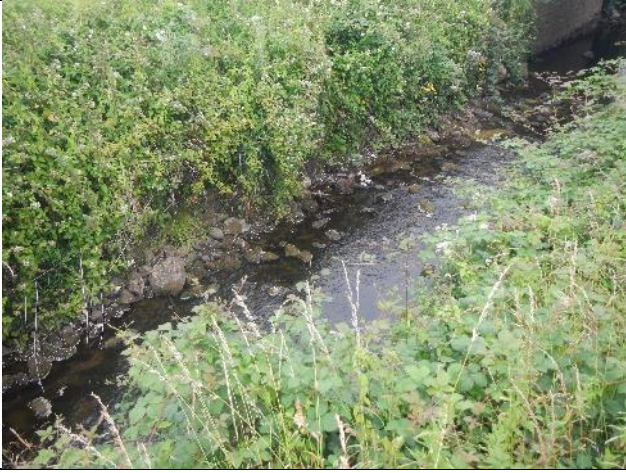
Figure 304: St 039. The lower reaches of the channel were reasonably accessible for fish, with the road culverts set at an acceptable level and retaining natural substrate; however, an extended shallow section (without pools or resting areas) had resulted from the channel realignment, straightening an increased gradient. This is likely to create some behavioural barrier in lower flows.

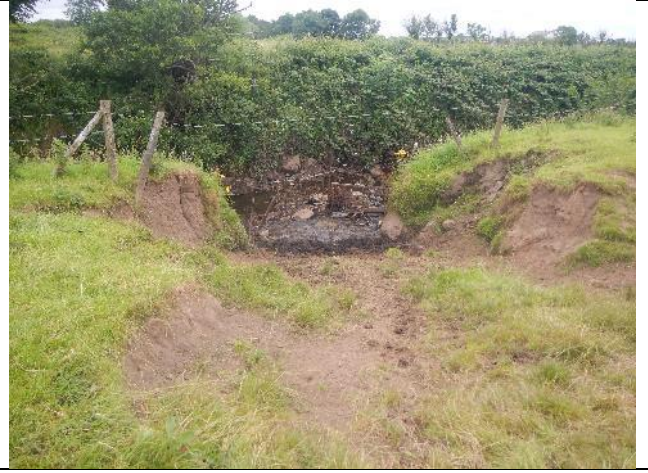
Figure 305: St 042 (53.937713, -9.120028). A clear impact of livestock at a drinking bay. While this is towards the lower end of the Strade River, the negative impact from fine sediment input will still affect the main river Moy.

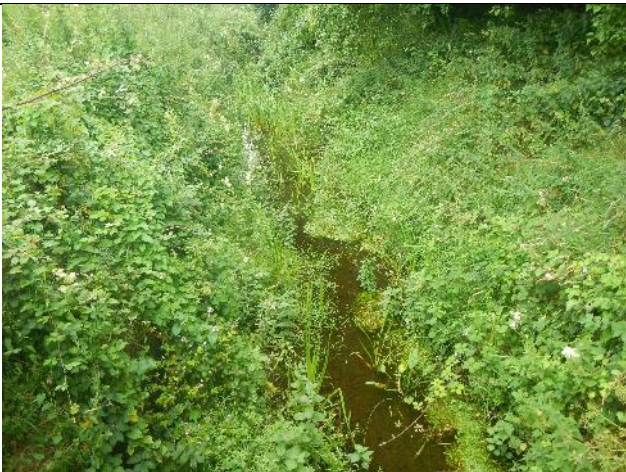
Figure 306: St(T1) 002 (53.92984, -9.117228). U/s and immediately d/s of the N58 road, this small RB tributary of the Strade was straightened and uniform, with minimal flow diversity and emergent vegetation encroaching into the channel. There were also signs of excess algal growth on the bed.

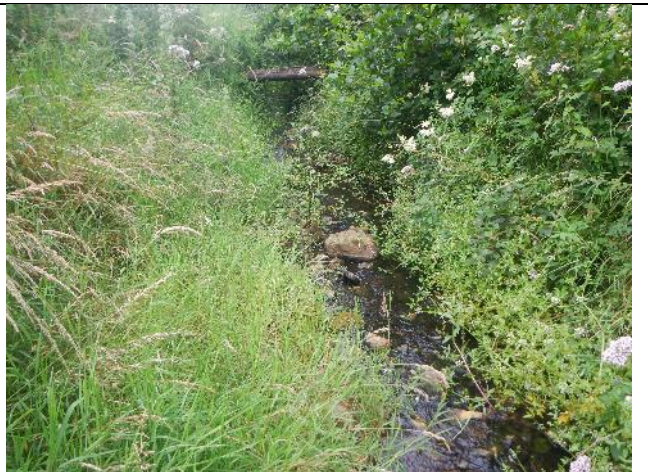
Figure 307: St(T1) 006 (53.929953, -9.11738). At a second road crossing, just d/s of the N58, increased gradient and the presence of coarse substrate provided improved juvenile salmonid habitat. Further d/s the channel was significantly straightened. Both road crossing points appeared to be reasonably passable in higher flow.

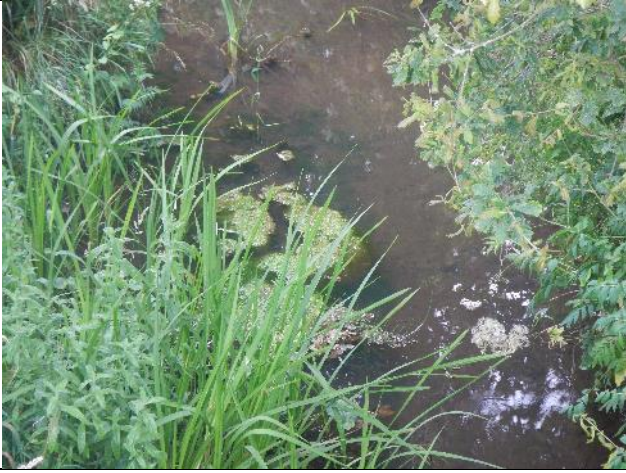
Figure 308: St(T1)7 (53.935737, -9.118042). Excess algal growth was regularly observed in slower flowing areas suggesting nutrient enrichment of the tributary.

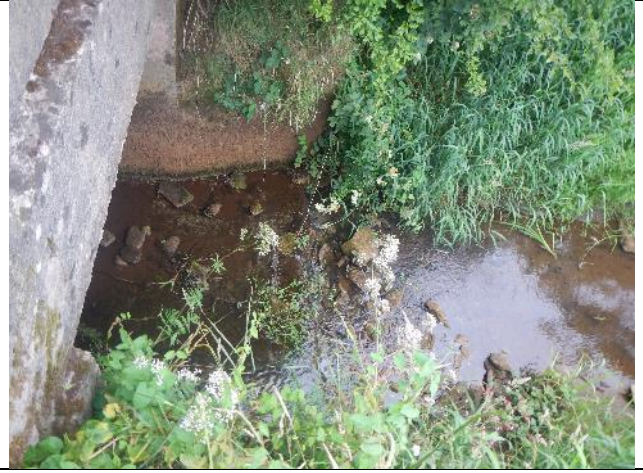
Figure 309: St(T1)10 (53.935777, -9.118007). The L715 road crossing was passable but shallow water and a step posed a small obstruction to fish passage.

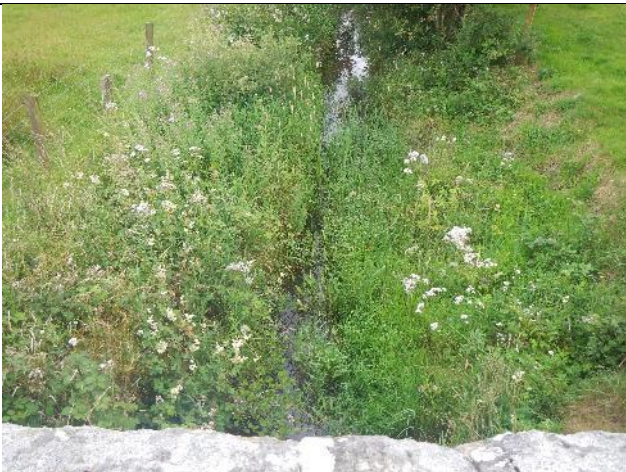
Figure 310: St(T2) 001 (53.934632, -9.125823). Only seen from one point on the L1715 road, the second tributary appeared to be little more than a weed-choked, straightened ditch draining Lough Cat, but it was largely buffer fenced.

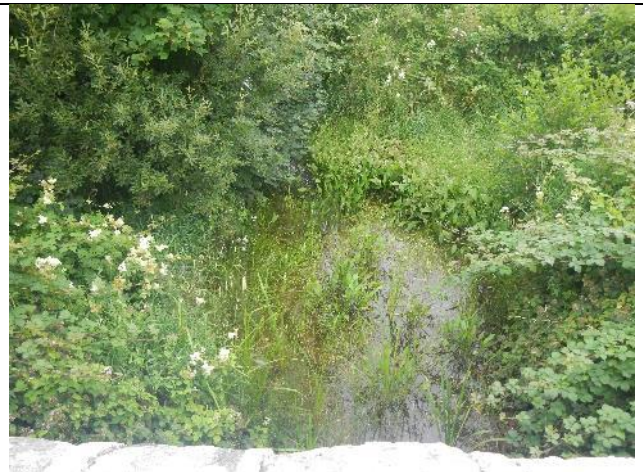
Figure 311: St(T2) 002. D/s of the road, the channel was weed-choked and barely discernible.

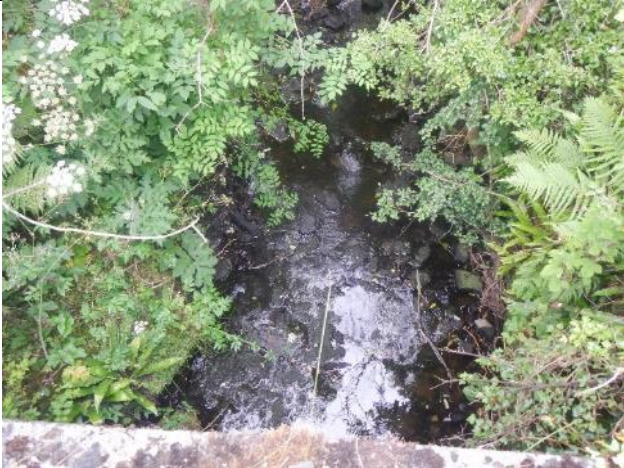
Figure 312: LiSt 003 (53.851408, -9.100147). The little Strade appeared larger than the Strade on maps, comprising two reasonably large, branched tributaries. Even at the furthest u/s point inspected around an area of forestry, it appeared capable of supporting juvenile salmonids.

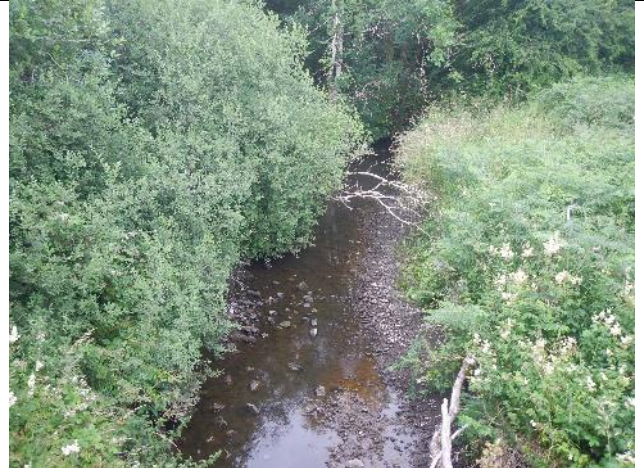
Figure 313: LiSt 004 (53.864535, -9.101107). At the second spot-check (L1713 road crossing), deposition at the wider channel cross section demonstrated the availability of gravel substrate and the river's potential as a spawning tributary.

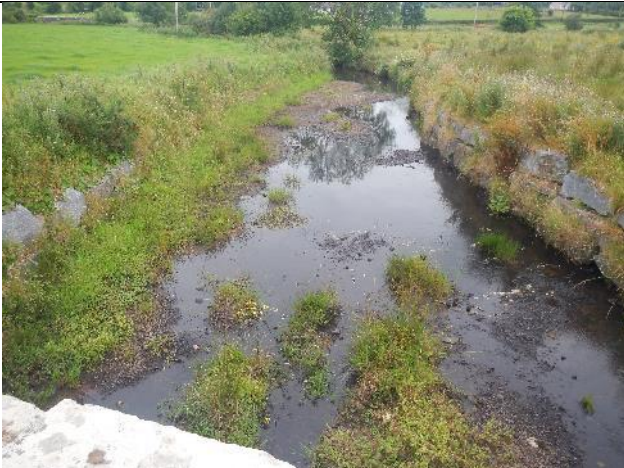
Figure 314: LiSt 008 (53.874942, -9.102335). Overwide channel at the next spot-check further demonstrating the habitat and spawning potential of this river if the channel could be returned to a more naturally variable width. The substrate was still likely to support salmonid spawning.

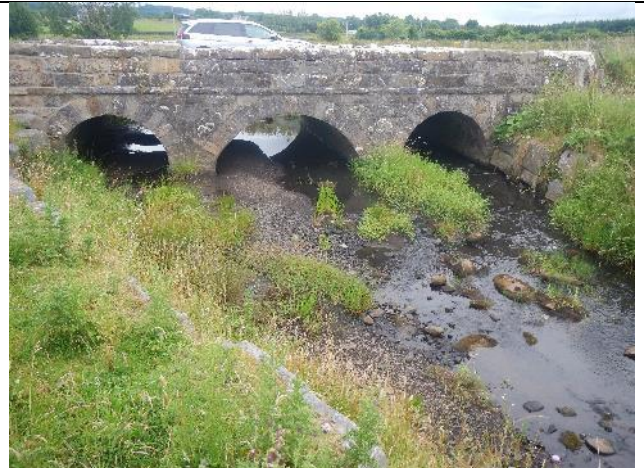
Figure 315: LiSt 009 (53.875122, -9.102458). The significant size of the bridge may suggest that the watercourse supported greater flow before extensive drainage of the catchment and may still do during wetter months of the year.

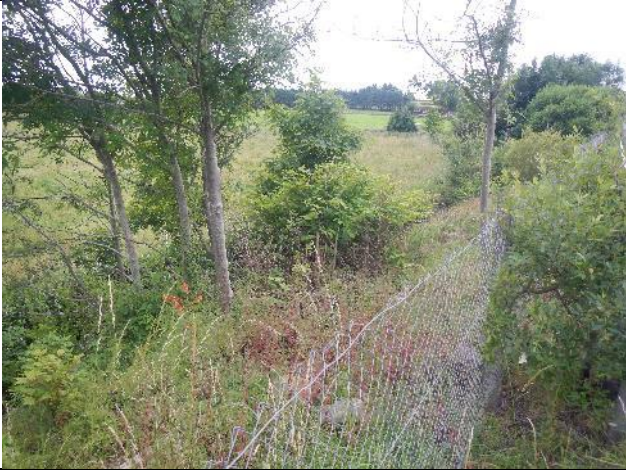
Figure 316: LiSt 012 (53.892647, -9.110872). Japanese knotweed was observed on the banks of the river, at a particularly straight section of channel along the N5 road. This highly invasive non-native species should be treated with herbicide by a licensed operative to prevent it spreading.

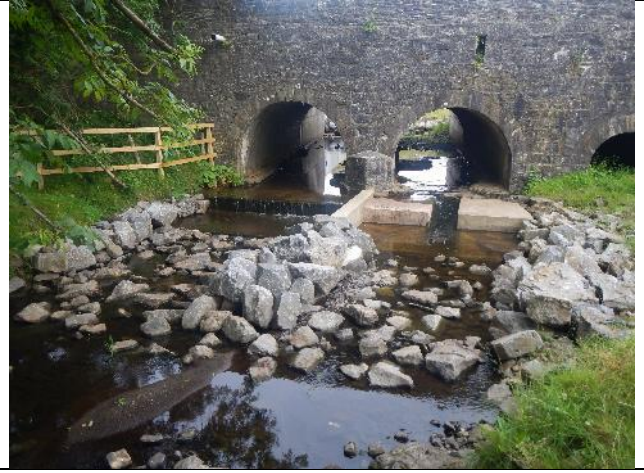
Figure 317: LiSt 017 (53.892908, -9.110955). Recent work at the N5 bridge footings may afford some fish passage but could have been fish friendlier if the rock armouring had simply been finished to the height above that of the footings. Access was not possible d/s, but increased sinuosity in the lower reaches may offer improved habitat quality worthy of further investigation.

Photo	Observation	Recommendation	Lat/Long	Priority
LiSt 017	<p>Missed opportunity for freely passable bridge footings</p> <p>Sinuuous channel in lower reaches of the river</p>	<ul style="list-style-type: none"> • Ensure expert fish passage advice is sought for all in-channel structures • Install further easement to footings • Undertake further investigation to ascertain potential for habitat enhancement 	53.892908, -9.110955 and d/s	2
LiSt(T2) 005	Uniform, realigned channel	Investigate potential for channel restoration. N.B. medium to low priority owing to minimal cost-benefit in comparison to larger watercourses	53.871932, -9.09791	2
LiSt(T2) 007	Excess algal growth/enrichment	Investigate sources	53.874682, -9.100033	2

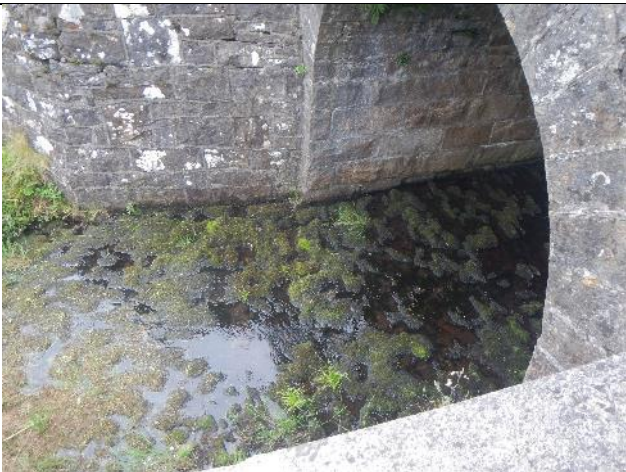
Figure 318: LiSt(T1) 002 (53.852845, -9.094737). At the u/s spot-check, the first Little Strade tributary was little more than a trickle.

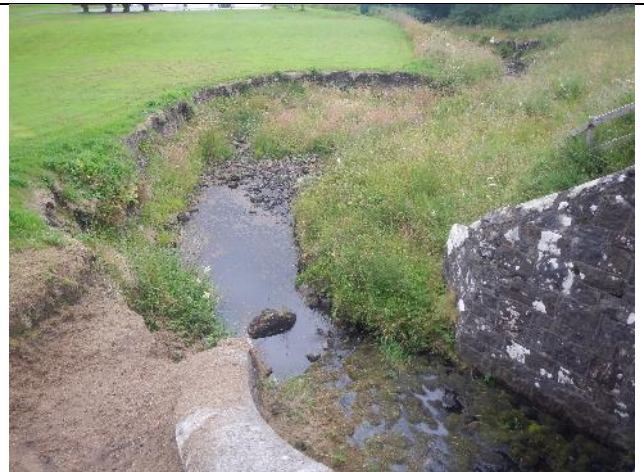
Figure 319: LiSt(T1) 003. Even in higher flow, fish access further u/s would be inhibited by infrastructure associated with e road crossing, but the habitat d/s appeared to have potential for juvenile salmonids, particularly in higher flow months.

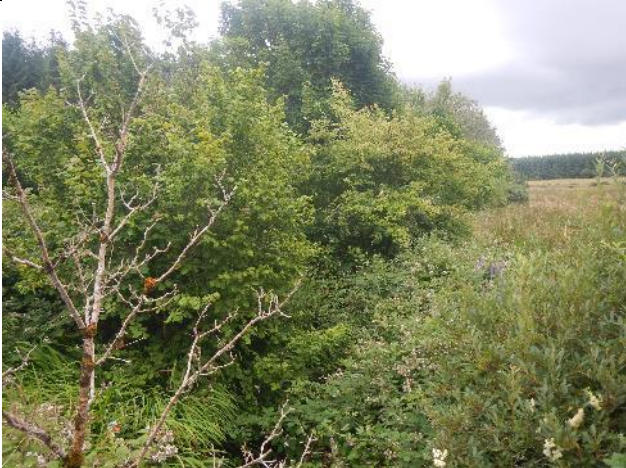
Figure 320: LiSt(T2) 001 (53.863023, -9.091295). At the u/s point inspected, this tributary was straightened, very overgrown and overshadowed, but was therefore reasonably protected by the bankside vegetation.

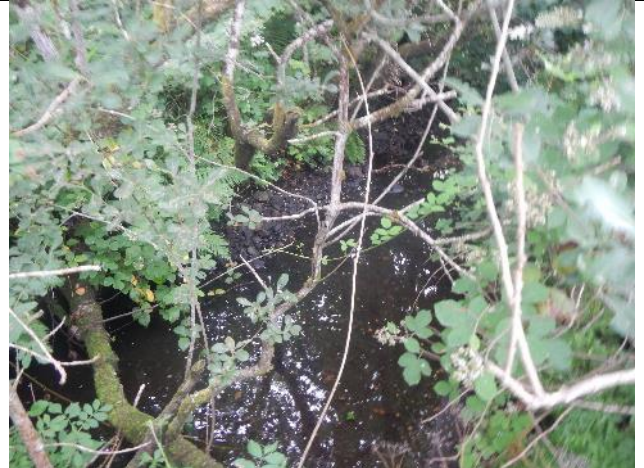
Figure 321: LiSt(T2) 004. Although the flow was minimal, the substrate was coarse and relatively free from fine sediment, suggesting much higher flows at other times.

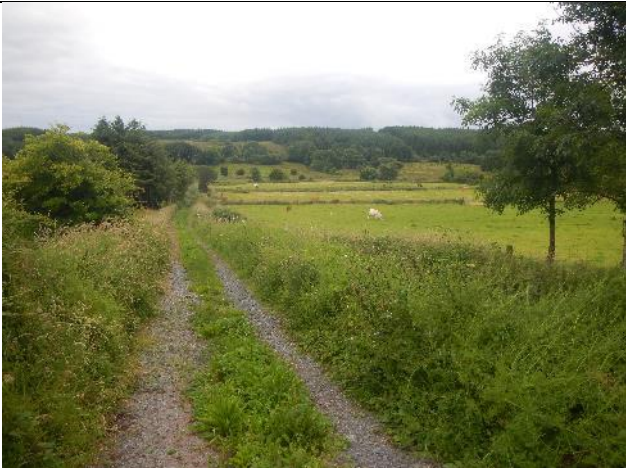
Figure 322: LiSt(T2) 0005 (53.871932, -9.09791). Much of the adjacent land through the middle reaches (poorly accessible by road) appeared to be improved grazing, where areas of wet ground, boundaries on maps and aerial photography suggest significant straightening of the watercourse had occurred.

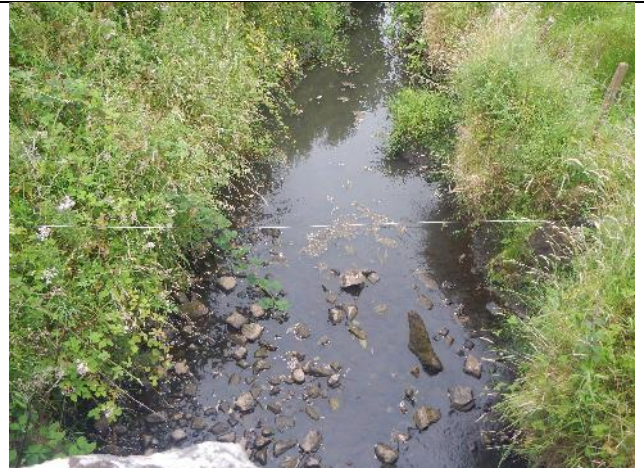
Figure 323: LiSt(T2) 007 (53.874682, -9.100033). At the furthest d/s spot-check, discolouration of the water and excess algal growth strongly suggested enrichment issues (and likely livestock access to the watercourse) on what could be a spawning tributary.
